# **Investigation of the Building M6-794 Roofing Fatality Type A Mishap**

**Complete Report with Endorsements  
And Final Approval By Appointing Official**

Mishap Report  
May 2006

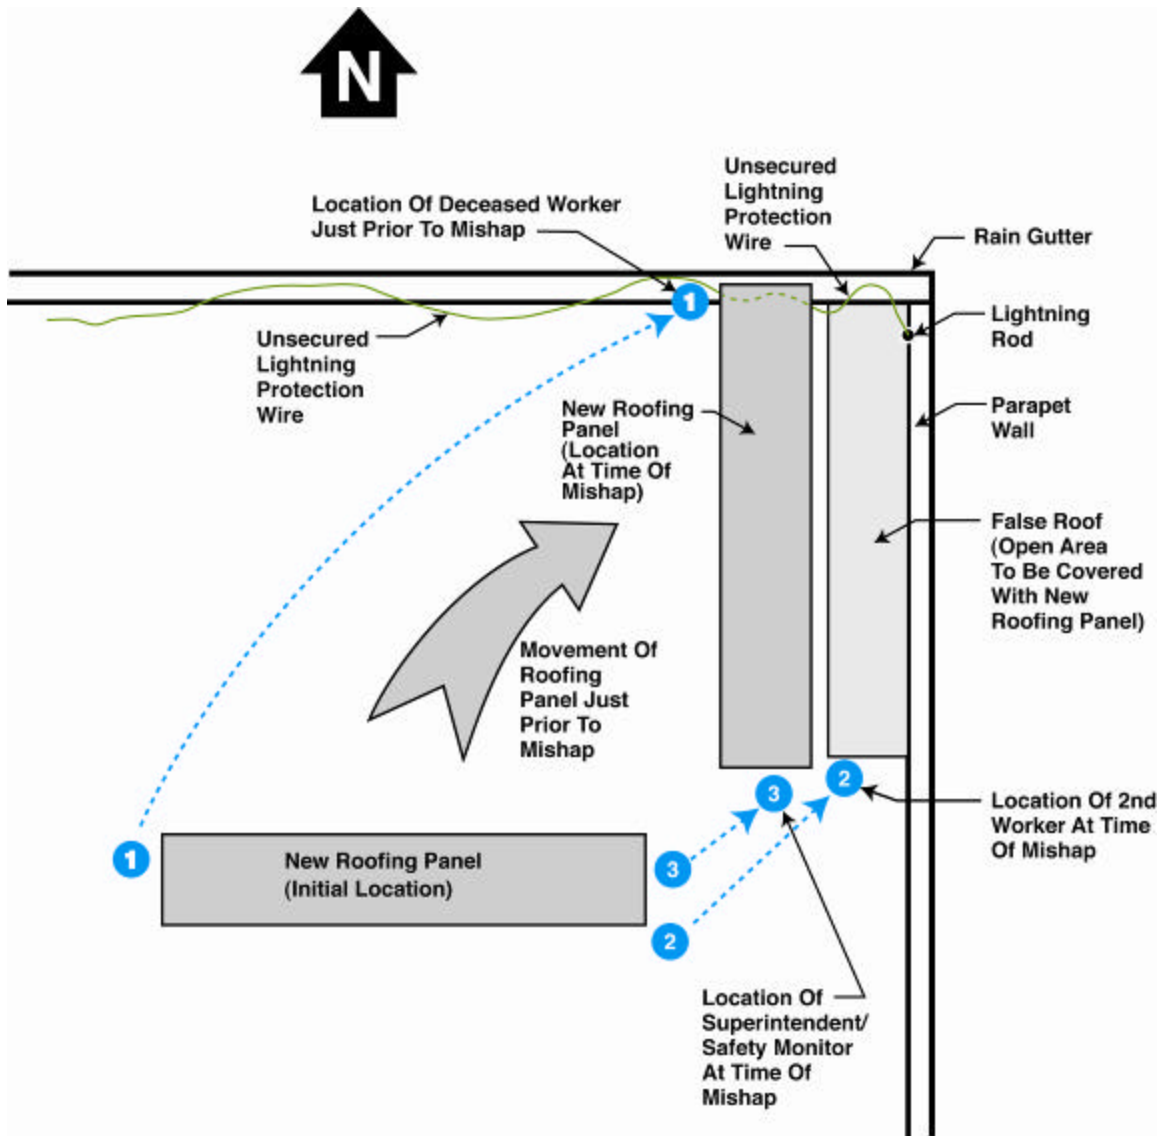
**Figure 1. Plan (Bird's Eye) View of Northeast Corner of Building M6-794 (Mishap Location)**

parallel to the roof edge. The superintendent/safety monitor (Worker 3) then picked up the uphill end of the new panel, while Worker 1 (deceased) picked up the downhill end. Together they began to carry the new panel into its final position, rotating it perpendicular to the roof edge. Worker 1 was located closest to the leading edge of the roof and walked with the panel toward the edge, while the superintendent/safety monitor acted as a pivot point, holding his end of the panel (see Figure 1).

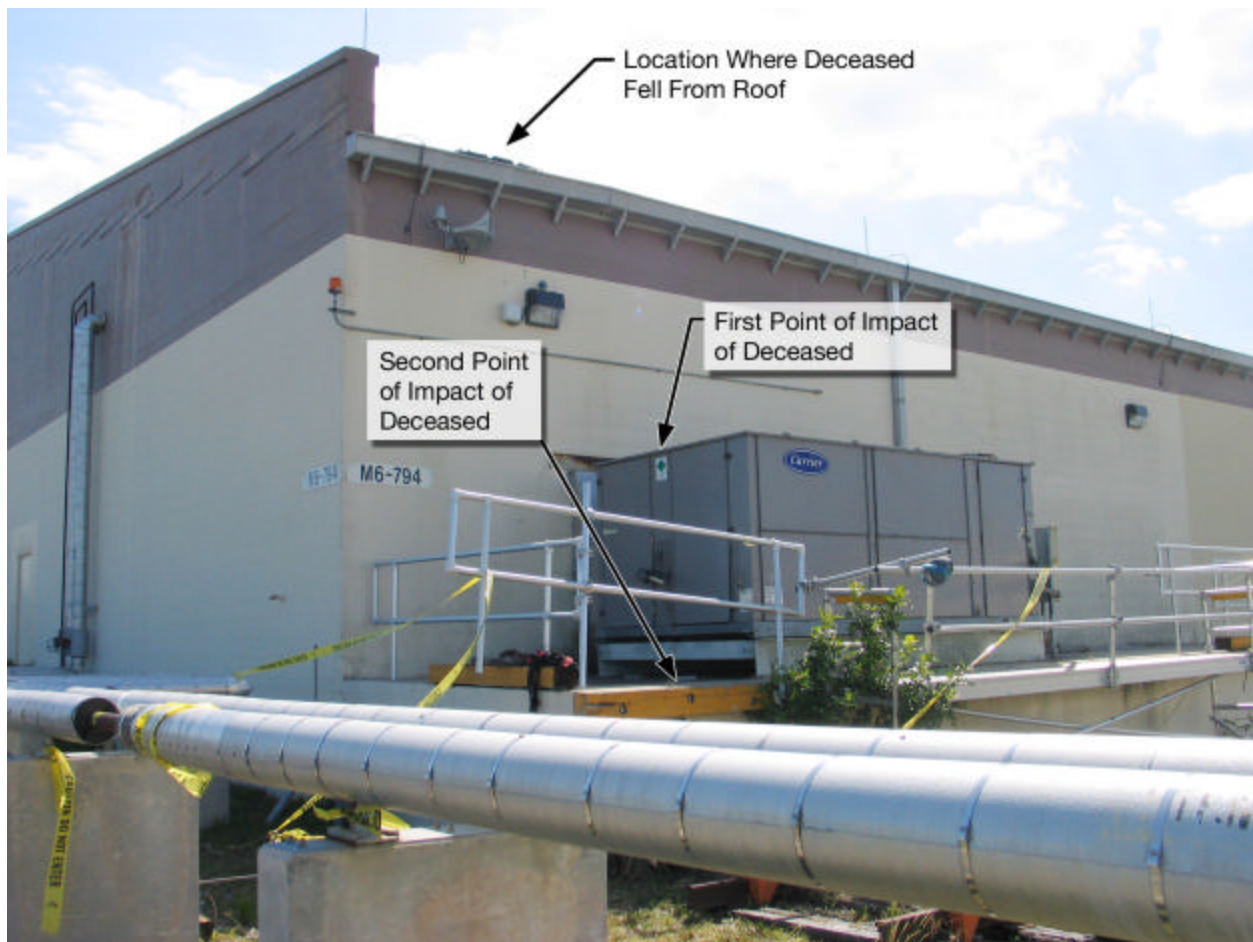
**Figure 2. Mishap Site**

At approximately 1325, Worker 1 lost his footing, let go of the new roofing panel, and fell from the roof. He fell backward approximately 10 ft, his head struck an air-conditioning unit, and he then fell an additional 7 ft to a concrete loading dock.

The lightning protection wire was unsecured at the edge of the roof and posed a tripping hazard. The Board could not determine with certainty whether Worker 1 tripped on the lightning protection wire or on something else (e.g., corrugations in the roofing panels), or if he stumbled and the lightning protection wire prevented him from regaining his balance and he subsequently fell from the roof.

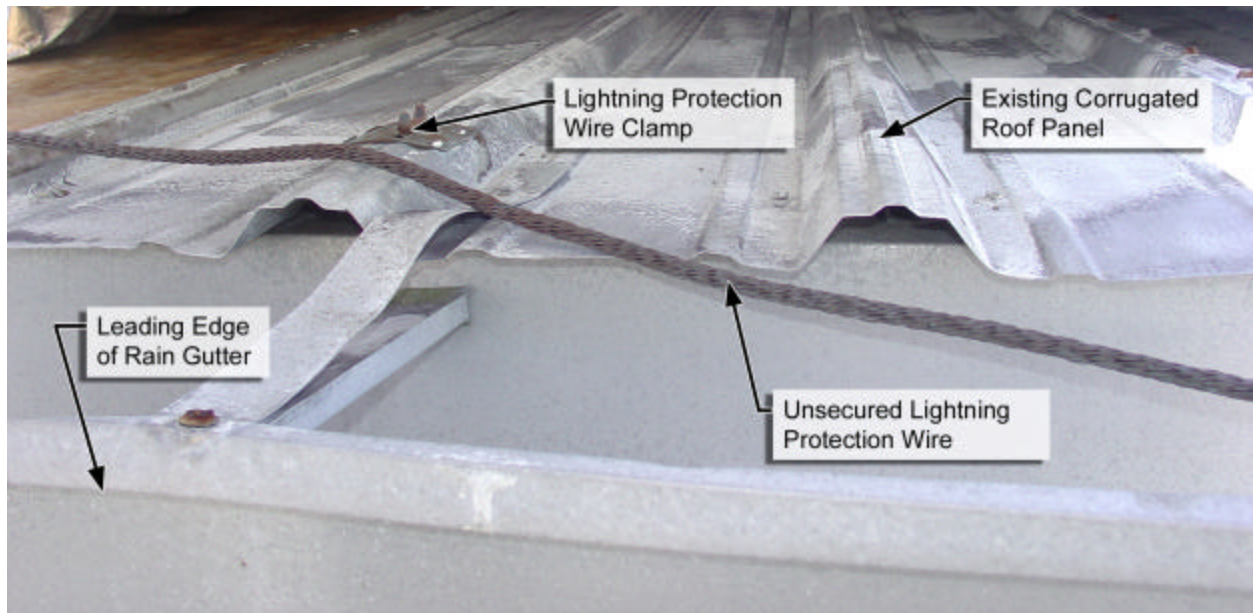
**Figure 3. Close-up View of Leading Edge of Roof at Point Where the Deceased Fell**

Subsequent to the mishap, the Board noticed damage to the rain gutter, near the location of the fall, with outward bending of the upper rim of the gutter in particular. The Board concluded that the deceased most likely contacted the gutter as he fell from the roof. This gutter damage can be seen in Figure 3.

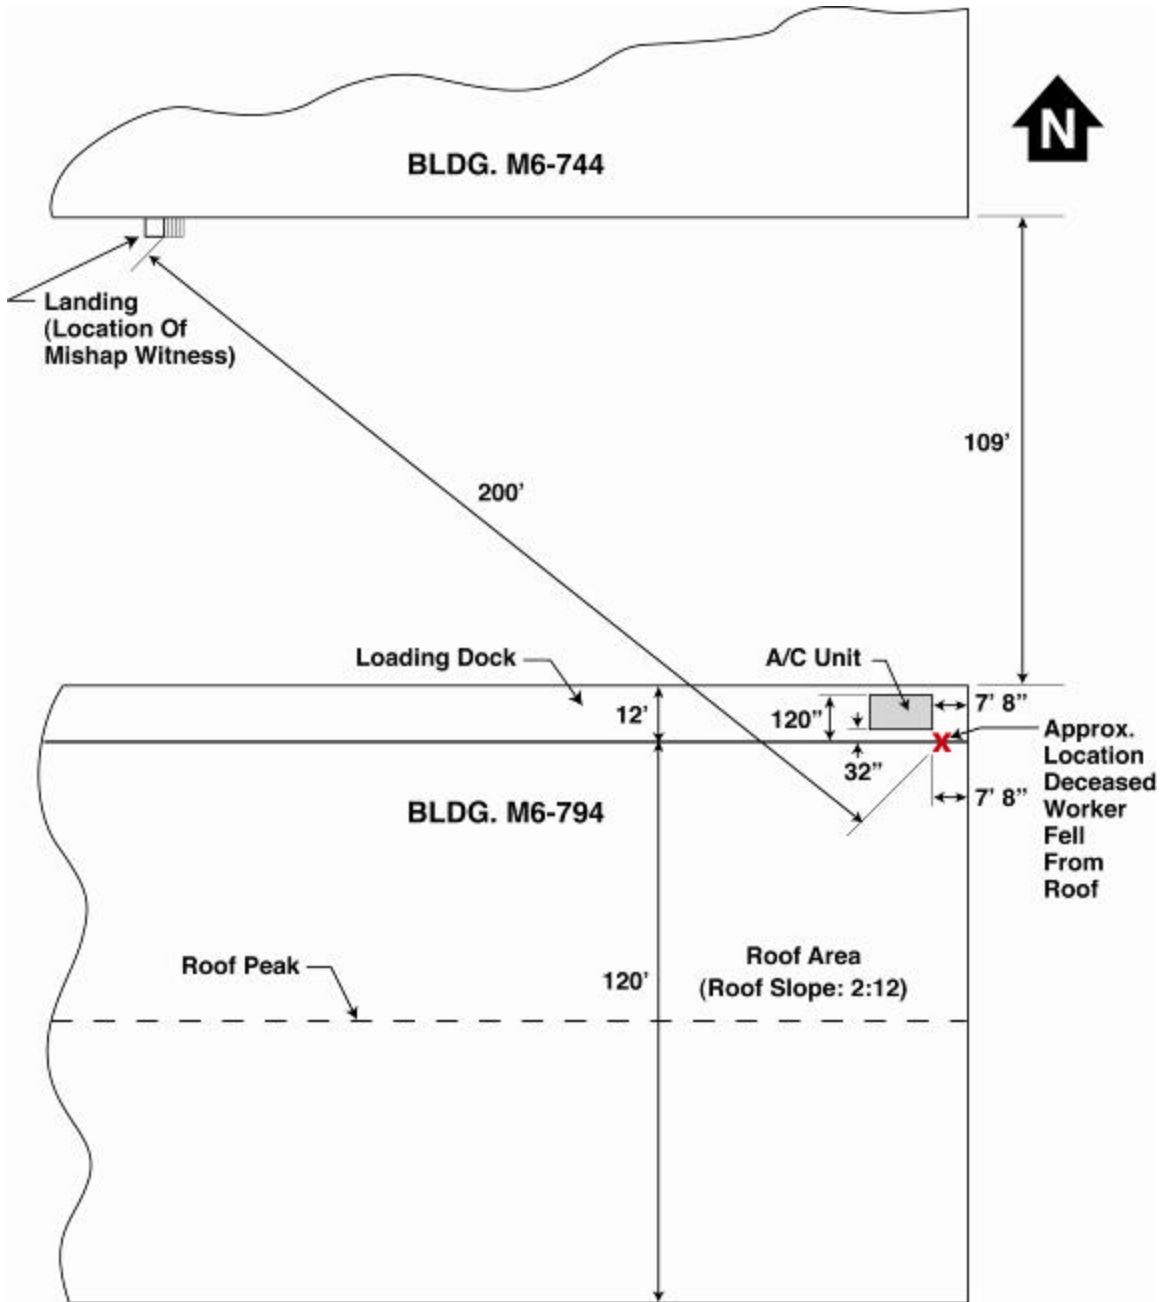
Figure 5. Location of Mishap Witness Relative to Mishap Site

The mishap was witnessed by an SGS logistics coordinator standing on a first-floor exterior landing (approximately 4 ft high), on the south side of Building M6-744, approximately 200 ft northwest of the scene of the mishap (see Figure 5). At the time of the mishap, the sun was directly overhead and did not appear to interfere with the line of sight of the witness. The witness called 911 within seconds of observing the mishap.

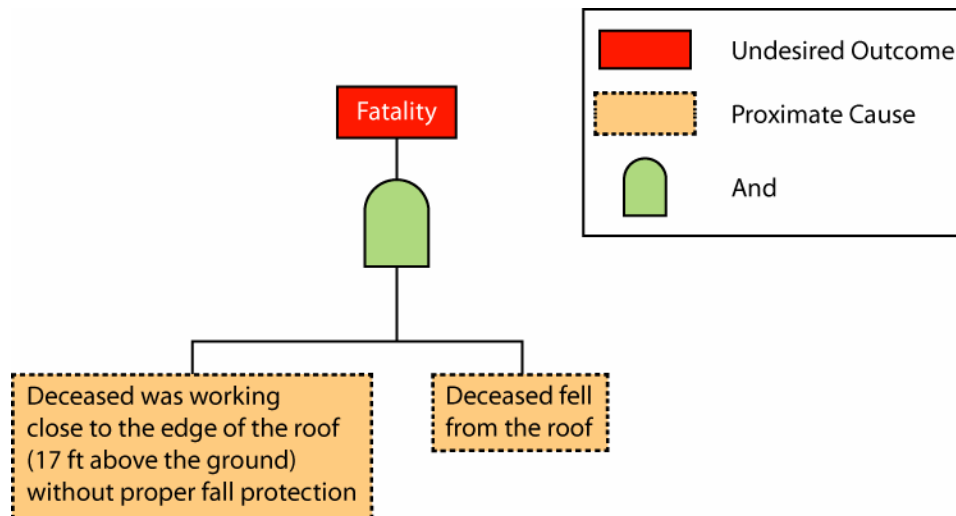
**Figure 6. Proximate Causes of Fatality**

Starting with the mishap event “Fatality,” the Board evaluated the final proximate causes and those events and conditions that led up to them. See Figure 6.

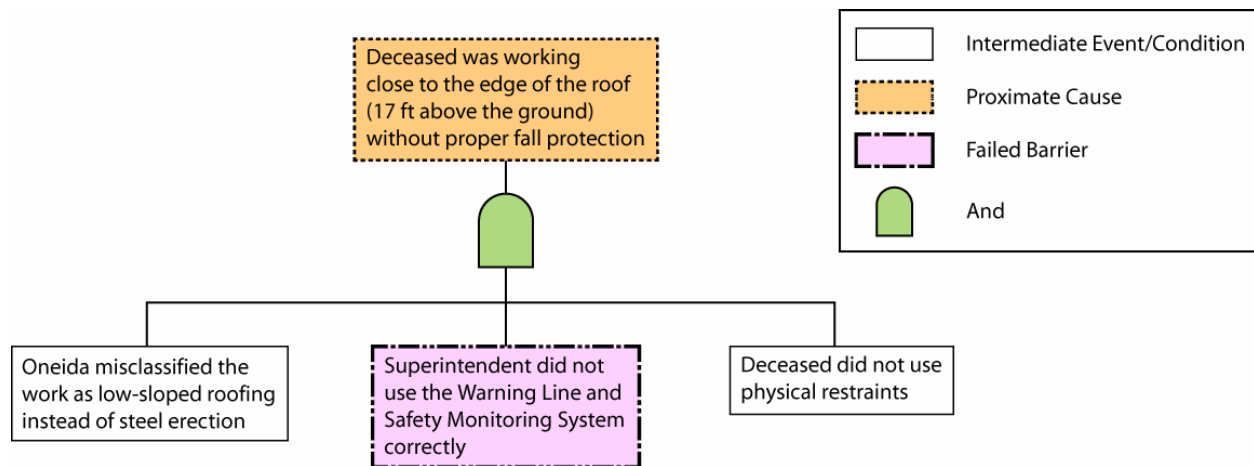
**Figure 7. Events Leading to the Deceased's Working Close to the Edge of the Roof Without Proper Fall Protection**

During the actual work, the superintendent/safety monitor and the deceased worker maneuvered the panel into the required position, which placed the deceased close to the edge of the roof, with his back to the edge. The superintendent, who should have provided the safety monitoring, did not warn the deceased that he was close to the edge (approximately 6 to 12 inches). No other additional fall protection (physical tie-offs, guardrails, safety nets, etc.) was provided. Therefore, the Board determined a proximate cause of the mishap to be that **the deceased was working close to the edge of the roof (17 ft above the ground) without proper fall protection.**

The intermediate causes of the deceased's working close to the edge of the roof without proper fall protection were identified and analyzed and are presented in Figure 7 and the following subsections.

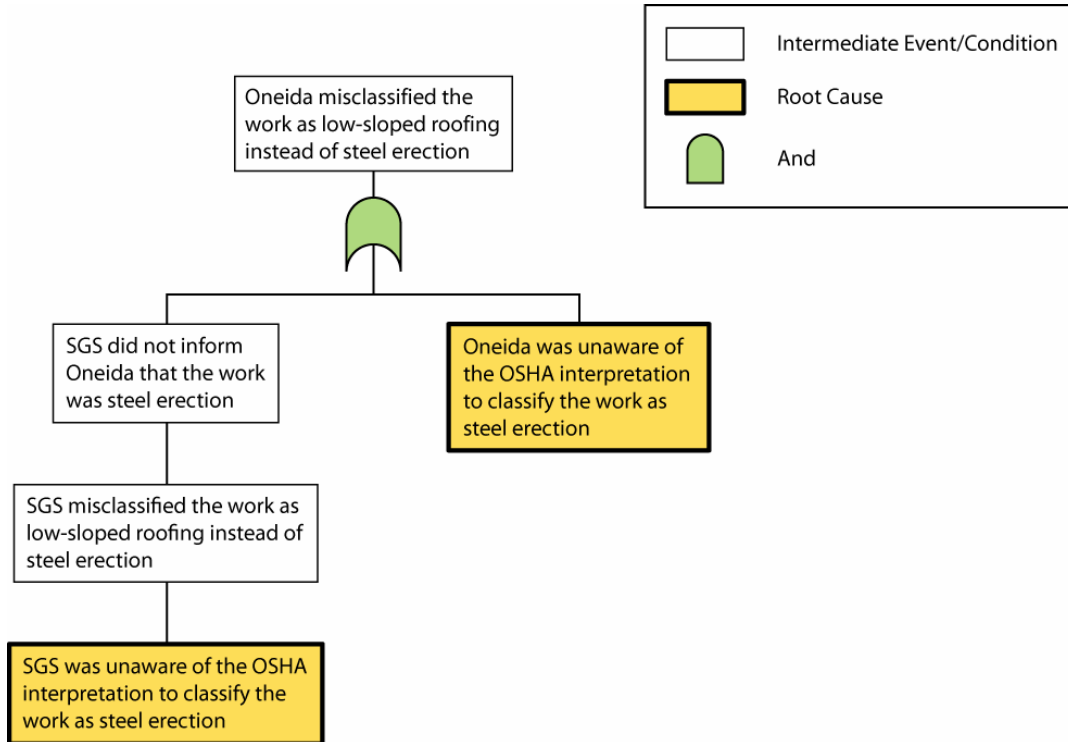
**Figure 8. Root Causes of Oneida Misclassifying the Work as Low-Sloped Roofing Instead of Steel Erection**

Based upon the OSHA letter of Standard Interpretation and the OSHA postmishap investigation, the Board determined that Oneida misclassified the work as low-sloped roofing instead of steel erection. **Oneida was unaware of the OSHA interpretation to classify the work as steel erection (Root Cause 1).** SGS did not inform Oneida that the work was steel erection because SGS also misclassified the work as low-sloped roofing instead of steel erection.

**SGS was unaware of the OSHA interpretation to classify the work as steel erection (Root Cause 2)** until OSHA conducted its postmishap investigation. Adherence to and implementation of the more stringent fall protection requirements for steel erection described in 29 CFR 1926, Subpart R, may have prevented the mishap. See Figure 8.

**Recommendation (RC2-1):** Prior to issuing an RFP, the prime contractor should review OSHA Standards and letters of Standard Interpretations to properly classify work.

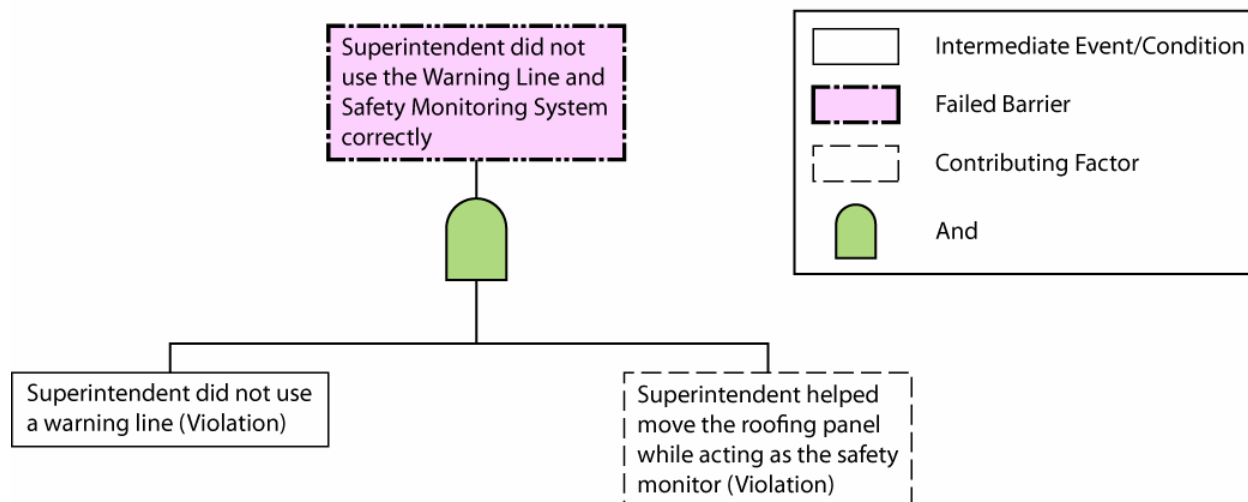
**Figure 9. Violations Contributing to Superintendent’s Failure To Use the Warning Line and Safety Monitoring System Correctly**

The Warning Line and Safety Monitoring System, which is permitted by OSHA 29 CFR 1926.501(b)(10) for work on low-sloped roofs, was not used properly by the Oneida superintendent. Two OSHA violations were that the superintendent (1) did not use a warning line and (2) helped the Oneida workers carry the roofing panel while acting as the safety monitor (Figure 9).

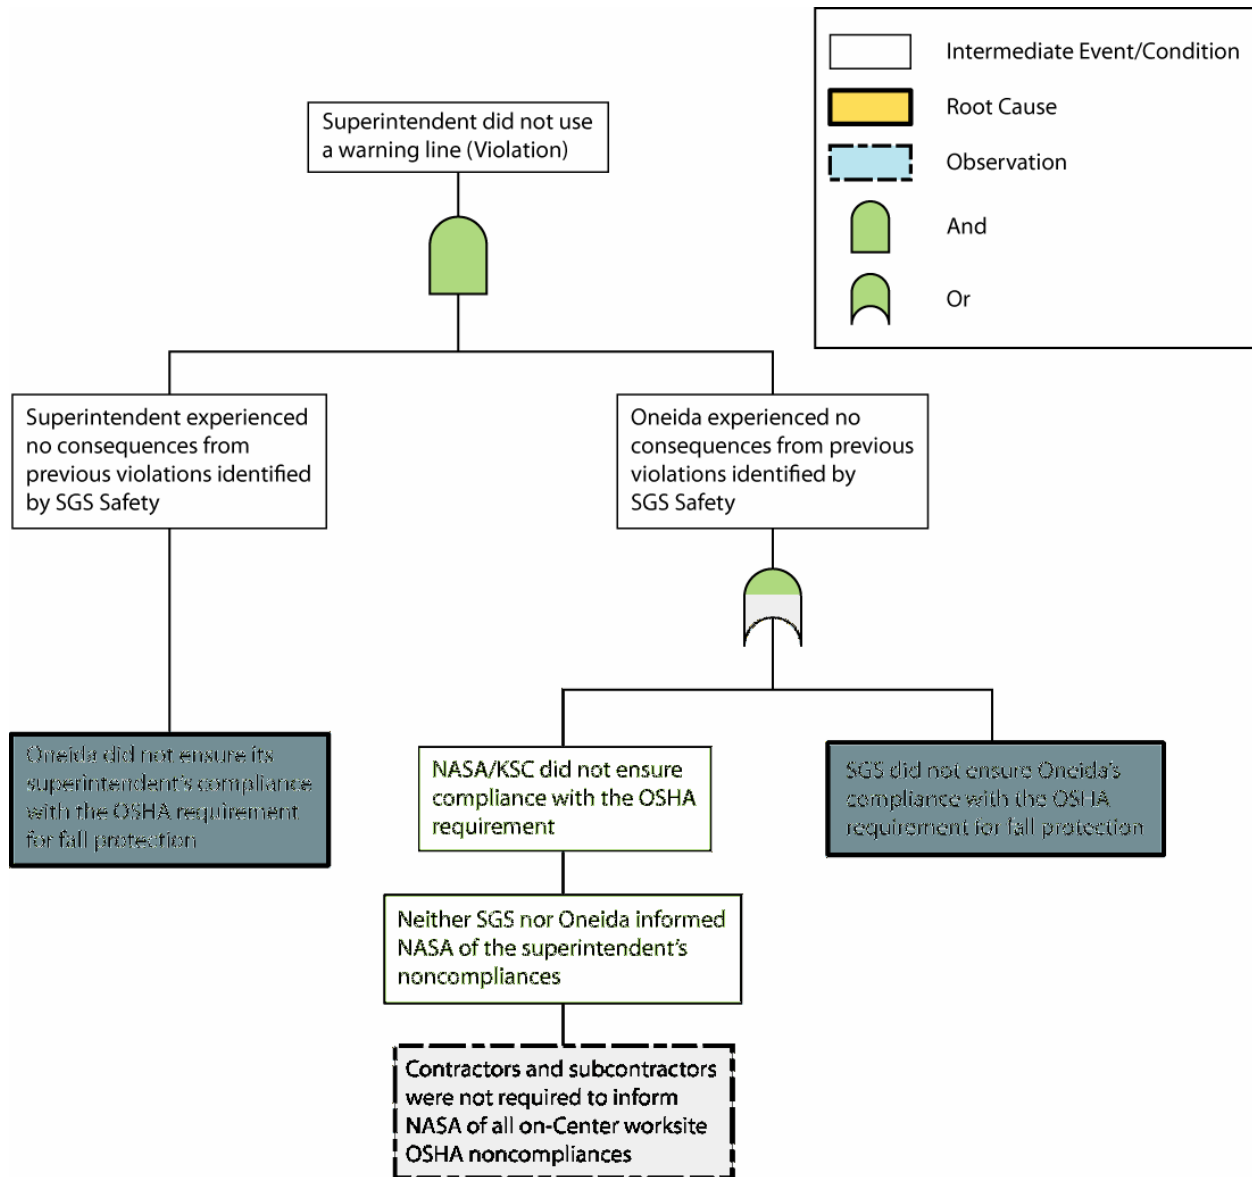
**Figure 10. Root Causes of and Observations Regarding Warning Line Violation**

Oneida considered this work to be low-slope roofing and was using a Warning Line and Safety Monitoring System as fall protection. The Board noted that the superintendent had been written up by SGS Safety for warning line and safety monitor violations on three separate occasions prior to this mishap. However, the noncompliances were corrected on the spot and no further retraining, corrective action, or disciplinary action was taken by Oneida toward the superintendent or by SGS toward Oneida. The Board determined that because the noncompliances could have had fatal consequences and were committed by the same individual over a 6-day period, the noncompliances should have been an indicator to SGS and Oneida management of the superintendent’s lack of implementation of this

OSHA requirement. These noncompliances did not indicate a lack of knowledge of the warning line because the superintendent took corrective action after each notice of noncompliance by SGS Safety.

- c. Oneida experienced no consequences from previous violations identified by SGS Safety.

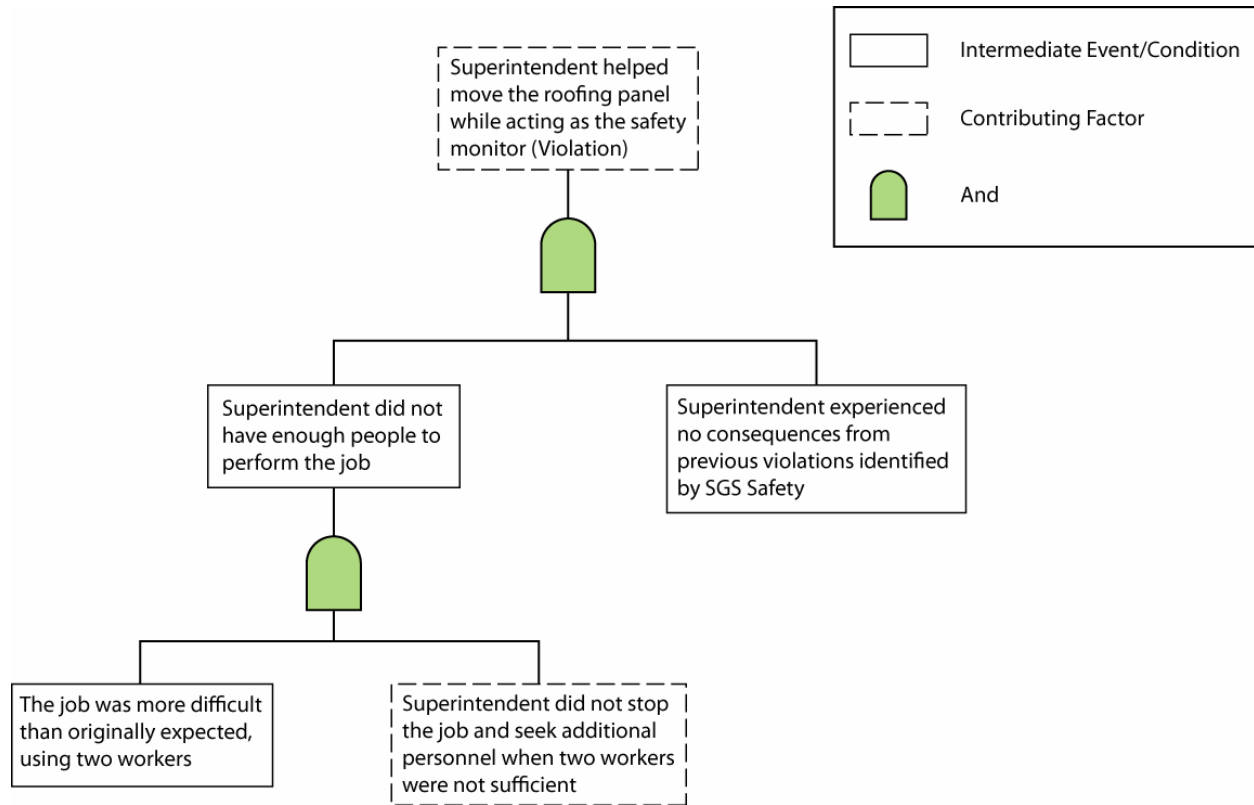
**Figure 11. Factors Contributing to and Observation Regarding the Safety Monitor Violation**

- a. OSHA 29 CFR 1926.502(h) states that the employer shall designate a competent person to monitor the safety of other employees, and that the employer shall ensure that the safety monitor complies with the following requirements: (1) be competent to recognize fall hazards; (2) warn the employee when it appears that the employee is unaware of a fall hazard or is acting in an unsafe manner; (3) be on the same walking/working surface and within visual sighting distance of the employee being monitored; (4) be close enough to communicate orally with the employee; and (5) *not have other responsibilities which could take the monitor's attention from the monitoring function* (emphasis added).

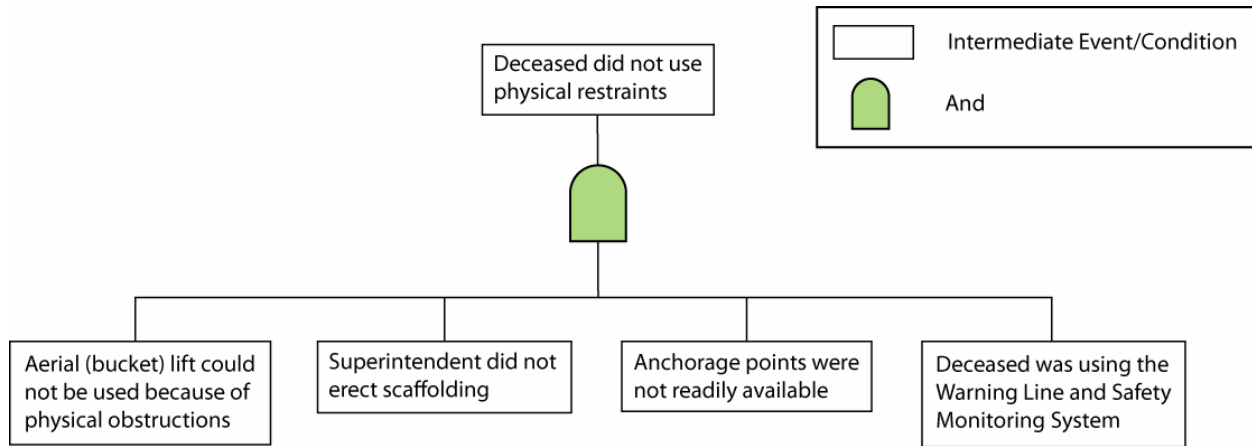
**Figure 12. Events Leading to the Failure of the Deceased To Use Physical Restraints**

- a. Aerial (bucket) lift could not be used because of physical obstructions.

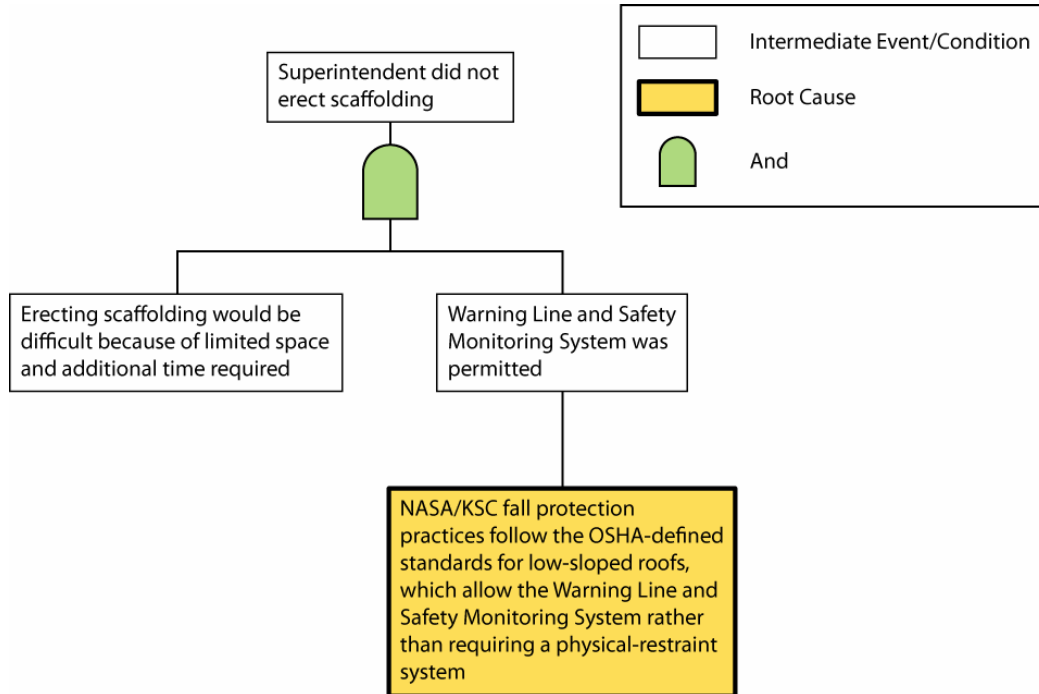
**Figure 13. Events Leading to the Superintendent’s Decision Not To Erect Scaffolding**

After the mishap, scaffolding was installed in the available 7-ft 8-in-wide area to provide the Board a view of the roof. This scaffolding would not have allowed the workers full access to all areas of the leading edge where the work was being performed. Therefore, additional fall protection would still have been needed, besides scaffolding, to meet the fall protection requirements.

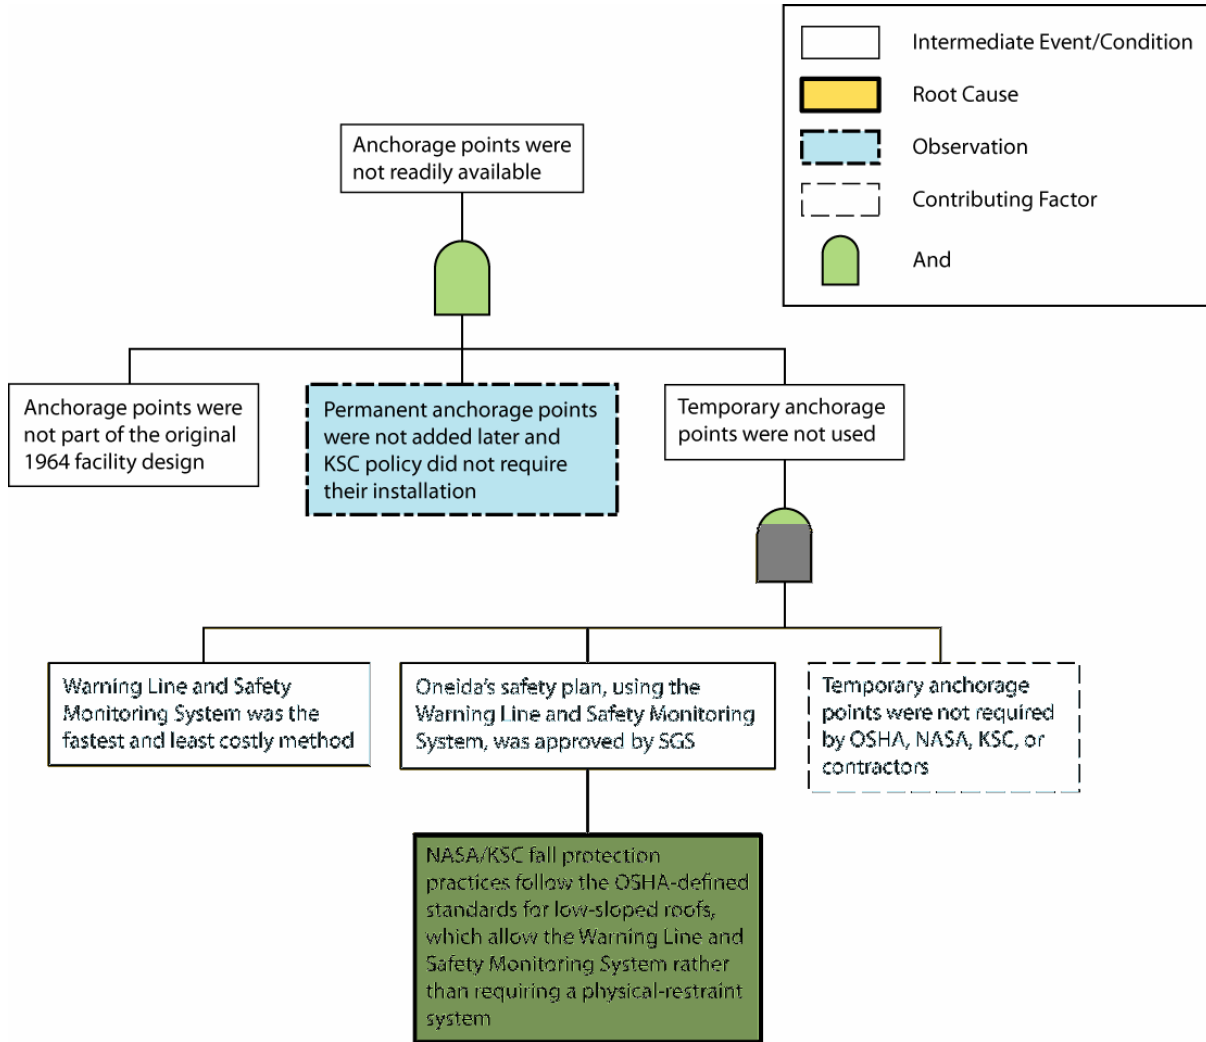
**Figure 14. Events Leading to the Unavailability of Anchorage Points**

- c. Anchorage points were not readily available (Figure 14).

Neither permanent nor temporary anchorage points were available or made available on Building M6-794 at the time of the mishap. The Board determined that permanent anchorage points were not part of the original 1964 facility design. **Permanent anchors were not added later, and KSC policy did not require their installation (Observation 8).**

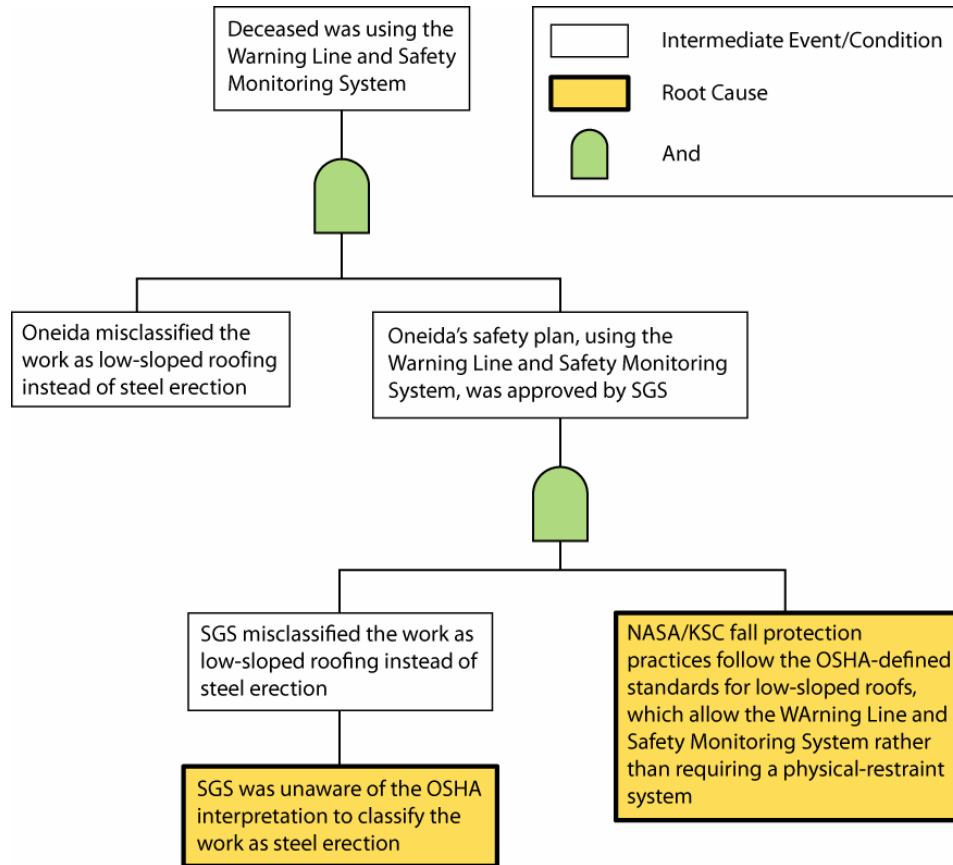
**Figure 15. Events Leading to Use of the Warning Line and Safety Monitoring System**

The Building M6-794 roof met the requirement for a low-sloped roof (2:12 horizontal:vertical slope) but was wider than 50 ft (approximately 120 ft). This regulation permitted the use of a warning line system combined with a safety monitoring system for the Building M6-794 roof, but a safety monitor alone was not sufficient because of the width of the roof.

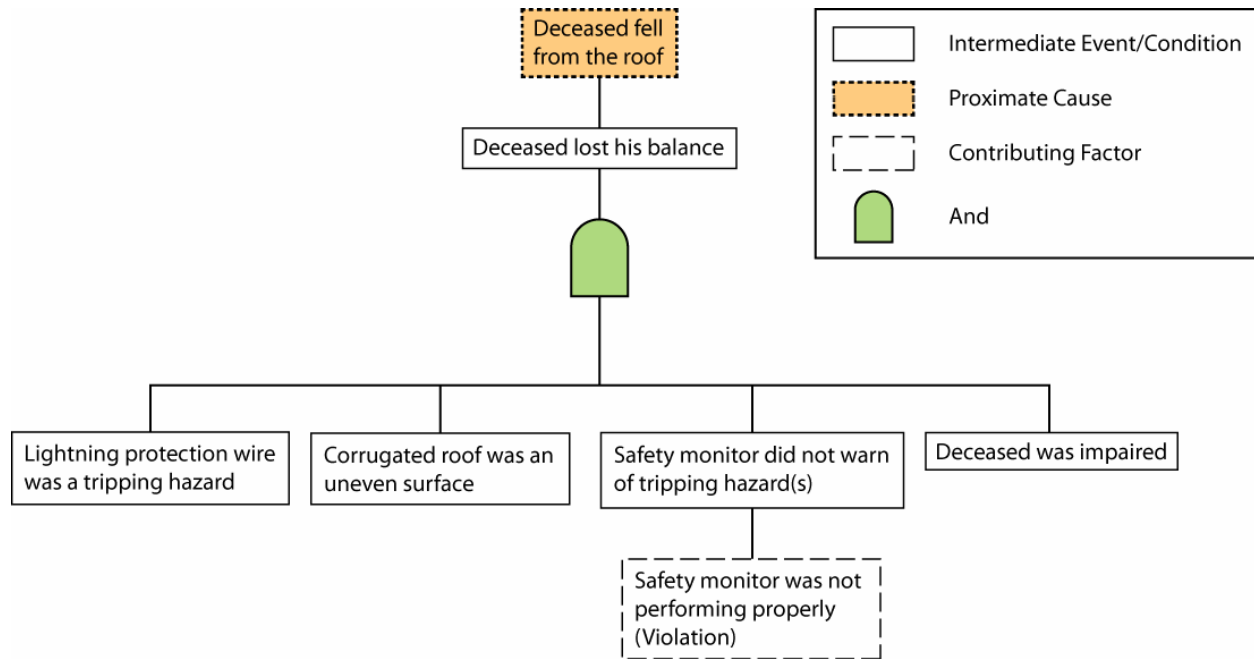
**Figure 16. Events Leading to the Deceased's Loss of Balance**

The Board determined that the deceased either tripped or stumbled prior to falling off the roof rather than simply backing off the roof. The two most likely tripping hazards were the lightning protection wire that was located approximately 6 inches from the edge of the roof and the uneven working surface caused by the corrugated roof. The Board also determined that there was no oral warning provided by the superintendent/safety monitor to possibly allow the deceased to avoid the tripping hazard.
