WIRE Mishap Investigation

Board Report

June 8, 1999

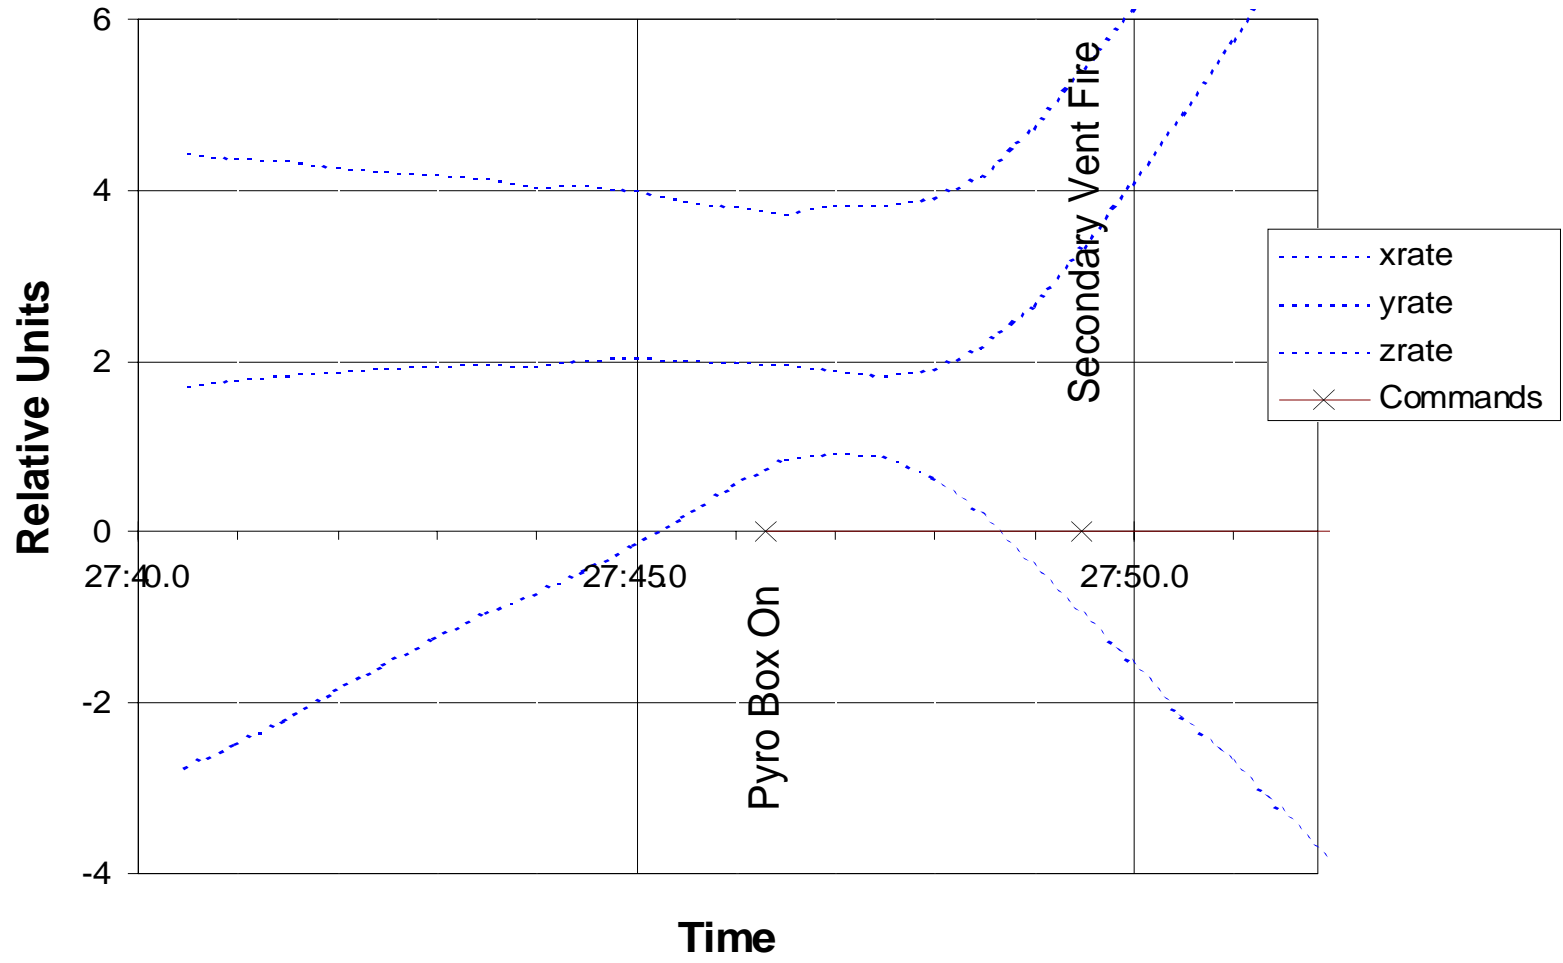
WIRE First Pass Telemetry

Table 2, WIRE First Pass Telemetry, plots the spacecraft x, y, and z-axis body rate change data as a function of time. It can be seen that the WIRE spacecraft begins to move after the pyro electronics box is turned on, but before the time of the secondary vent fire command. This data indicated to the Board that the cover could have been ejected about the time the pyro electronics box was turned on.
