PART NAME: TCS Multi-Layer Blanket
PART NO: V070-361995-024 (L/H) & V070-361995-025 (R/H)
SERIAL NO: 52B51B (-024) & 52C0XX (-025)

PROBLEM DESCRIPTION

Blankets were installed incorrectly over PVD Drain Lines in FRC3. Incorrect installation allowed the blankets to billow toward the Xo 378 Bulkhead vents, restricting venting of the FRCS cavity.

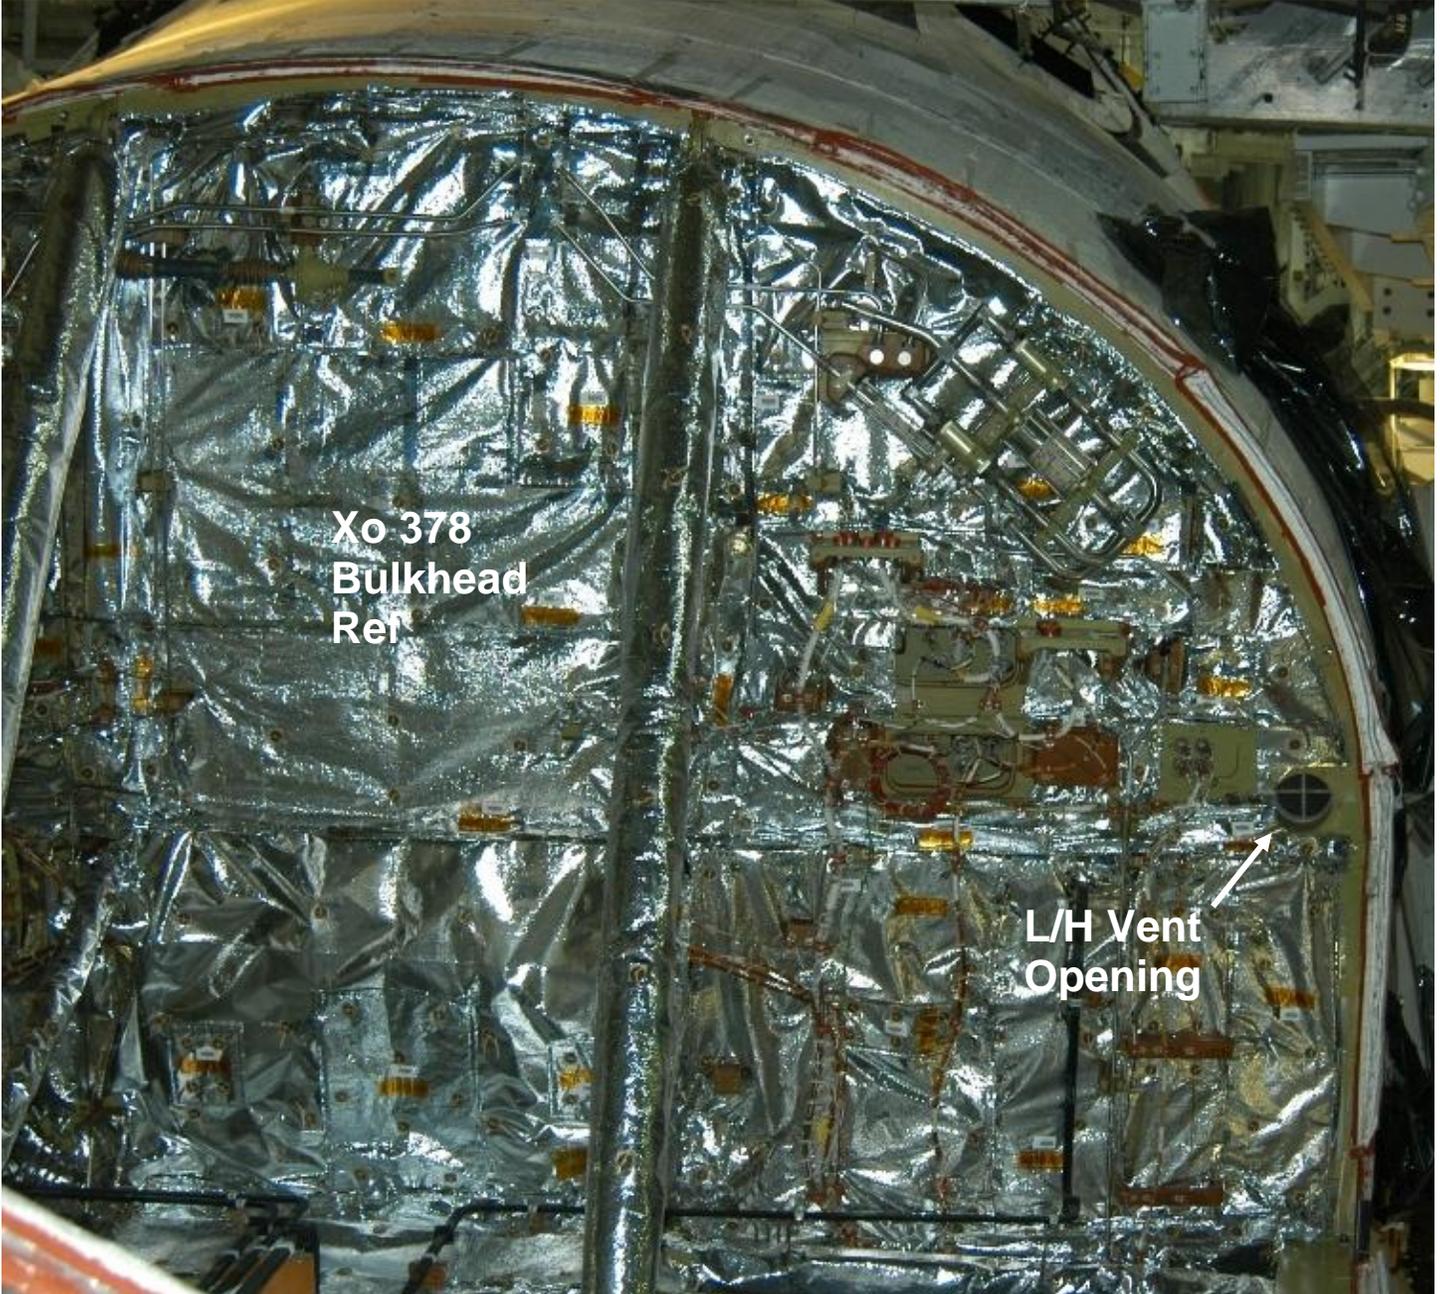
**L/H Vent Opening and Xo 378 Bulkhead Shown
R/H Vent Opening Opposite and Symmetrical
Orientation View**

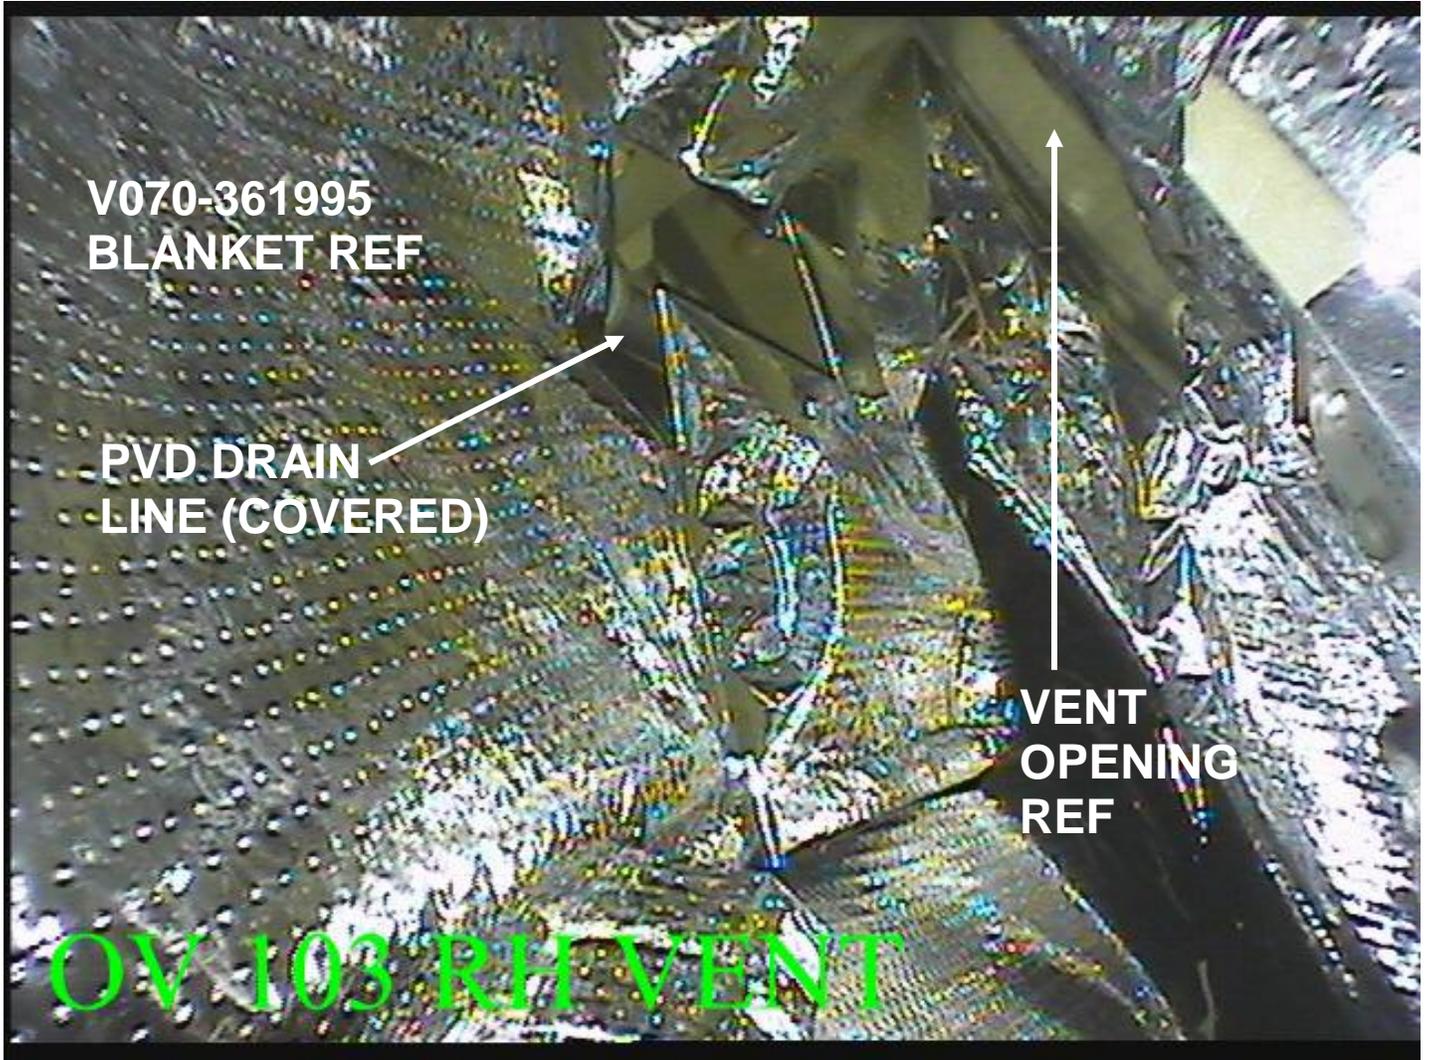
Borescope inspections on FRC3 showed that TCS blankets in the FRCS module were very close to the vents, and were not installed under PVD drain lines. Design intent is to install the V070-361995-024 (LH) and V070-361995-025 (RH) MLI blankets under PVD drain lines in the FRCS. The blankets contain existing cutouts and cutlines, allowing installation under these lines. When properly installed, the blankets are restrained by the PVD drain lines and cannot billow into the Xo 378 vent areas. Using templates to simulate a Xo378 vent port (on FRC5) TCS Engineering determined that blockage of the vent ports can occur when blankets are installed on top of the drain lines. Improper installation of the TCS blankets was determined to be the cause of the vent anomaly.

**Borescope Inspection Photo of OV-103 PRIOR to Blanket Rework
(View Looking Down and Outboard from Electrical Access Door)**

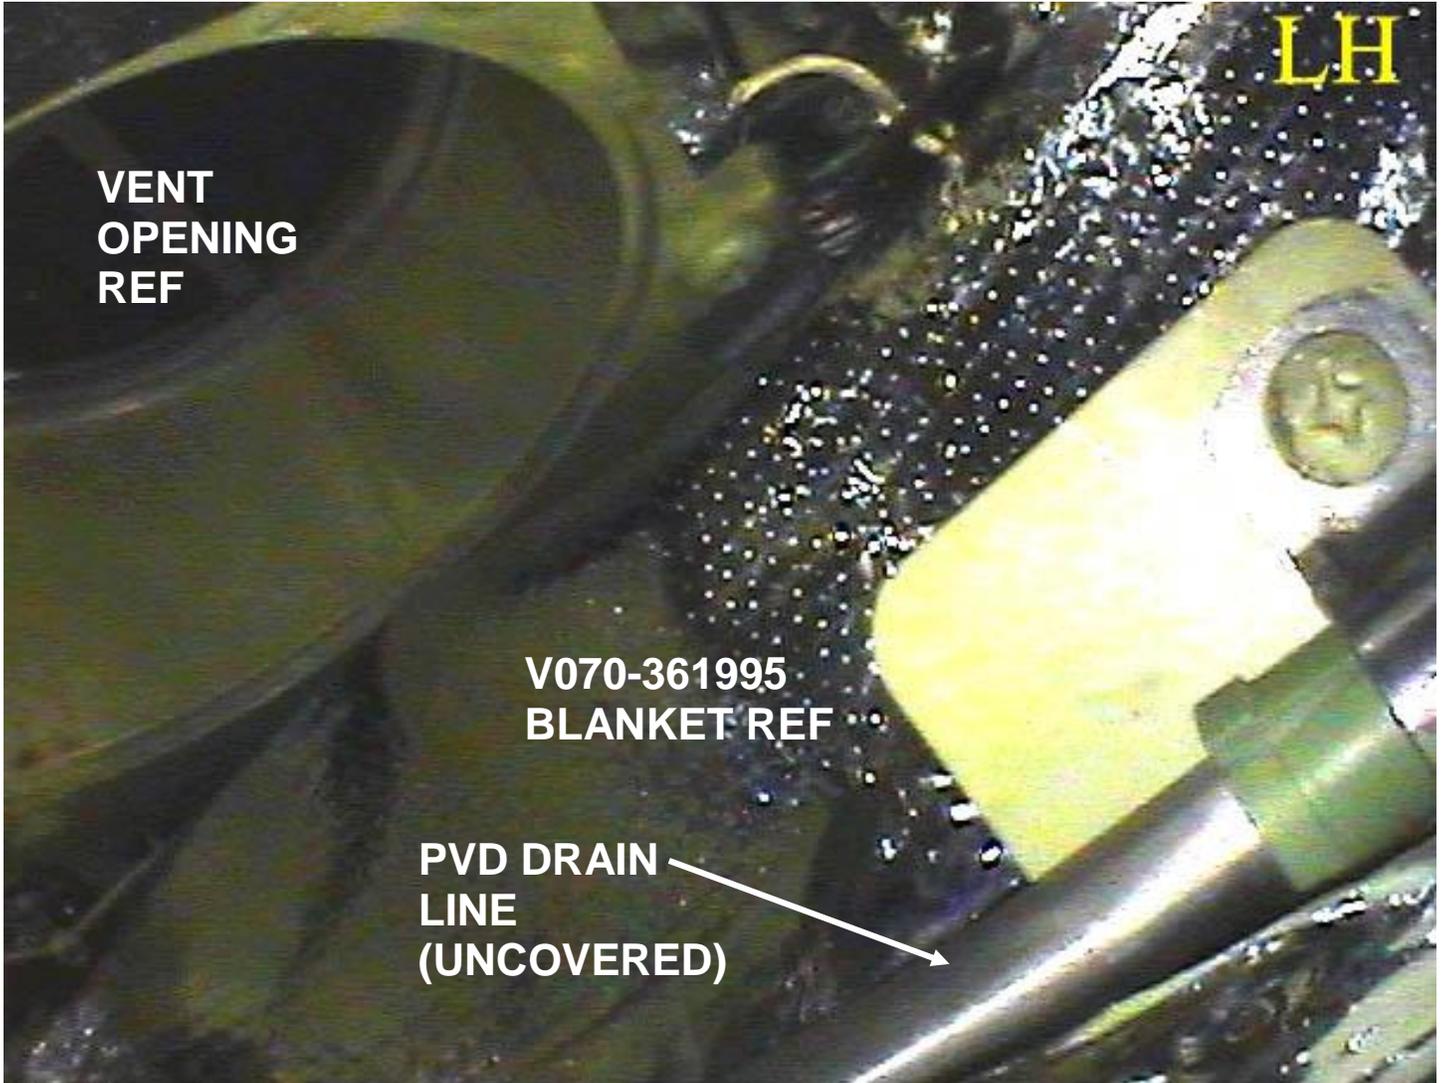
**Borescope Inspection Photo of OV-103 AFTER Blanket Rework
(View Looking Down and Outboard from Electrical Access Door)**

FRC3 and FRC4 blankets were reworked and repositioned to eliminate the interference with the Xo378 vents and prevent any possibility of billowing. Blankets were installed under drain lines as per design intent, fastened to thruster box blankets with buttons and tie cord per drawing, and taped to thruster box blankets along inboard seams with approved TCS tape per Specification instructions. Post rework borescope photos show no obstruction to purge vent operation. Reference attached photo.

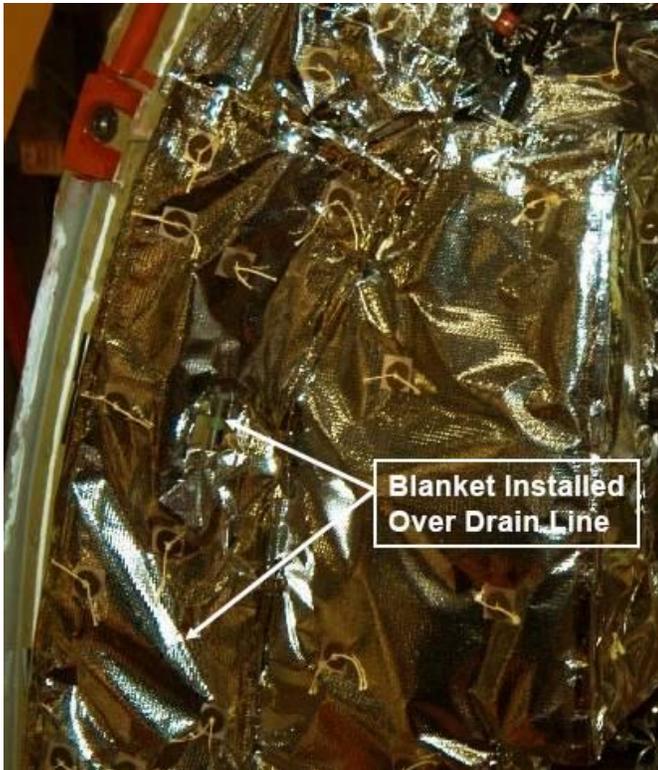
STS-121 Closeout Photo

FRC3-33-1113 was written to document the problem on OV-103. CAR 121RF08 was written for corrective action. Closeout photo from STS-121 is attached, showing discrepant blanket installation.

Above photos are provided for side-by-side comparison of incorrect STS-121 FRC3 blanket installation (over PVD drain line) with correct blanket installation (under PVD drain line). Correct blanket installation photo above is from FRC5 after blanket rework. OV-105 photo was chosen because FRC5 was removed, which provided clear access for photograph.
