## **Orbiter Landing Gear Rigging, STS-114**

Steve Sebesta  
United Space Alliance  
Orbiter Element, Subsystem Area Manager

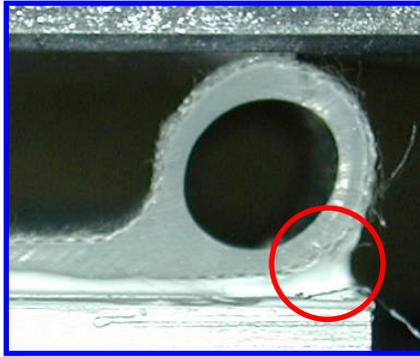
The initial rigging check-out run performed with the new seals installed indicated significant load increase on the system. The door stop measurements and the door hook measurements indicated the doors did not close properly. Based on some preliminary seal testing done at GRC that indicated the seal bond line configuration had a significant affect on the seal loading, the fillet bond on the bulb side of the seals was removed allowing the seals to function properly. (Reference Figure: RTV Fillet and Clean Bond Line) After this correction the RH door closed properly but the LH door did not. This run did not take into account the MR shims that would be required to meet seal compression requirement.

RTV Fillet

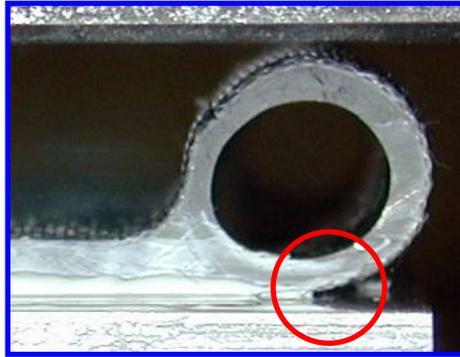
Clean Bond Line
