**STS-114 ET Vent Arm Umbilical Purge Shroud IFA Closure
Rationale, STS-114-I-014
&
Update ISPR-02
“ET Vent Arm System (ETVAS) Umbilical System
Malfunction”**

**CR# S050425DG
SICB**

04/22/2006

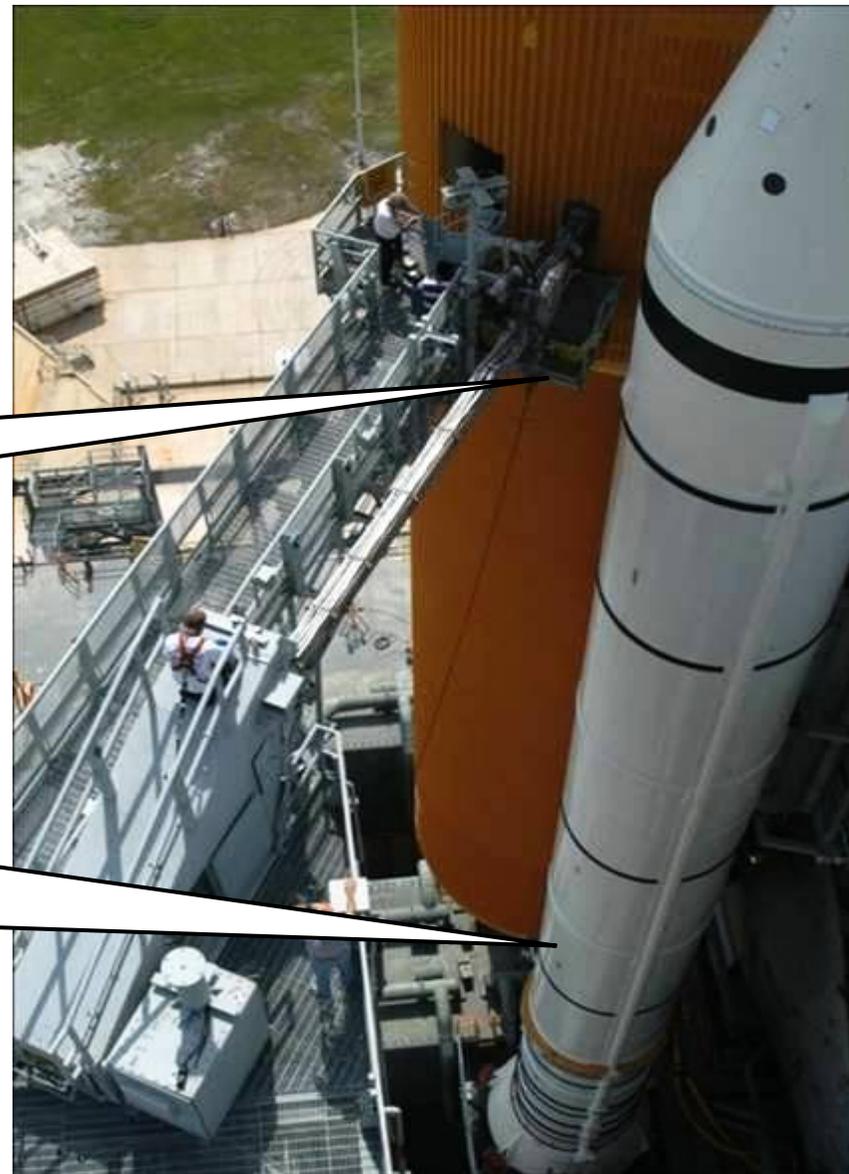
- LN2 Dripping onto SSV TPS, EB-3 and EB-7 attach points

Source of LN2

EB-3, EB-7 attach points

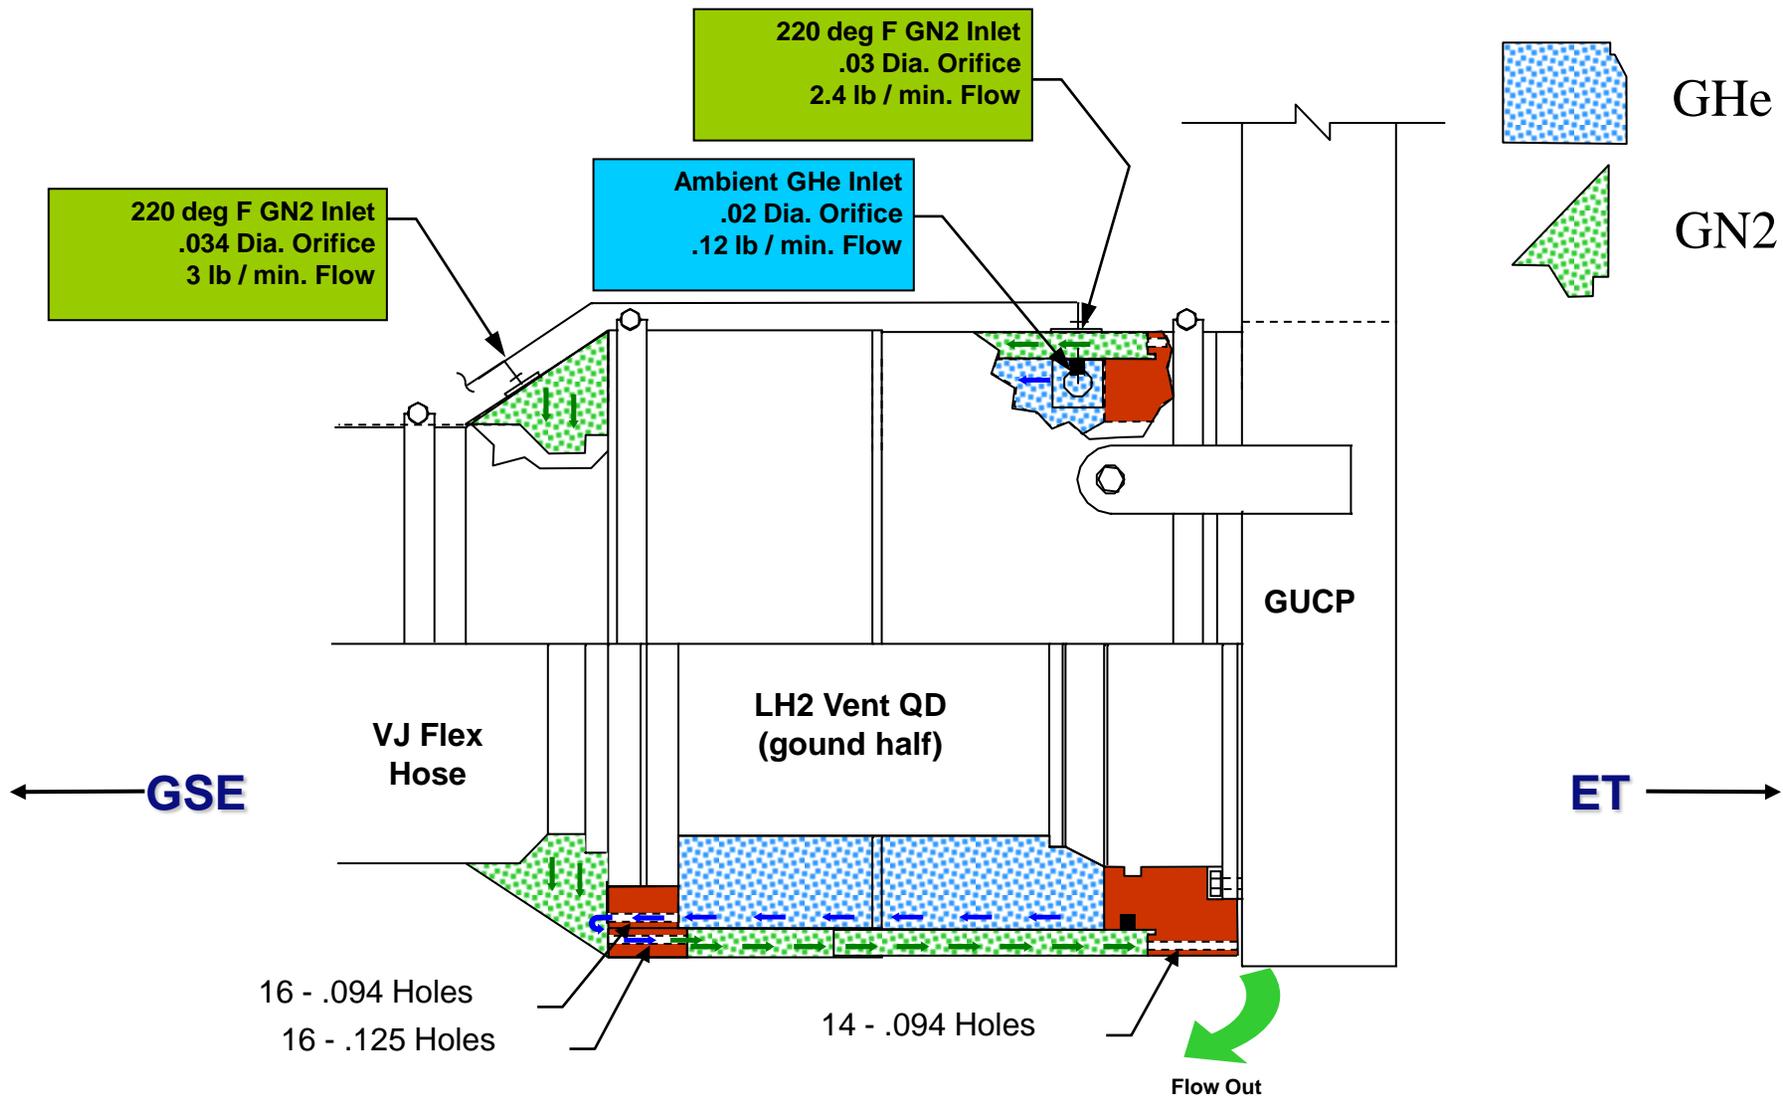
Old Purge Shroud Operation

- (reference figure next page)
- GHe enters the shroud into the space between the inner shroud wall and the LH2 Vent QD.
- Heated GN2 enters a cavity that is created by the shroud inner and outer wall.
- The GHe migrates towards the back of the shroud into the aft cone section mixing with the GN2 to be heated
- Both gases migrate along the lower outer wall toward the front of the shroud and exit through holes along the front surface up against the GUCP.

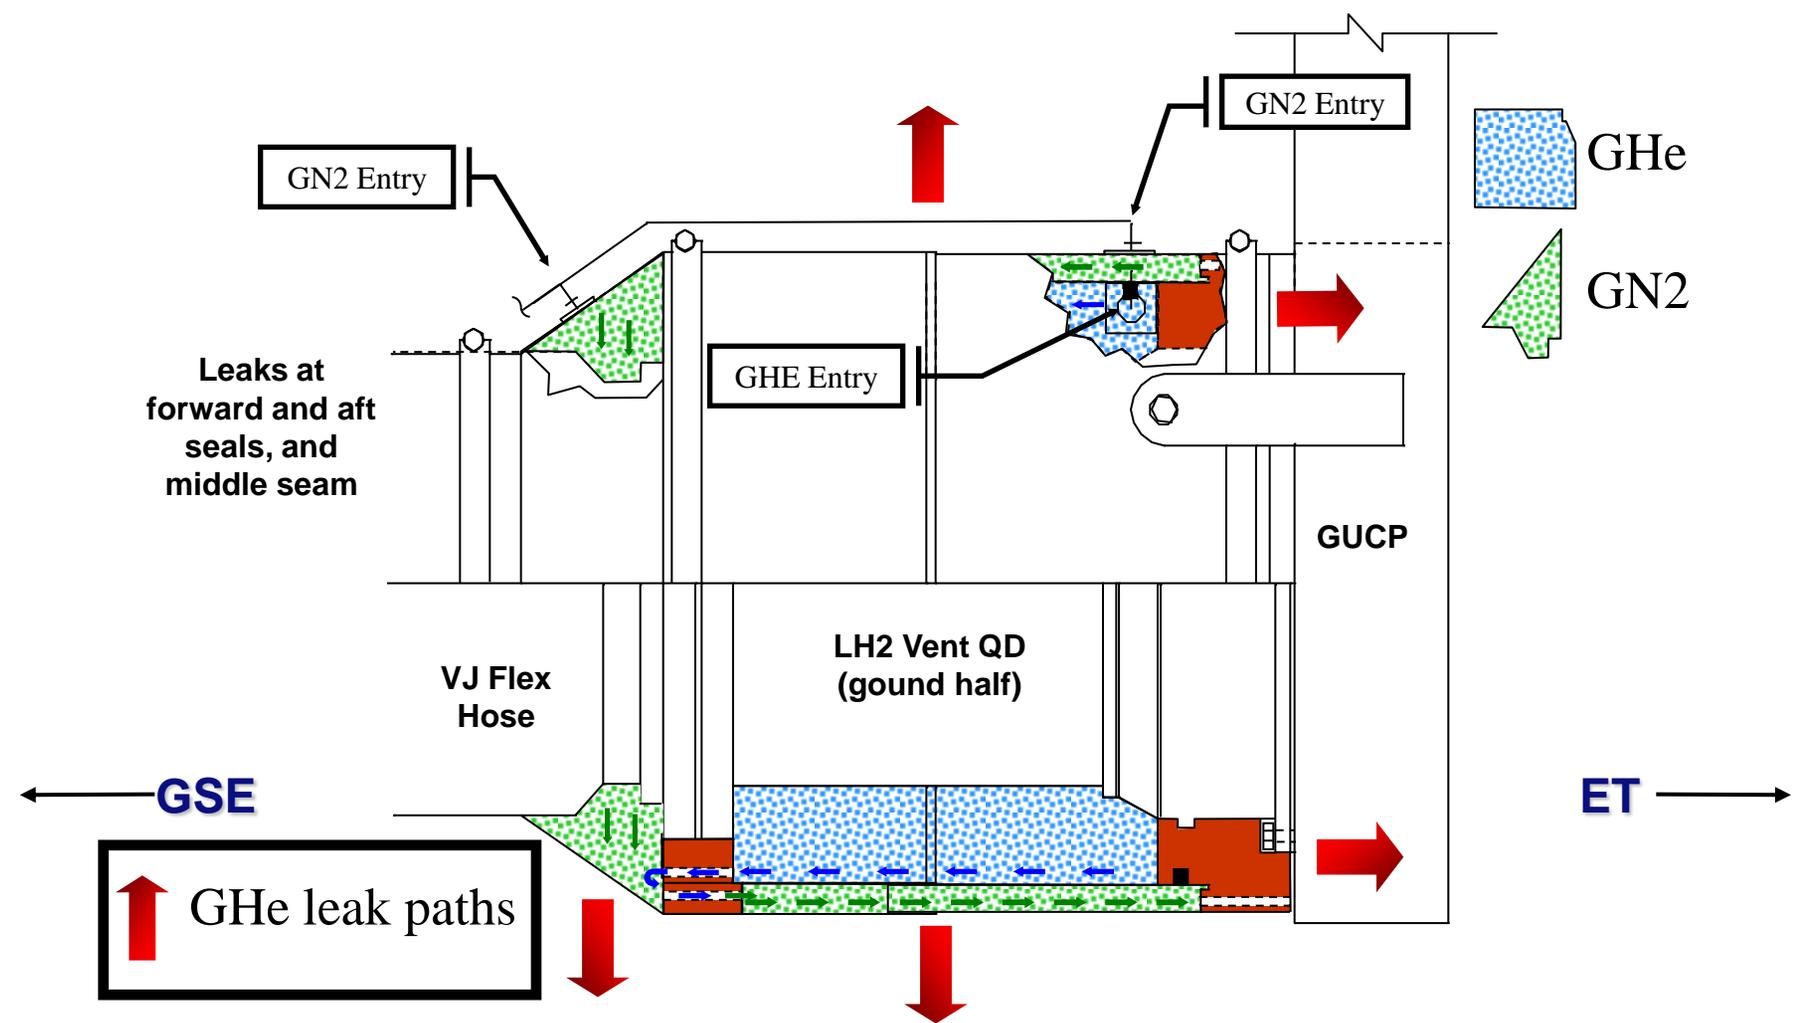
GH2 Vent QD Shroud Cut-Away (suspected leak pattern)

- (reference figure next page)
- Gap between the LH2 vent QD and the phenolic ring at the GUCP interface allowed venting of GHe
- GN2 intrusion into the inner cavity due to evacuating GHe
- The GN2 liquefy's due to contact with the LH2 Vent QD.
