**BLANKET V070-361995 (LH & RH) MAY
INTERFERE WITH PVD PURGE VENT
ON XO 378**

Element/End Item: **OV-103**
Flow/Usage: **116/FLIGHT 33**
Facility: **OPF-3**
Design Center Concurrence: **KSC**
Category:
OPR: **TCS**
TTL ORG: **TO**

To restrain blankets V070-361995-024 & -025 from billowing into PVD purge vents on Xo 378.

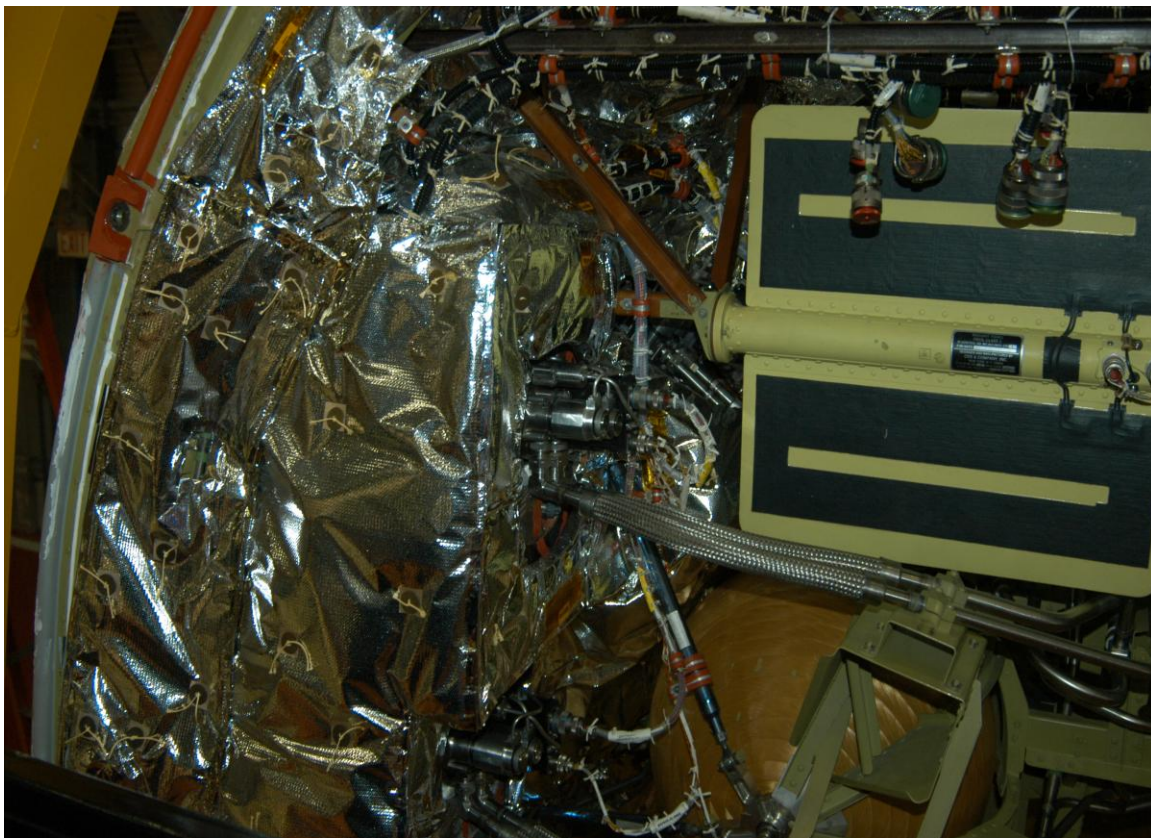
Figure 11-1 V5008.003 Run 1 (STS-121) LH Closeout Photo

Note: MLI blanket is over (aft side of) drain lines and not secured to adjacent blanket on thruster housing. No closeout photos of RH side.

Probable Cause Statement: Installation drawing does not show details for the instln of blankets V070-361995-024 & -025.

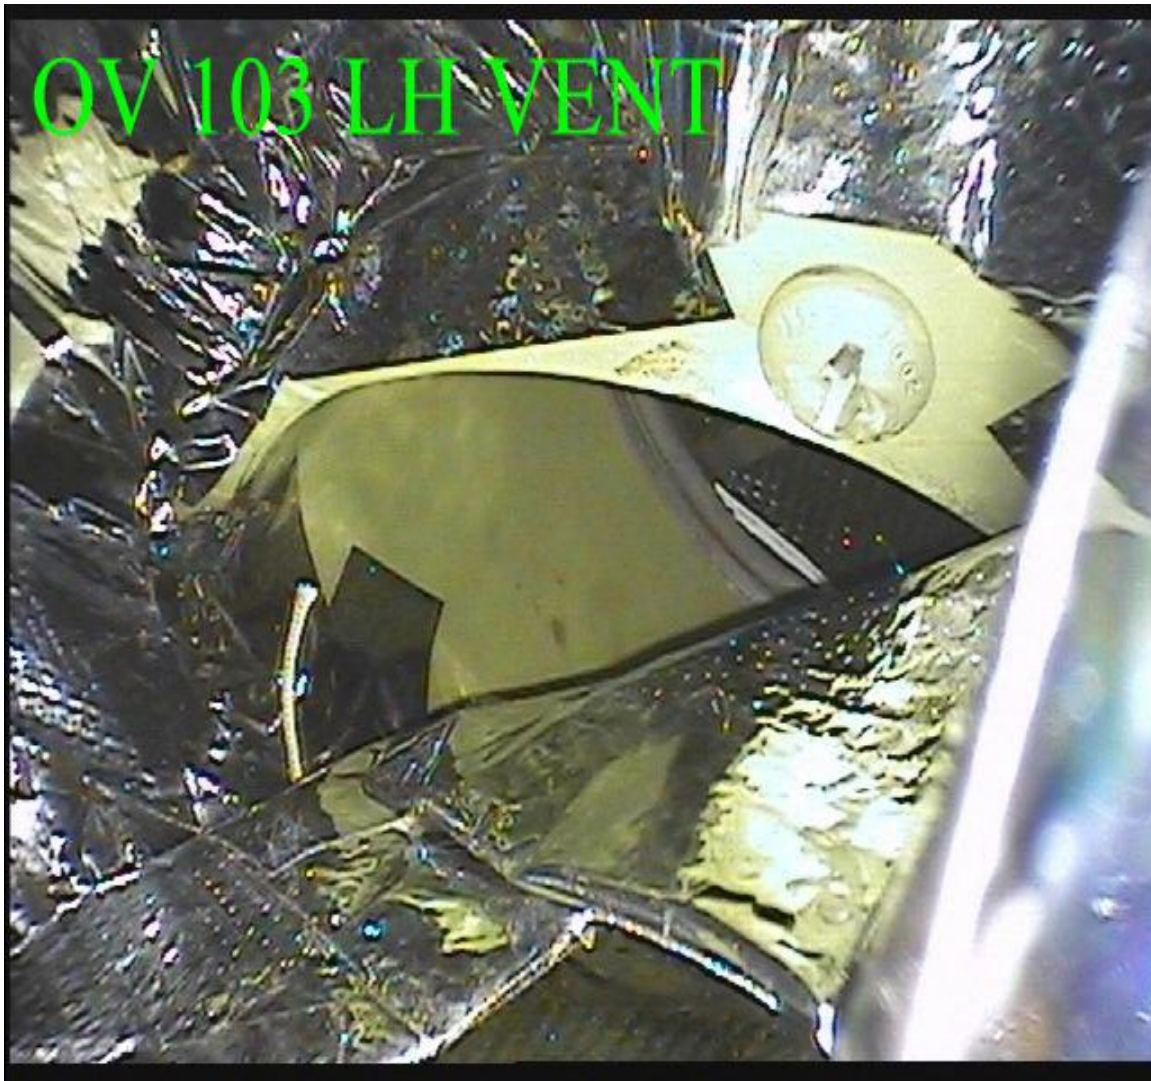
Figure 11-2 Boroscope view of LH Xo 378 purge vent (IPR 116V-0015)

Note: Flow path obstructed by blanket.

Engineering Interim Summary: During STS-121 ascent, the Xo 378 bulkhead delta-pressure transducer showed higher than normal pressure differential across the bulkhead. This was documented as an IFA (ref IPR 116V-0015). The actual pressure differential encountered was 1.2 psi. The structure is certified to .95 psid. Blockage of the Xo 378 purge vents from the FRCS side was considered the most likely cause.

Borescope inspections on FRC3 showed that TCS blankets in the FRCS module were very close to the vents, and were not installed under PVD drain lines. Design intent is to install the V070-361995-024 (LH) and V070-361995-025 (RH) MLI blankets under PVD drain lines in the FRCS. The blankets contain existing cutouts and cutlines, allowing installation under these lines. When properly installed, the blankets are restrained and cannot billow into the Xo 378 vent areas. When installed improperly, the blankets could billow into the vent area. Improper installation of the TCS blankets was determined to be the likely cause of the vent anomaly. CAR 121RF08 was written for corrective action.

Installation drawing V070-361900, F/D shows V070-361995-024 & -025 at zone 55A but does not specify installation details. Specific installation details for these blankets are needed to prevent blanket migration over the PVD purge vents on Xo 378. Engineering recommends the following installation drawing clarifications to ensure no venting obstructions with blankets:

- install under drain lines
- tie to thruster box blankets using lacing cord and buttons
- tape to thruster box blankets along inboard seams

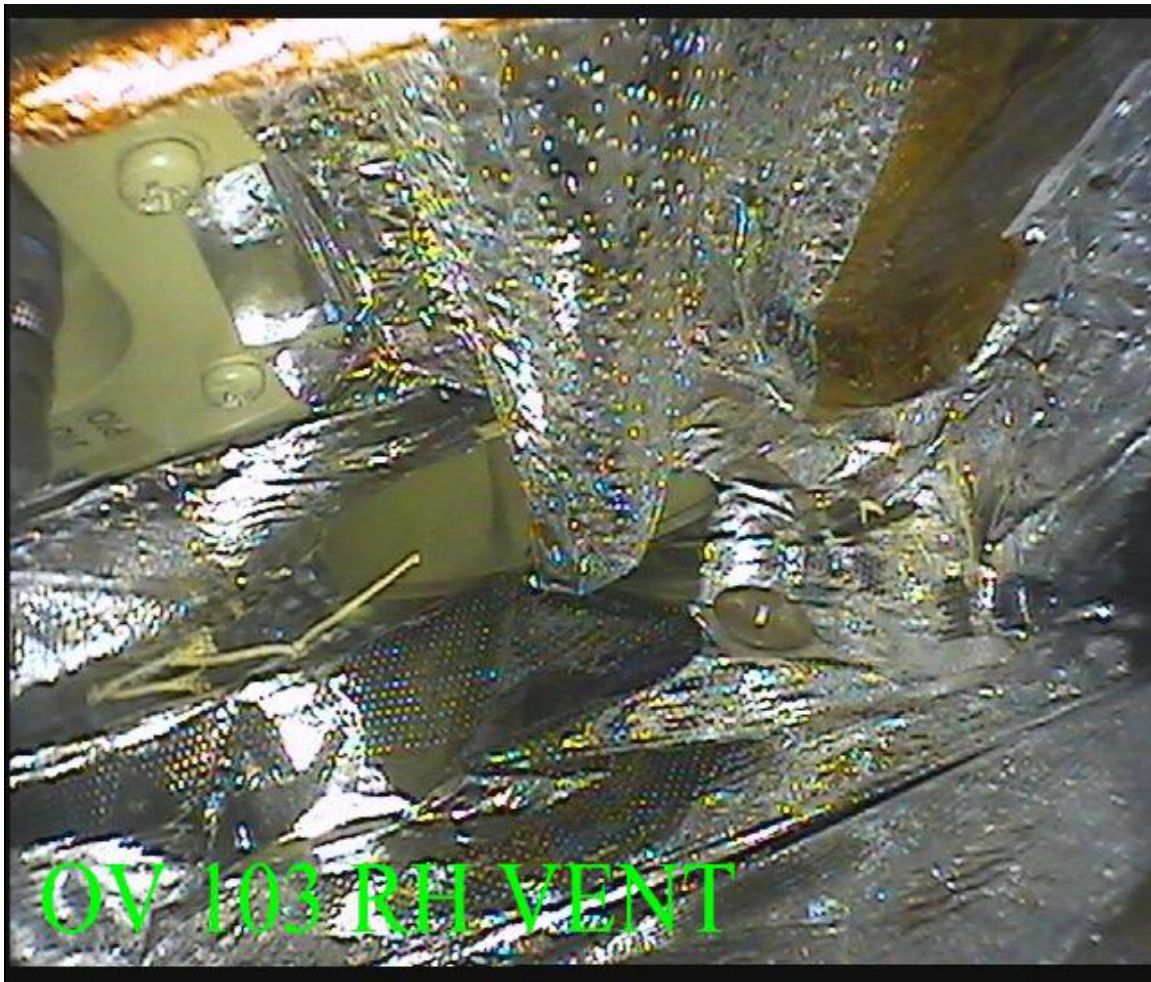
Figure 11-3 Boroscope view of RH Xo 378 purge vent (IPR 116V-0015)

Note: Flow path obstructed by blanket.

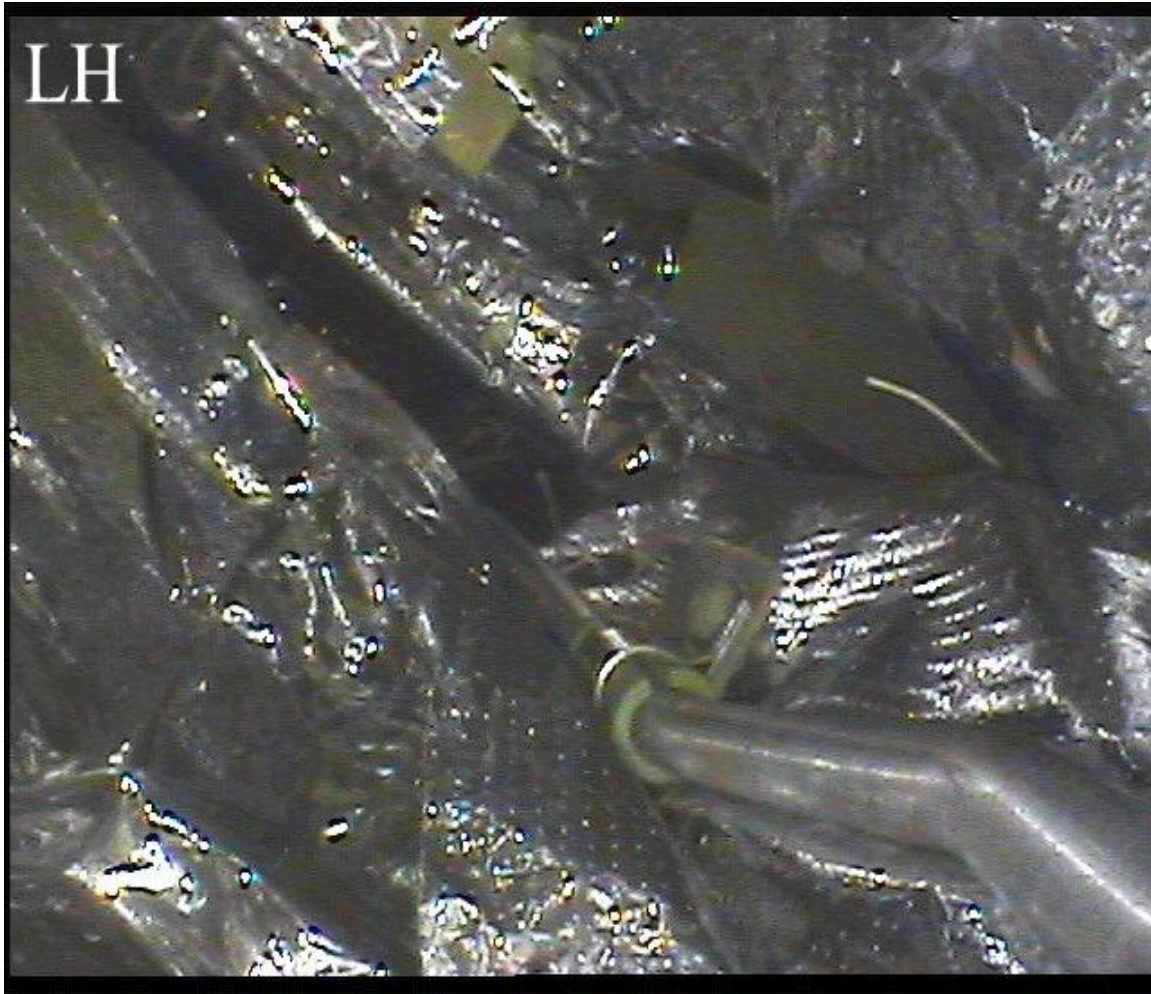
Figure 11-4 Boroscope view of LH Xo 378 purge vent after repositioning of blanket (SPC # 90790)

Note: MLI Blanket under drain line and secure to adjacent blanket. Flow path no longer obstructed by blanket.

On FRC3 the blankets were reworked and repositioned as recommended above. Blankets were installed under drain lines, fastened to thruster box blankets with buttons and tie

cord, and taped to thruster box blankets along inboard seams. Post rework borescope photos show no obstruction to purge vent operations for STS-116.

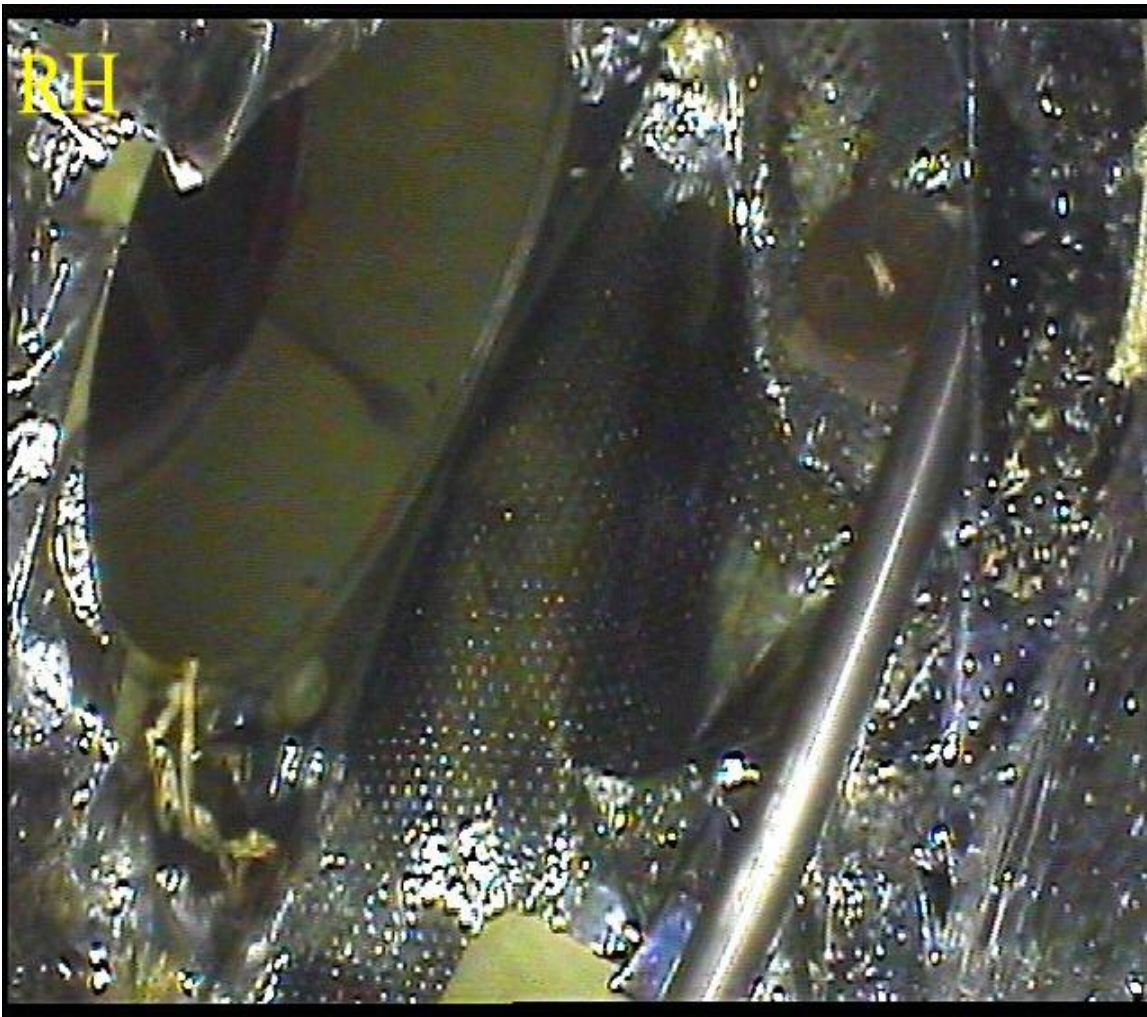
Figure 11-5 Boroscope view of RH Xo 378 purge vent after repositioning of blanket (SPC # 90790)

Note: MLI Blanket under drain line and secure to adjacent blanket. Flow path no longer obstructed by blanket.
