CRANE CHEMPUMP USE IN HYPERGOLIC SERVICING SYSTEMS

EVALUATION AND RECOMMENDATION

Date 01/10/2004

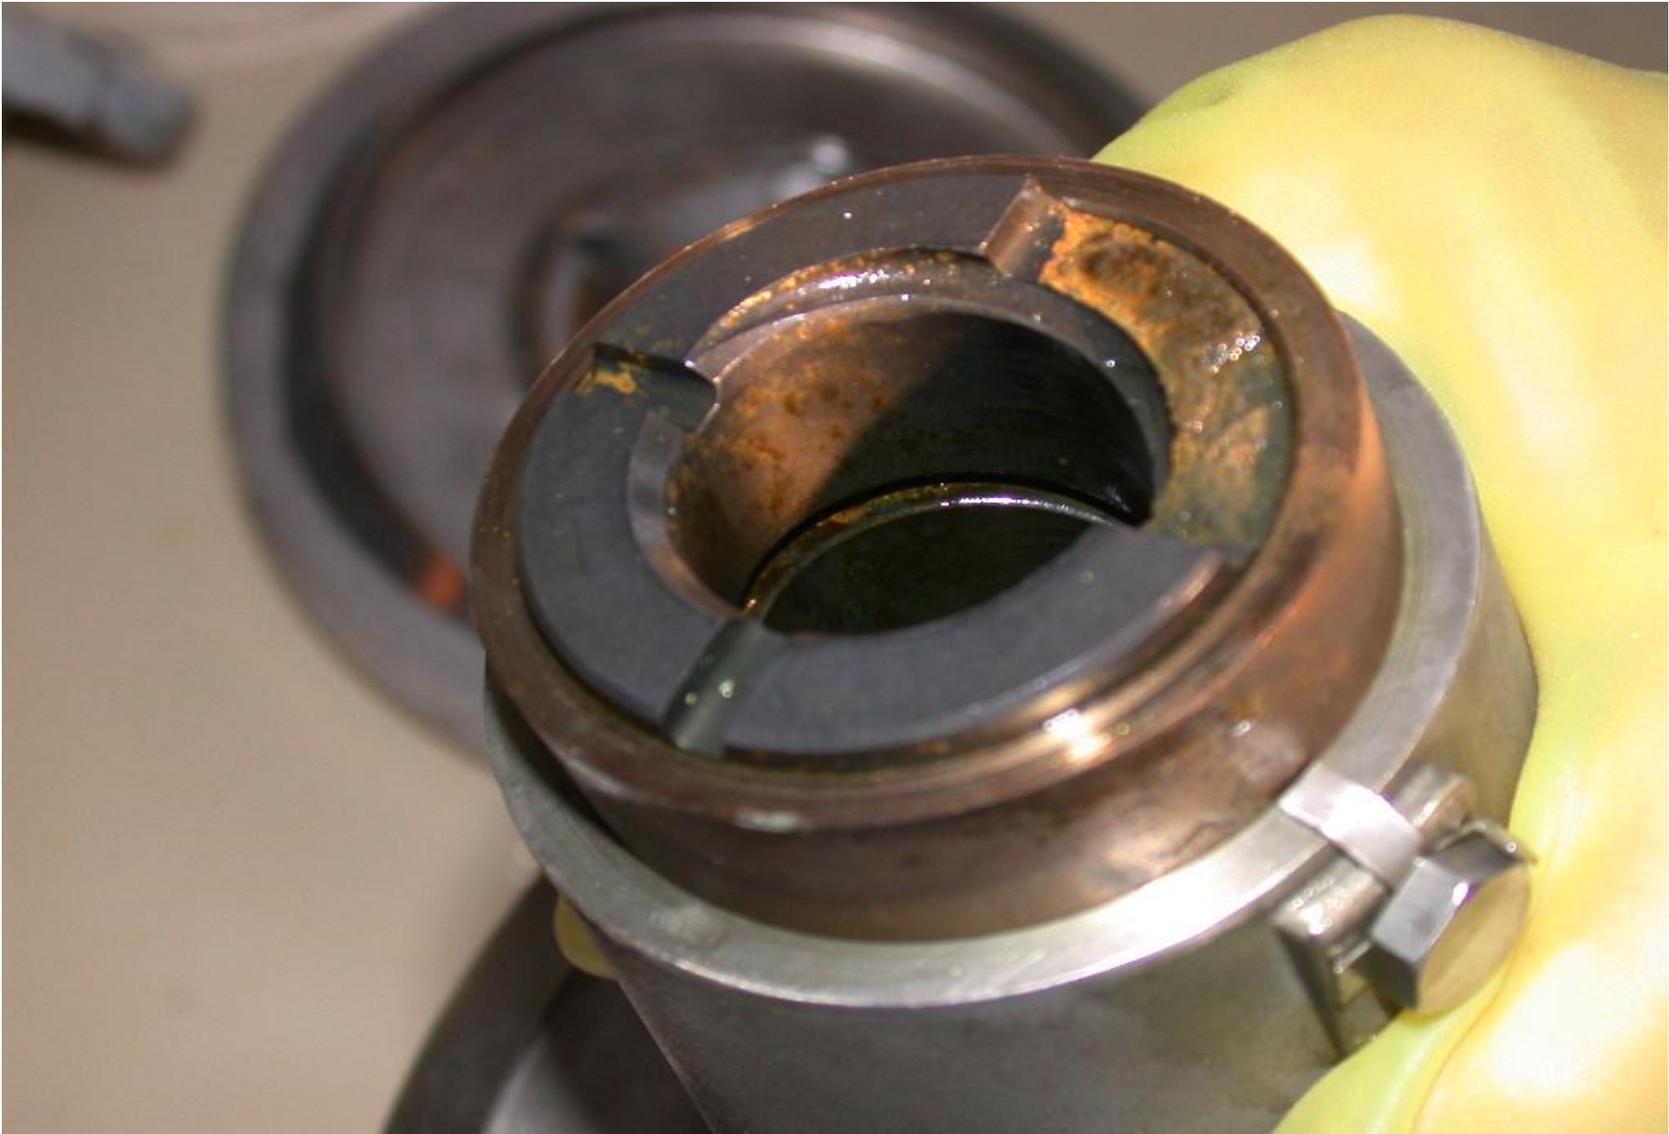
Oxid Pump 1 Front Bearing

- Observations of note were:
 - During the disassembly of the oxid pump #1, two of the three front bearing retaining screws were found in the bottom of the impeller housing
 - On oxid pump #2, all screws were only hand tight
 - On oxid pump #1, pieces of graphite were missing from the front and rear bearings
- General Observations:
 - Pump #1 shows more wear than pump #2
 - Oxidizer pumps show more wear than fuel pumps.
 - Pump design allows for metal to metal contact of moving parts.
 - Wear on fuel pumps does not seem to be excessive.
 - Wear on oxid pumps indicate out of tolerance conditions.
 - Areas of scoring are noted on all journals.
 - Journal design is different between oxidizer and fuel. Why?
 - We suspect pumps were not properly torqued to vendor's recommended specifications prior to shipping to KSC.
