Flex Hoses

Orbiter/03-08-05

- Failures Have Occurred in Metal Bellows Flex Hoses Used in Sub-systems ECLSS, PRSD, OMS/RCS, MPS and PVD
 - OV-105 Secondary Pressure Control System (PCS) O2 bulkhead flex hose leaked during STS-113 countdown delaying launch. Flex hose was R&R'd, Ref IFA-133-V-01
 - Failure drove the Flex Hose Investigation
- Vehicle Inspections Resulted in PR's Documenting External Damage and Bend Radius Specification Violations
- Suspect Internal Corrosion Found in Spare Metal Bellows Flex Hoses, led to a concern of a possible corrosion threat to Orbiter systems
- Certification Verification Evaluation Questioned Flex Hose Certification

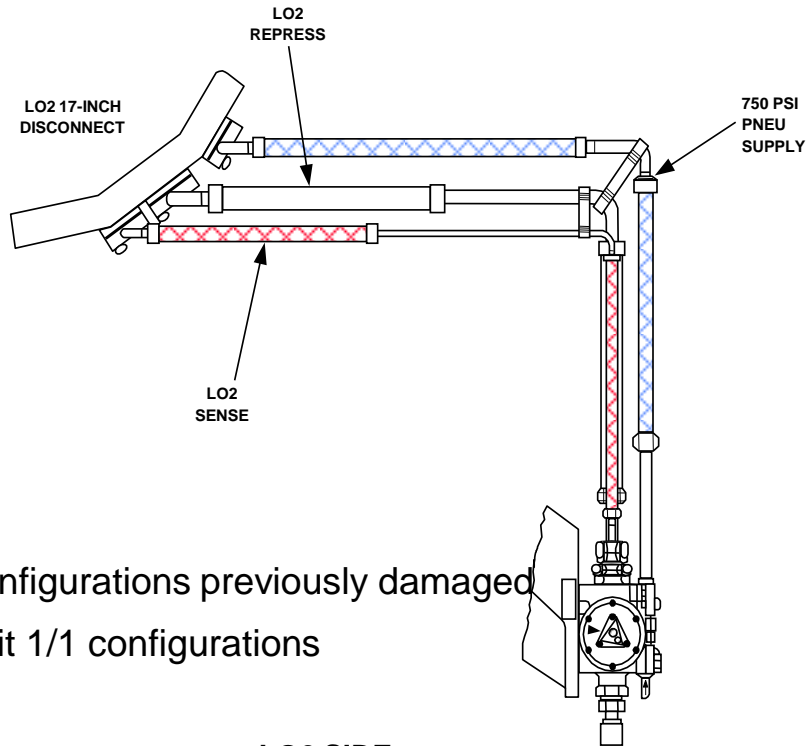
MPS LO2 Disconnect Flex Hoses

14 configurations previously damaged
-

10 Crit 1/1 configurations

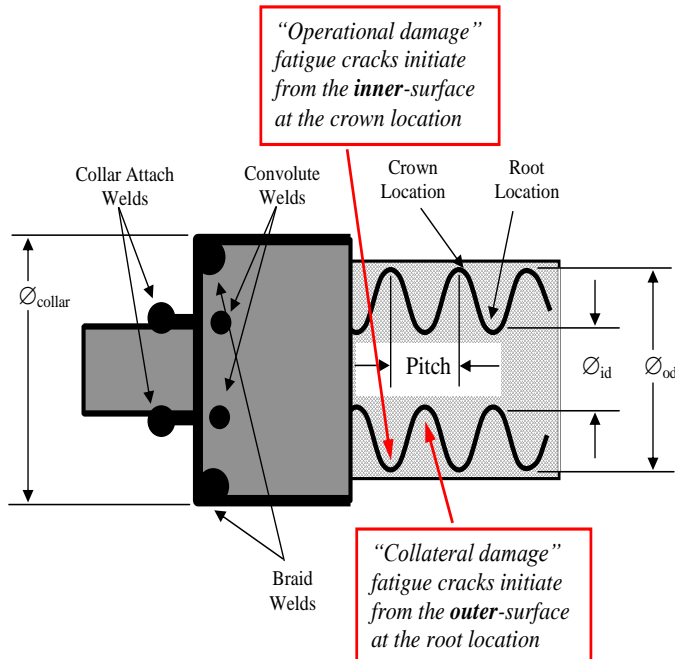
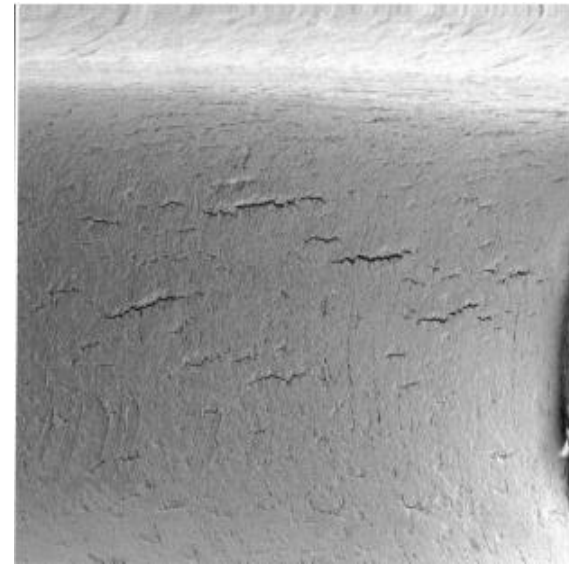
- Based upon observations from failure analysis, failure mechanism, and flight history
 - Apparently, stresses from handling (LCF) are sufficiently high enough to drive crack initiation and propagation independently from corrosion pit stress concentrations
 - Apparently, stresses from operation (HCF) are sufficiently low enough as not to significantly affect the operational fatigue life
