NASA/TM-2012-217348  
NESC-RP-09-00529

# International Space Station (ISS) Heat Rejection Subsystem (HRS) Radiator Face Sheet Damage

*Henry A. Rotter/NESC  
Langley Research Center, Hampton, Virginia*

March 2012

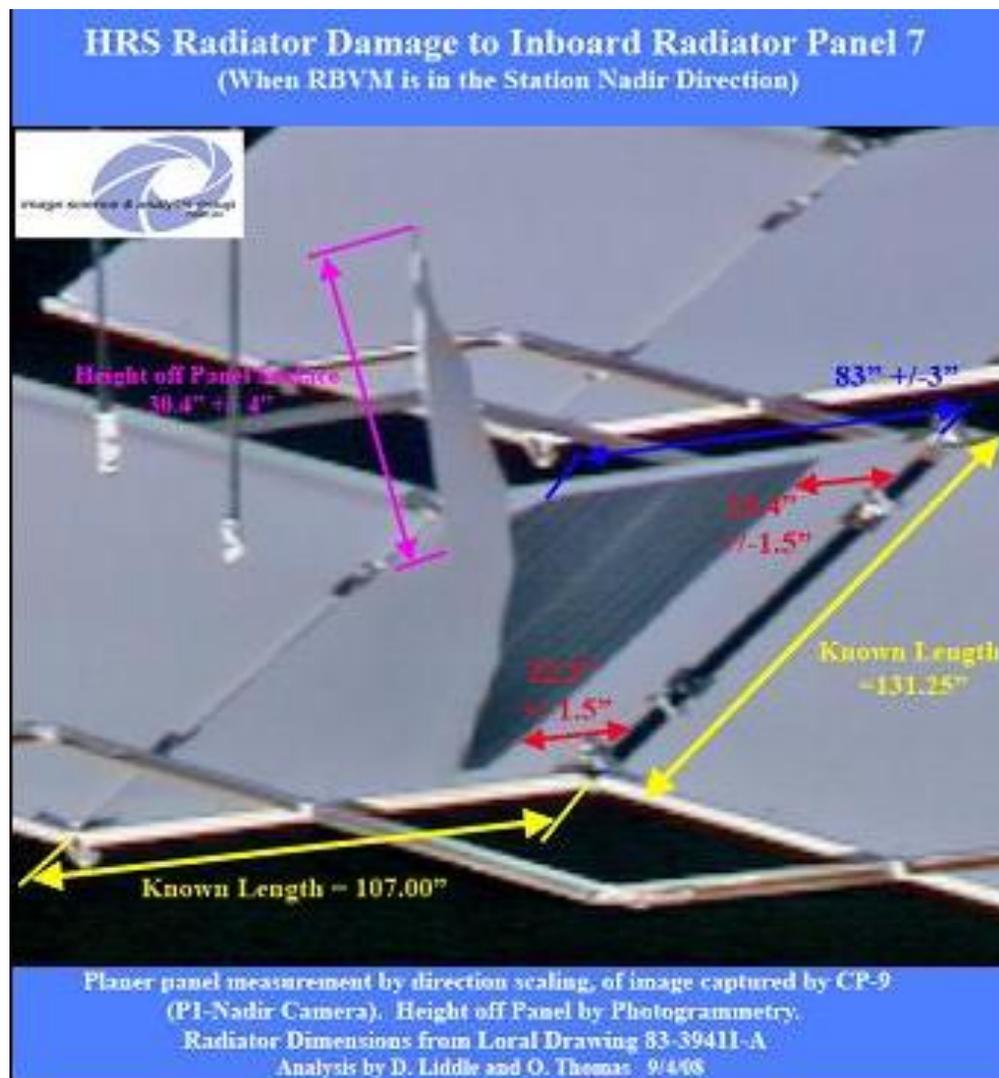
On September 1, 2008, a planned external image survey of the International Space Station (ISS) found the heat rejection subsystem radiator (HRSR) S1-3 panel 7 thin (0.010 inch) aluminum face sheet was peeled up (Figure 4.0-1). A survey of previous ISS images and videos verified that this radiator was in the normal configuration on August 29, 2008. A survey of ISS accelerometers and events during this time period found no evidence to determine when this event specifically occurred and offered no clues to its origin.

**Figure 4.0-1. HRSR S1-3 Panel 7 Damage**

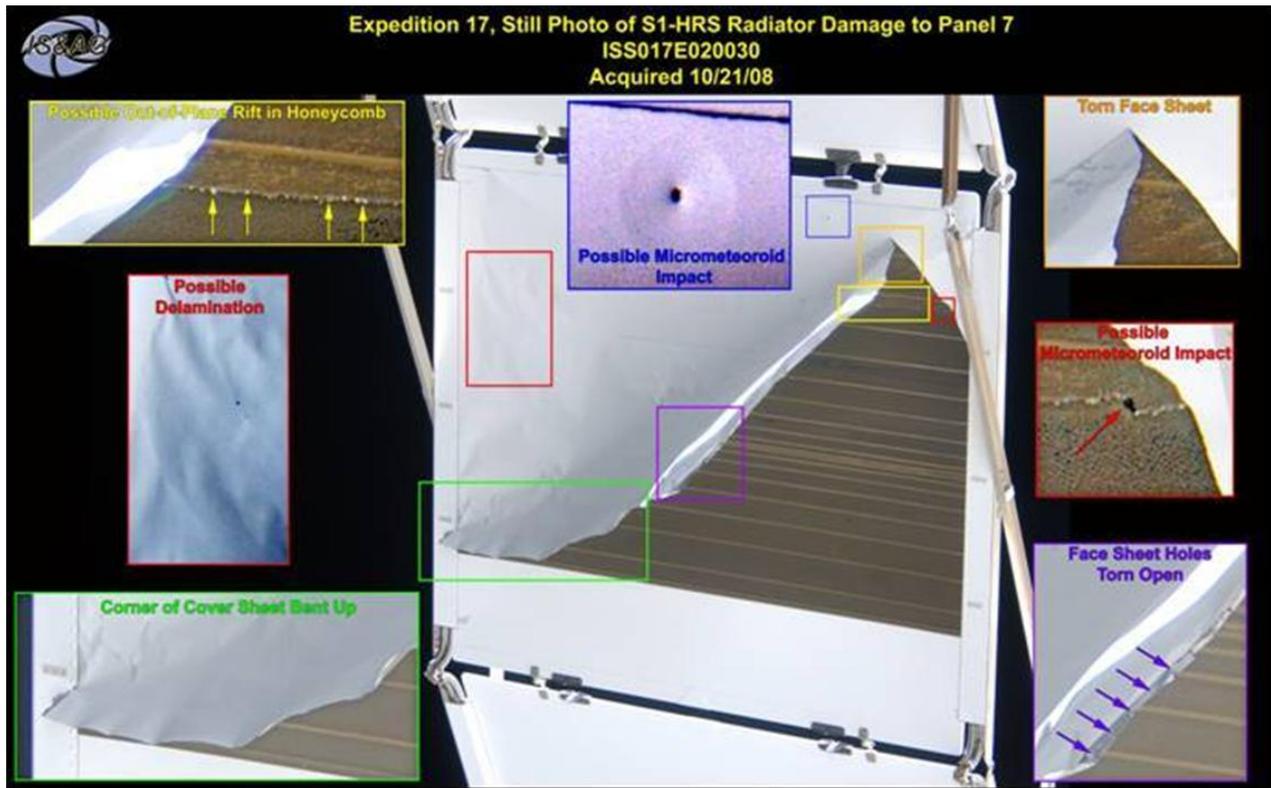
A detailed image survey showed that approximately half of the panel face sheet had peeled up, but was stable (i.e., not liberating debris) and not increasing in size (Figure 4.0-1). The large section of the peeled up face sheet contained perimeter bolt shearing and tearing, sheared face sheet material, and debonding from one of the adjoining face sheets. The peeled up sheet had significant wrinkles, was debonded from the internal materials, and contained one micrometeoroid orbital debris (MMOD) impact penetration exit (Figure 4.0-2). The back sheet had a small area of wrinkles and some debonding on the outer edge (Figure 4.0-3).

*Figure 4.0-2. Initial Damage Assessment of HRSR S1-3 Panel 7 Survey*

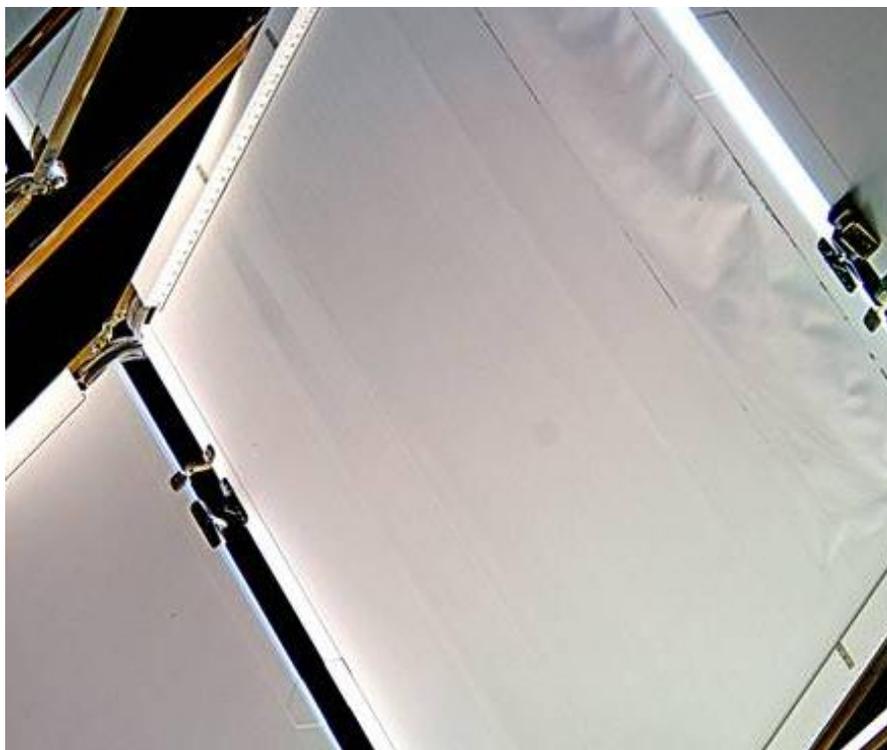
*Figure 4.0-3. S1-3 Panel 7 Back Side Face Sheet*

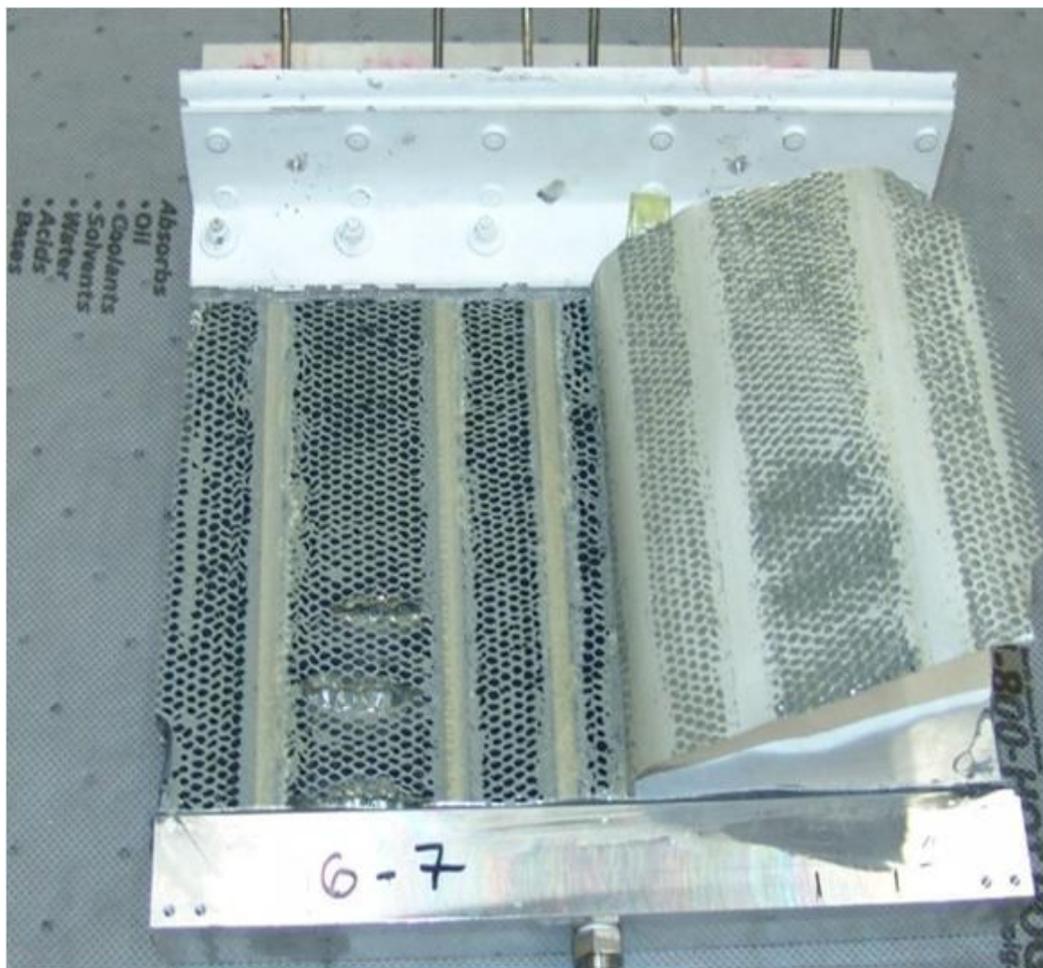
*Figure 4.0-4. Panel Test Segment with Face Sheet Peeled Back*

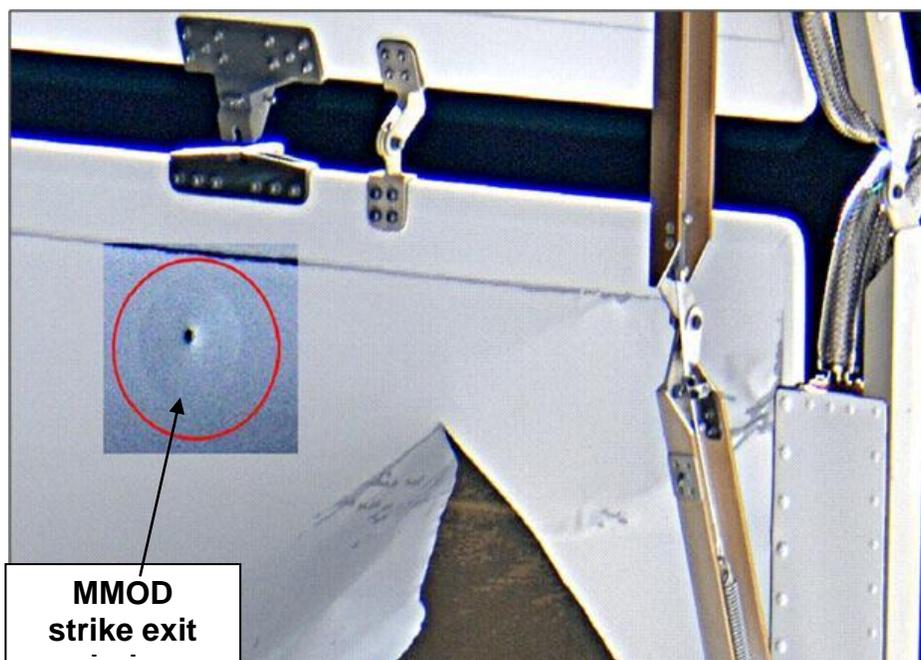
Image review of the ISS S1-3 panel 7 with the face sheet peeled up showed an MMOD impact entering on the panel back side and exiting near the panel top side outer edge, as shown in Figure 5.3-1. The team reviewed three reports [refs. 1, 16 and 17] on MMOD testing and analysis results to determine if an impact could induce the panel 7 damage. The findings in these reports indicated that MMOD particles would induce only localized damage for the size (~0.375-inch-diameter) round exit hole observed in the panel face sheet. None of the test results of larger particles indicated that MMOD could induce the observed face sheet peel. Figure 5.3-2 shows an exit hole through a radiator-like panel that is similar to the hole that was observed on panel 7. However, none of these reports had impacts on a pressurized void. So, no conclusions could be made if the MMOD hit on panel 7 was the initiation impulse or the hit occurred after the face sheet was displaced. MMOD impact testing through pressurized voids by Boeing showed a similar deflection ring around the exit hole, as shown in Figure 5.3-2. This could indicate the MMOD particle impacted a pressurized void in the panel and the impact shock wave initiated the dynamic event of the radiator face sheet peel up.

*Figure 5.3-1. Panel 7 MMOD Impact Exit Hole ~ 5/16 Inch (Note ring around hole)*

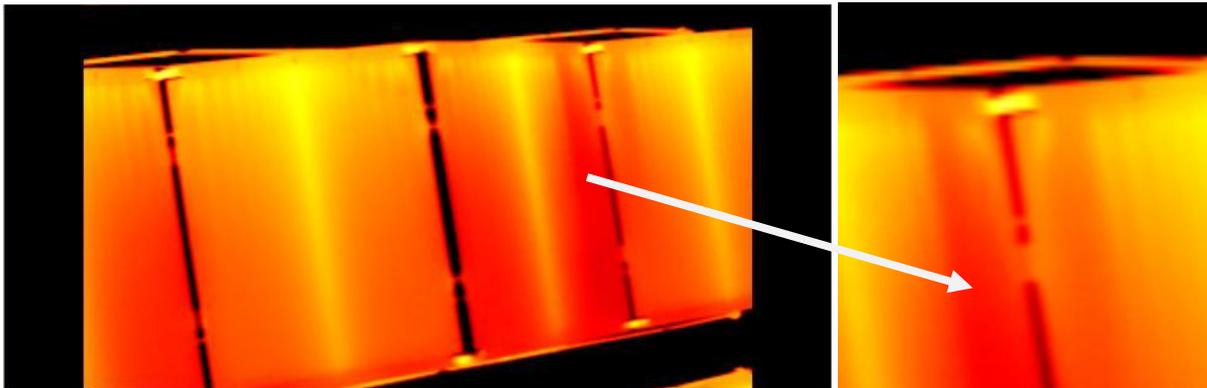
Figure 5.4-4 depicts the raw temperature data for panel 7 showing a possible nearly frozen outer flow tube under an undamaged face sheet (S1-2). The radiator outlet temperature was approaching -100°F. This is the only other potentially anomalous panel found in the IR imagery review.

**Figure 5.4-4. Possible Frozen Flow Path on S1-2 Panel 7 (Center Array)**

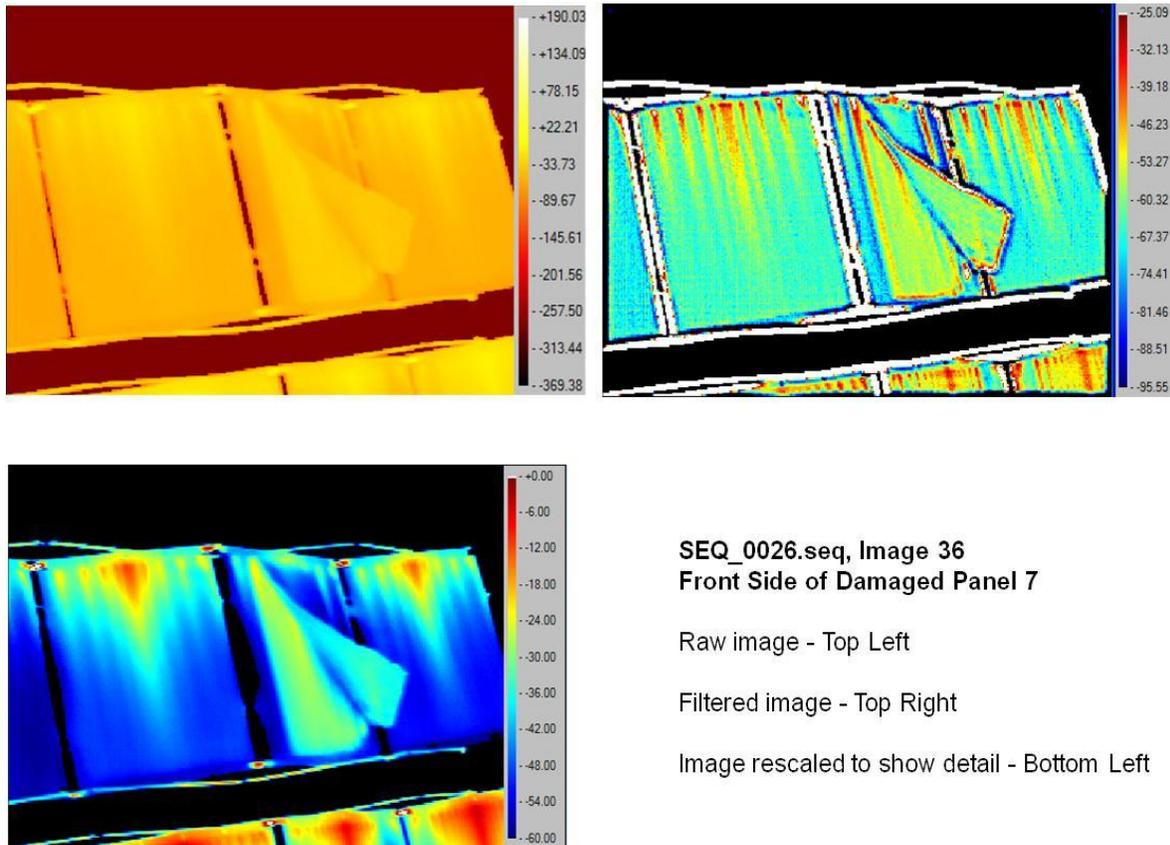
Figure 5.4-5 is an example of how the IR imagery temperature data can be analyzed to show that there is heat rejection lost for the area under the peeled up face sheet. However, this reduction has only a small effect on the performance of the total radiator system for Loop A.

*Figure 5.4-5. IR Imagery Processing Results*

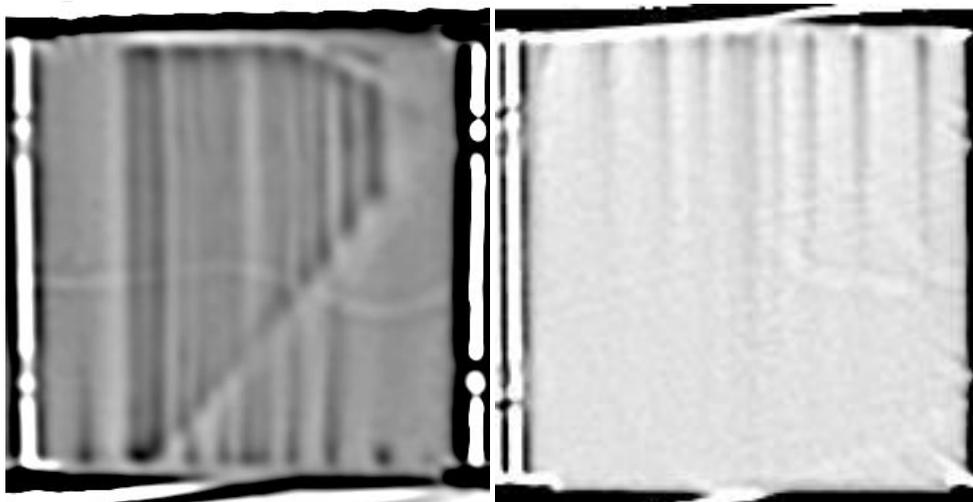
A comparison of the laplacian images for a damaged panel and an undamaged panel is shown in Figure 5.4-9.

*Figure 5.4-9. (a) Laplacian Image of a Damaged Panel (b) Laplacian Image of an Undamaged Panel*

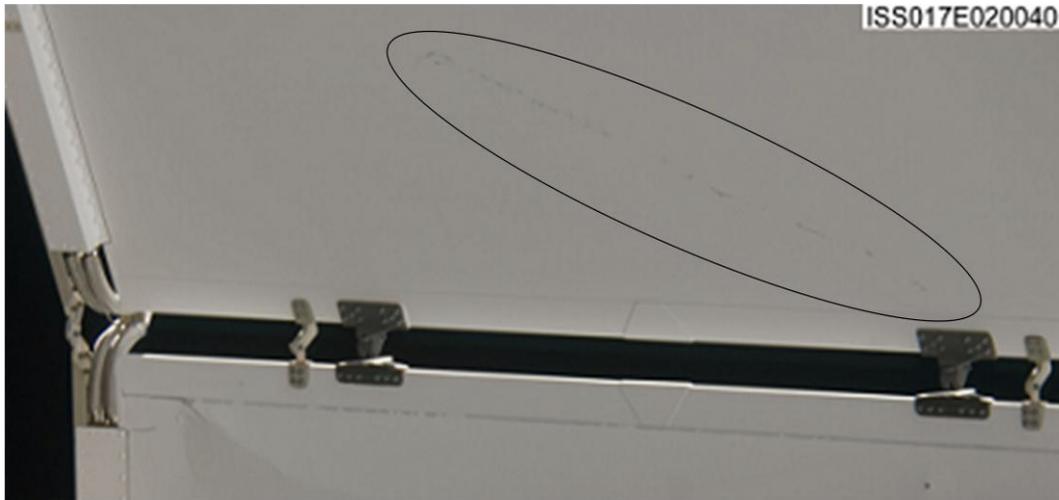
*Figure 6.4-3. Marking on Panel 7 Neighboring Panel*

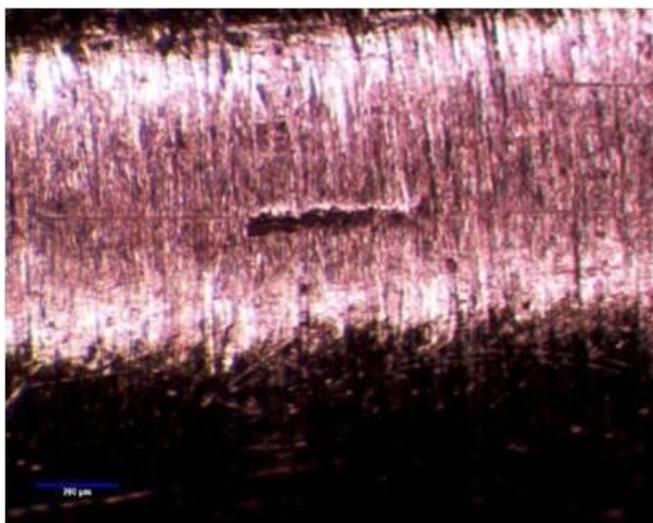
extracted from suspect areas. The checks found no detectable voids or anomalies. A surface flaw was found in the tubing stock, which would have been dispositioned to use “as is.”

**Figure 7.1-2. Parent Material Defect Detected During Inspection**

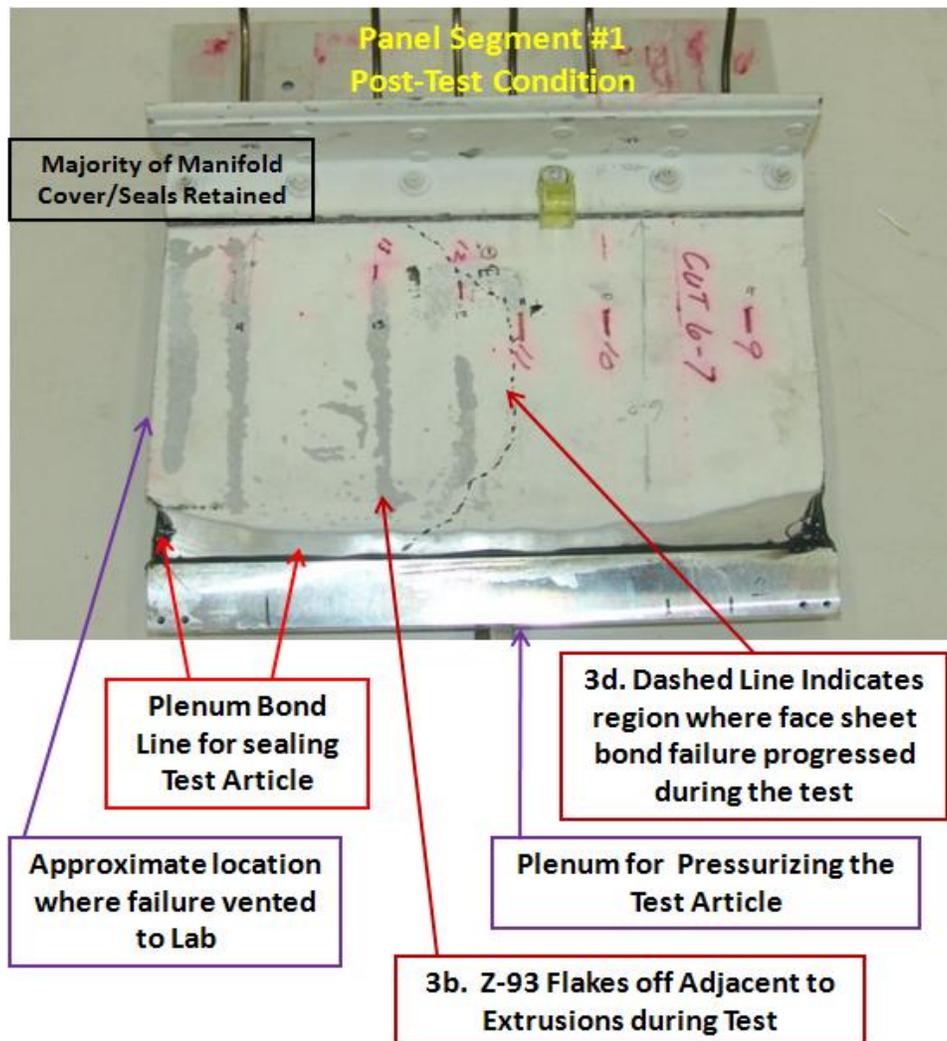
*Figure 7.1-8. Panel Segment 6-7, Post Leak Test Condition*

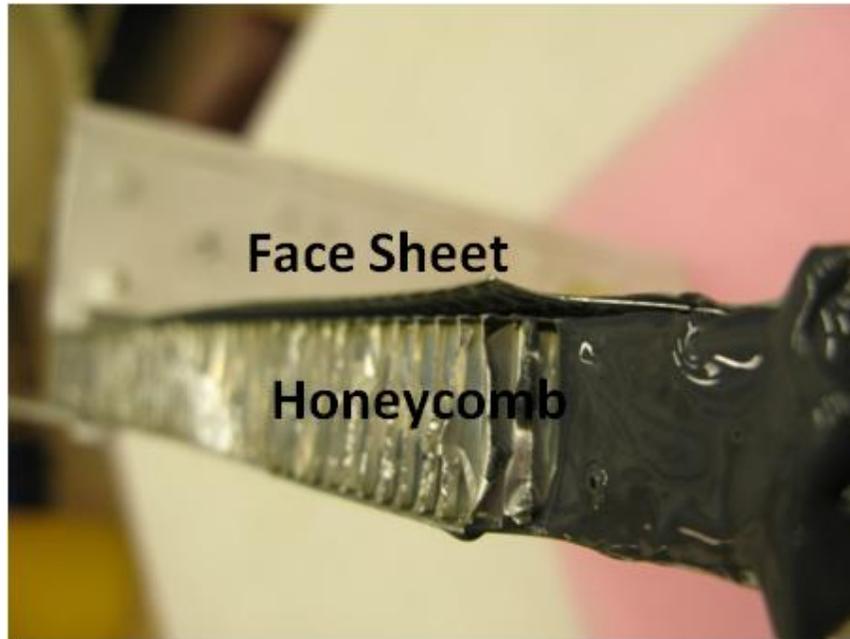
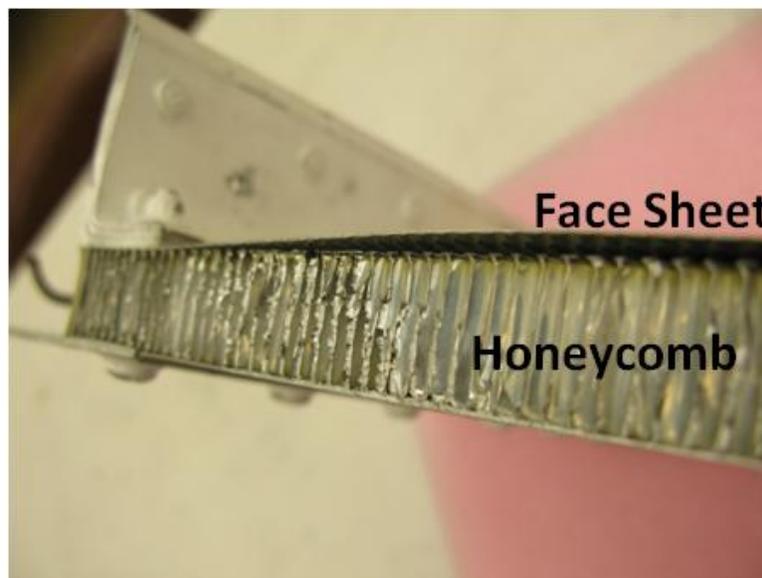
*Figure 7.1-9. Delaminated Face Sheet*

*Figure 7.1-10. Delaminated Face Sheet*

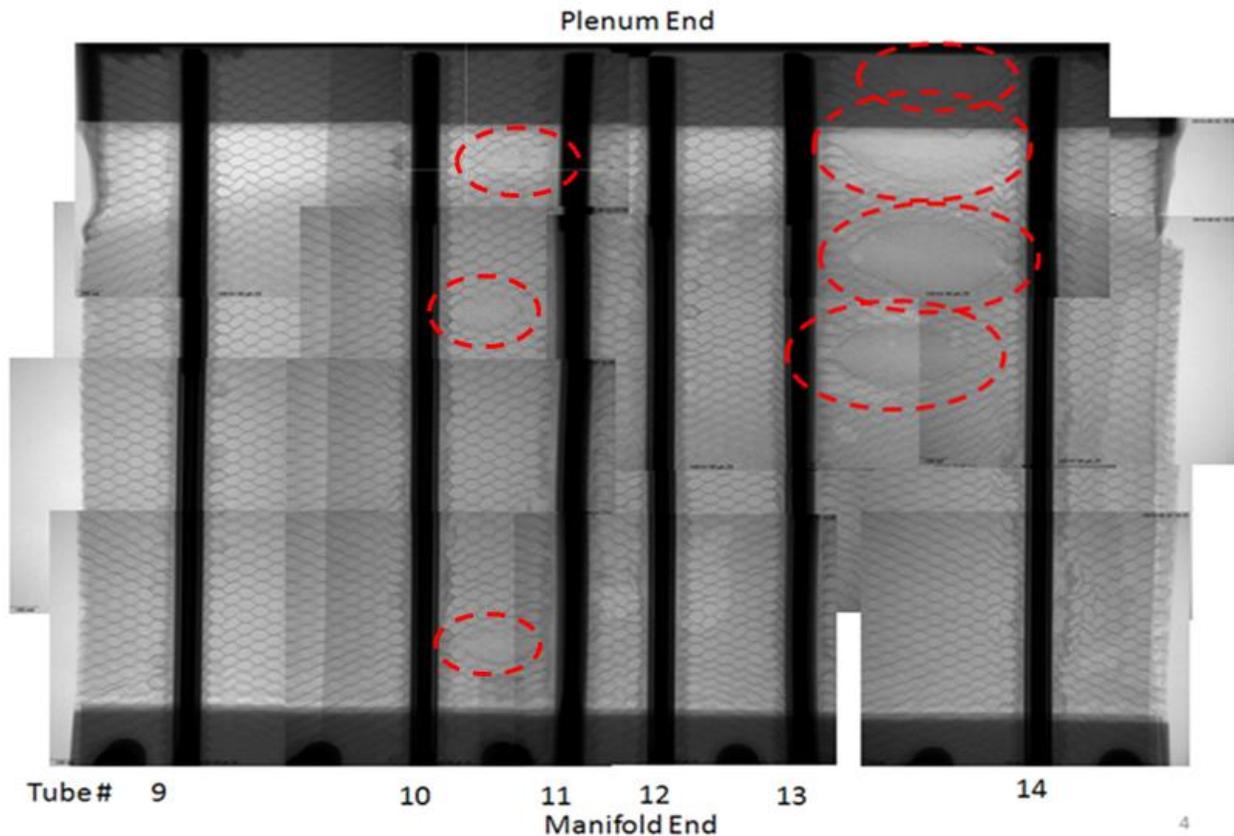
**Figure 7.1-11. X-Ray View Depicting Lagoons**

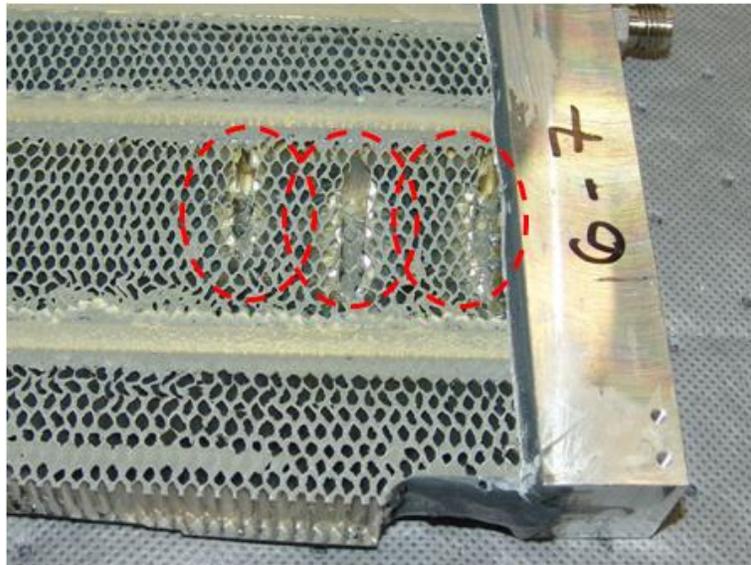
*Figure 7.1-12. HOBE Lagoons Revealed After Removal of Face Sheet*

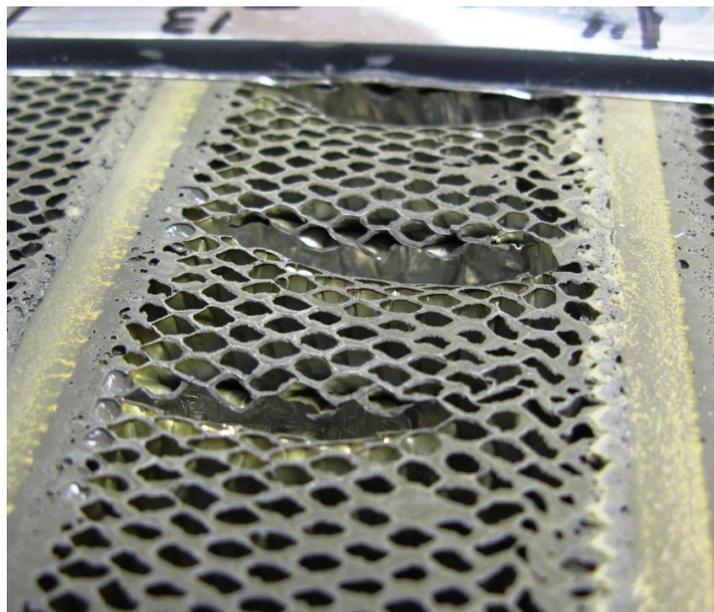
*Figure 7.1-13. HOBE Bond Failures from the Face Sheet*

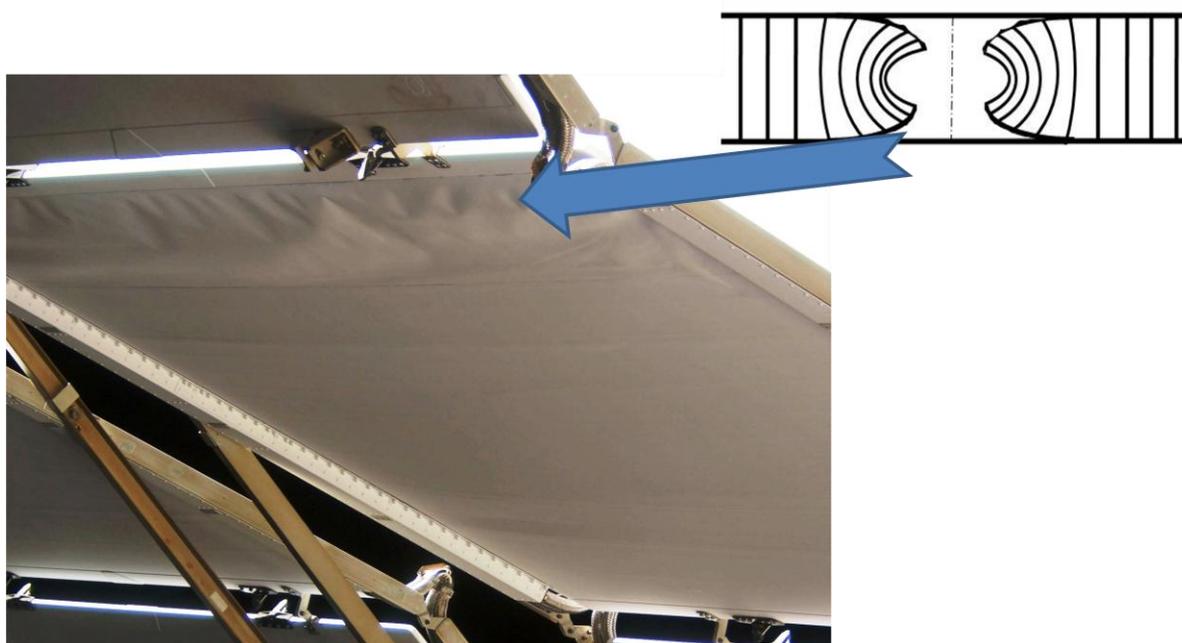
**Figure 7.1-14. Comparison Between Test Failure and Panel 7 Images Showing Ripples Perpendicular to the Flow Tube Orientation**

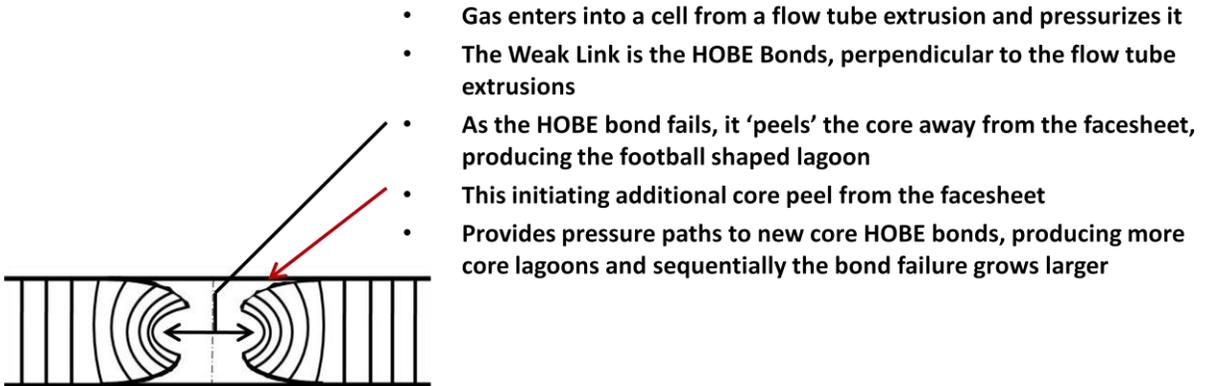
*Figure C-2. HOBE Bond Failure Drives Panel Delamination*
