**STS-114 ET Vent Arm Umbilical Purge Shroud IFA Closure
Rationale, STS-114-I-014
&
Update ISPR-02
“ET Vent Arm System (ETVAS) Umbilical System
Malfunction”**

**CR# S050425DG
SICB**

04/22/2006

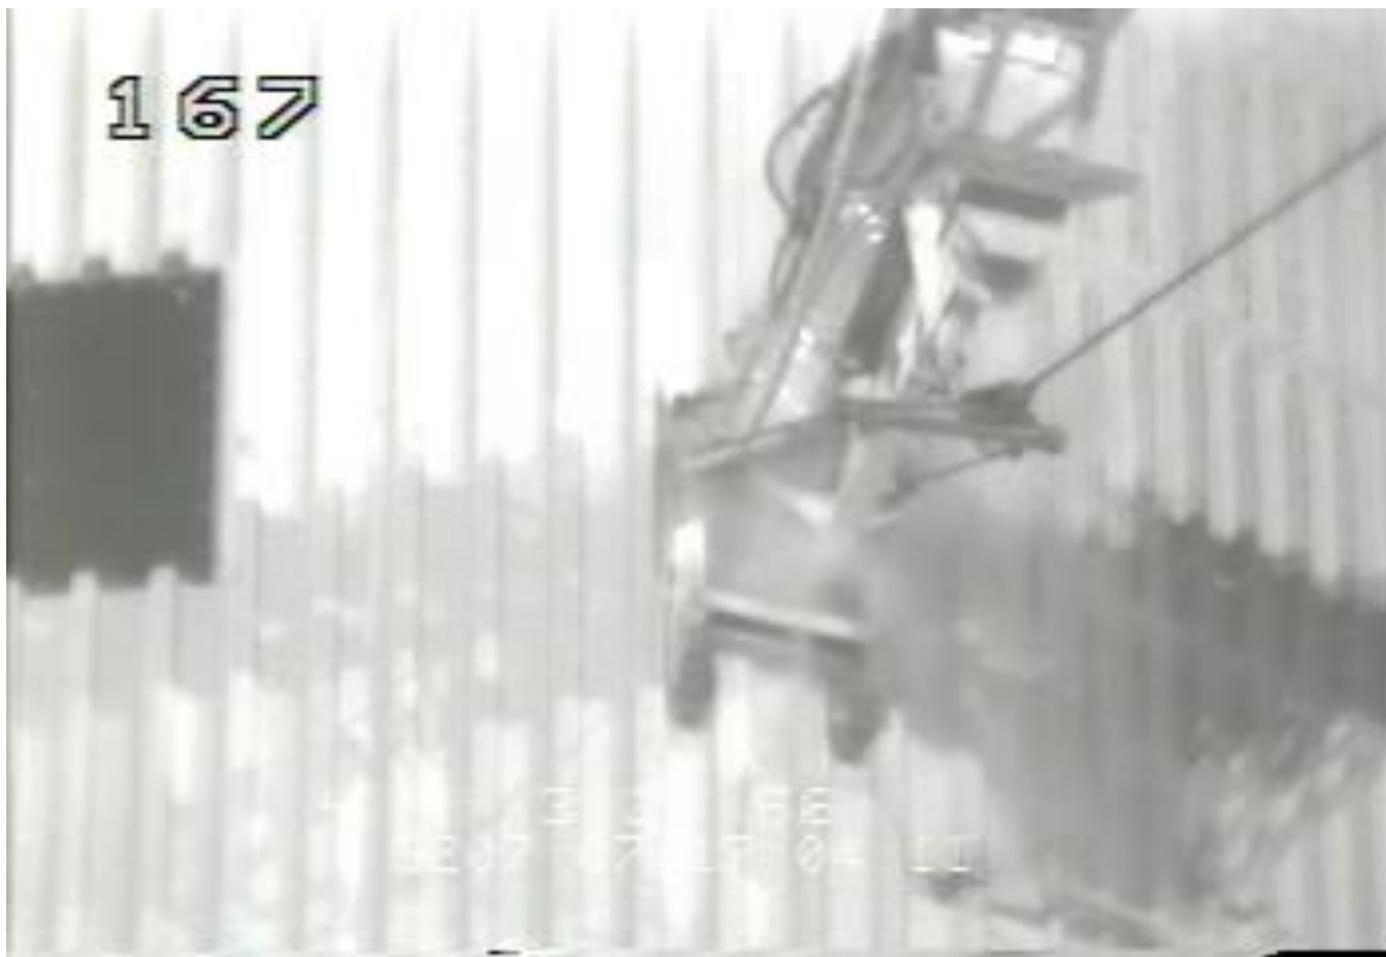
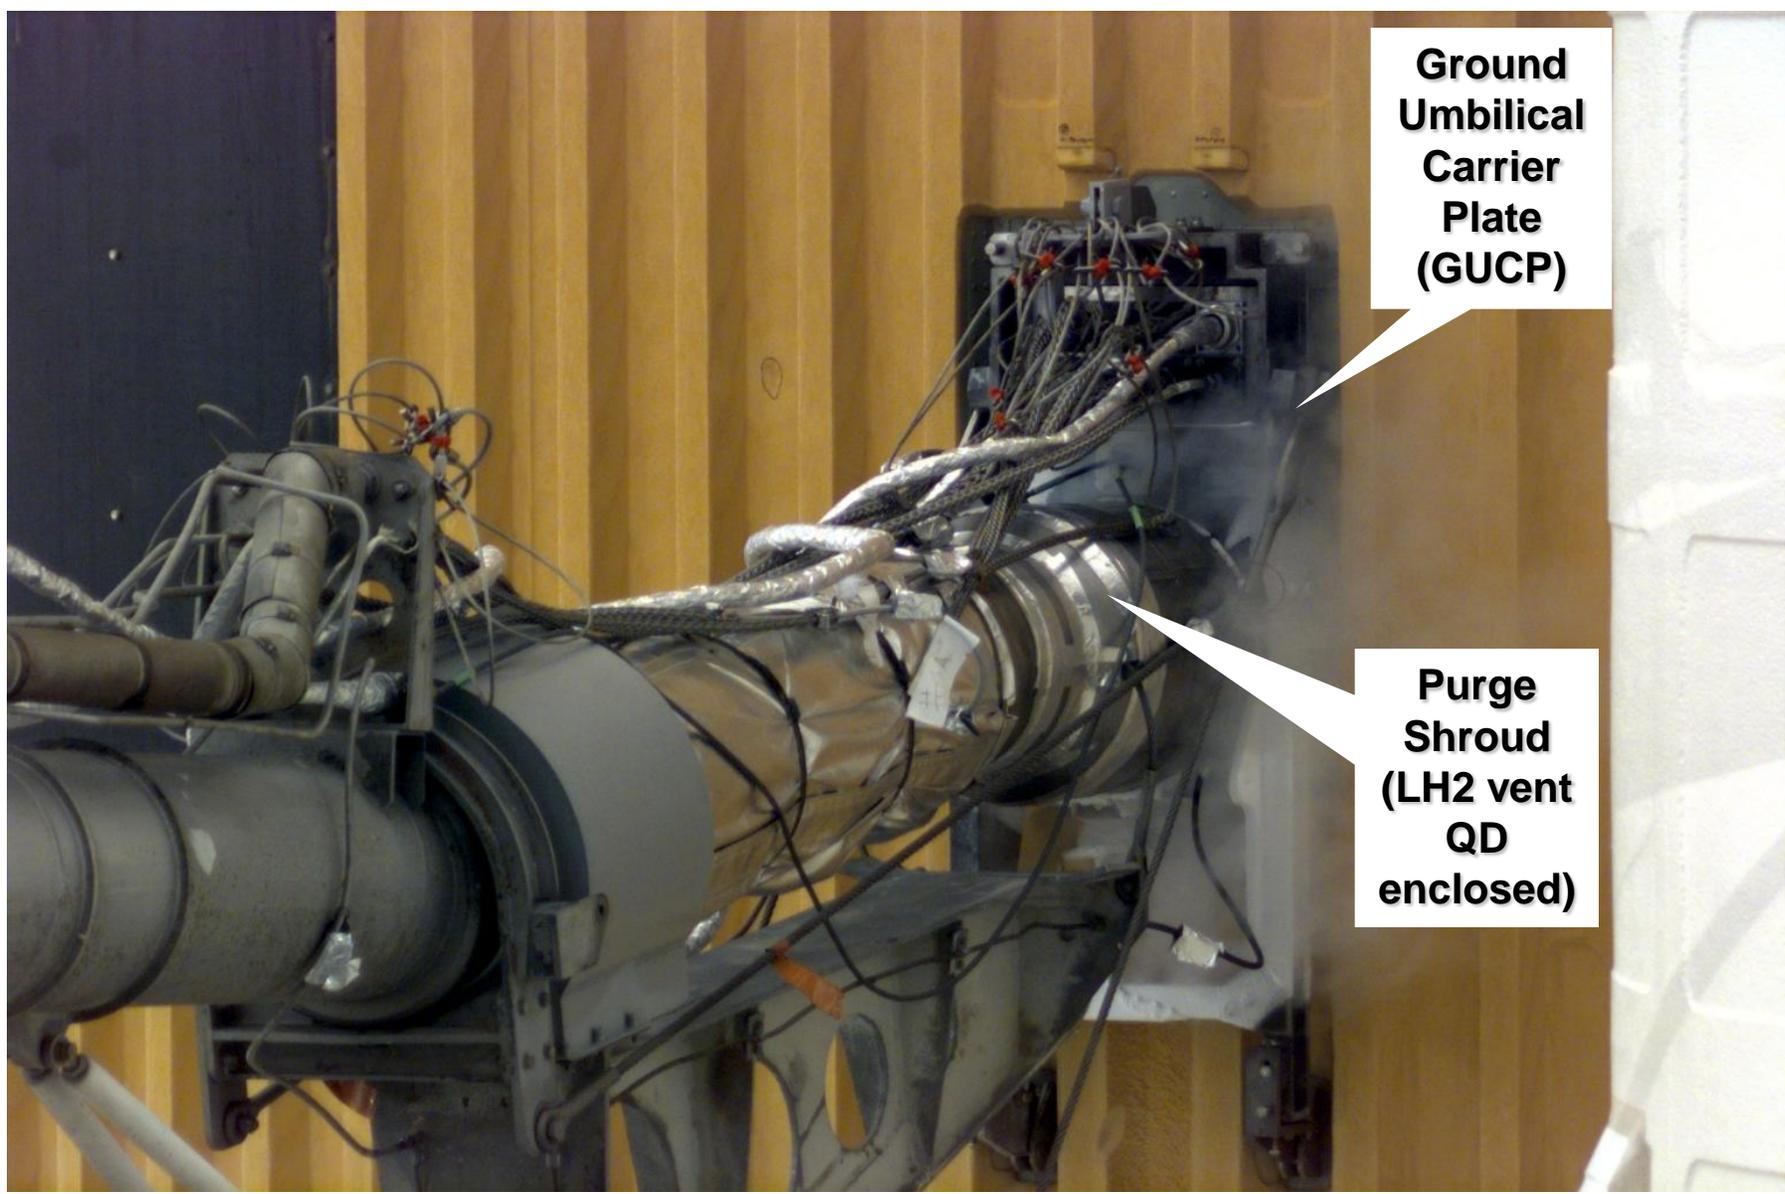
Problem Description – LN2 formation video

Ground Umbilical Carrier Plate (GUCP)

Purge Shroud (LH2 vent QD enclosed)

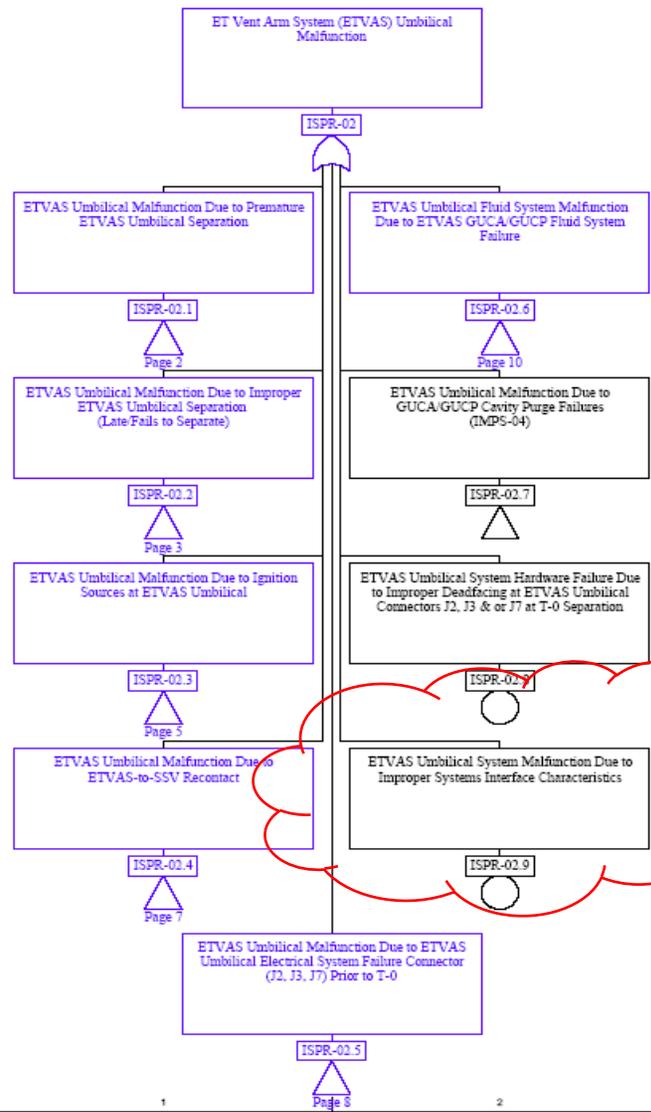
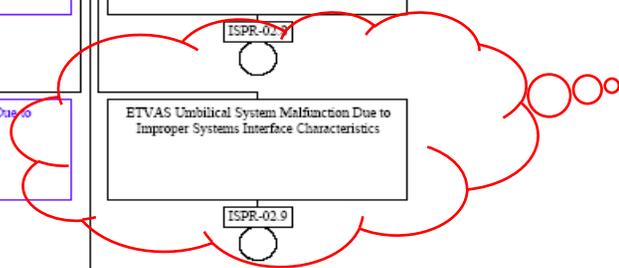
ISPR-02.9

- Add new fault tree block ISPR-02.9, “ETVAS Umbilical System Malfunction Due To Improper Systems Interface Characteristics”

Recommend adding an Improper Systems Interface Characteristics Cause to IHR ISPR-02
