Flex Hoses

Orbiter/03-08-05

- Failures Have Occurred in Metal Bellows Flex Hoses Used in Sub-systems ECLSS, PRSD, OMS/RCS, MPS and PVD
 - OV-105 Secondary Pressure Control System (PCS) O2 bulkhead flex hose leaked during STS-113 countdown delaying launch. Flex hose was R&R'd, Ref IFA-133-V-01
 - Failure drove the Flex Hose Investigation
- Vehicle Inspections Resulted in PR's Documenting External Damage and Bend Radius Specification Violations
- Suspect Internal Corrosion Found in Spare Metal Bellows Flex Hoses, led to a concern of a possible corrosion threat to Orbiter systems
- Certification Verification Evaluation Questioned Flex Hose Certification

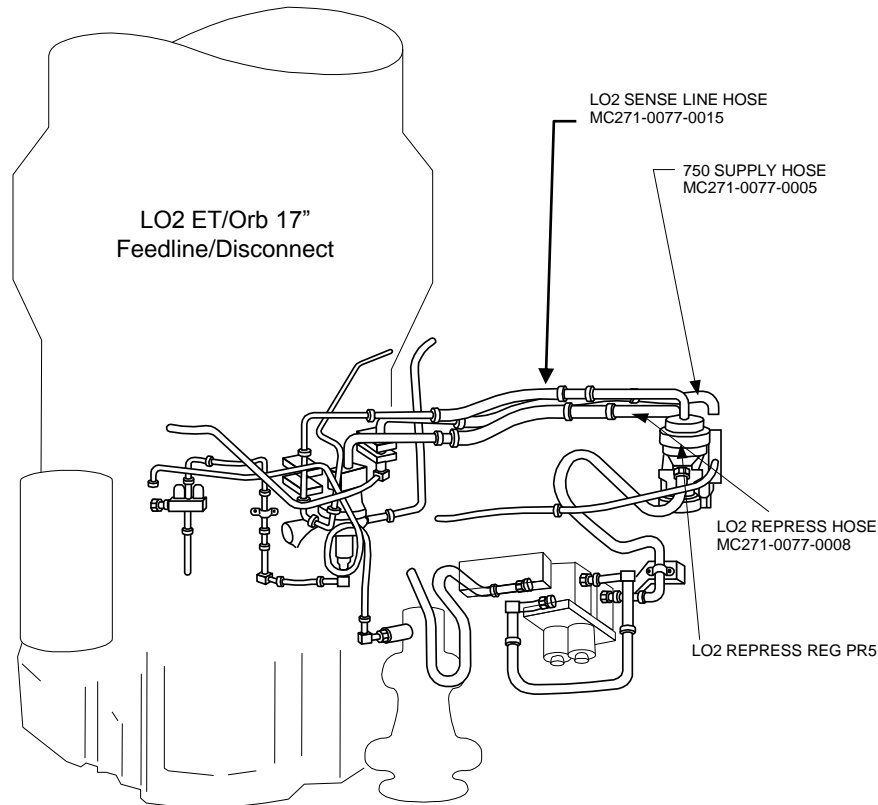
MPS LO2 Disconnect Flex Hoses

14 configurations previously damaged
-

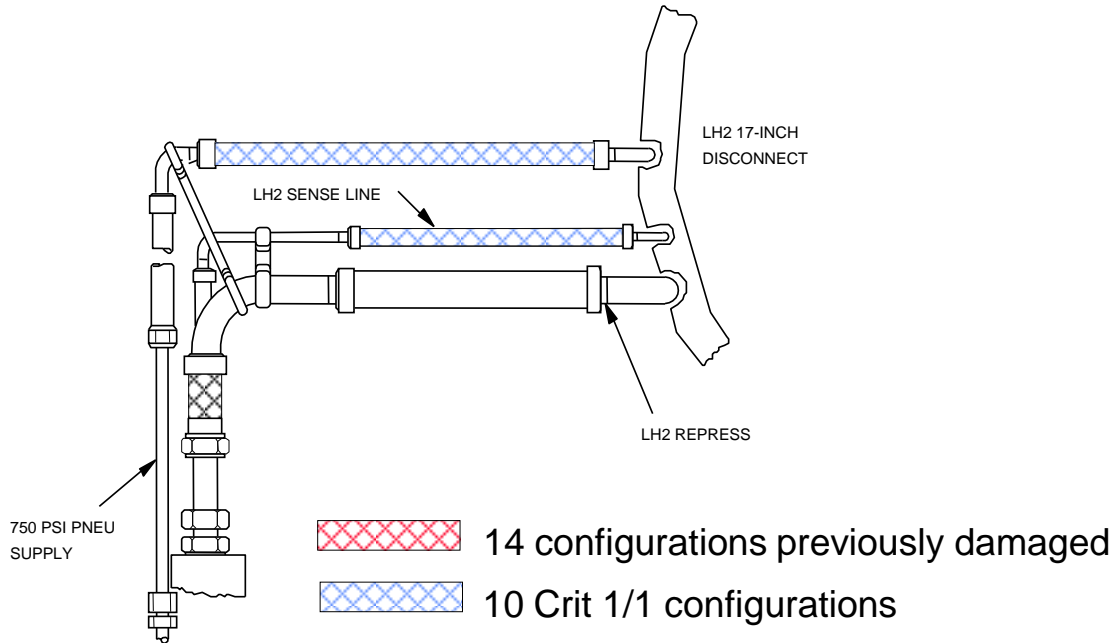
MPS LH2 Disconnect Flex Hoses

LH2 SIDE

- 1/4 IN. MANIFOLD SENSE LINE
- 3/8 IN. PNEUMATIC SUPPLY LINE
- 3/4 IN. MANIFOLD REPRESS LINE
