NASA/TM-2012-217348  
NESC-RP-09-00529

# International Space Station (ISS) Heat Rejection Subsystem (HRS) Radiator Face Sheet Damage

*Henry A. Rotter/NESC  
Langley Research Center, Hampton, Virginia*

March 2012

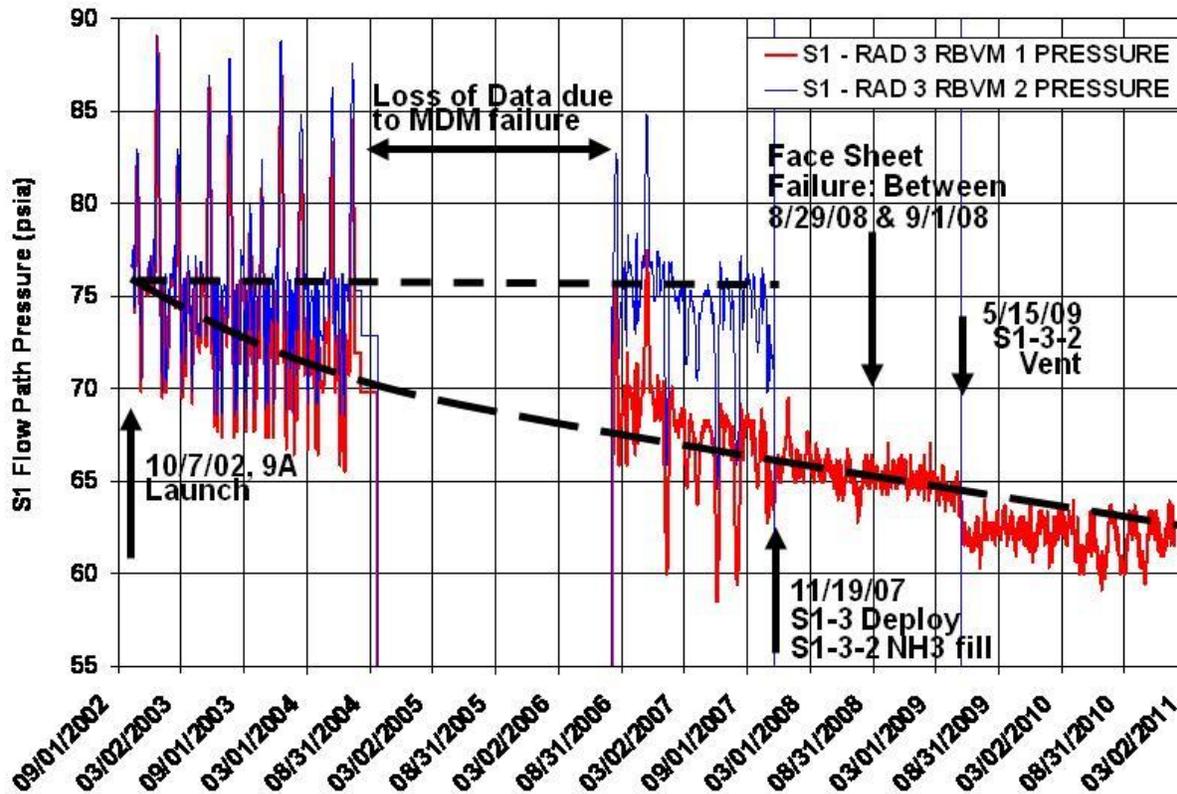
Figure 5.2-1. S1-3 Array Loop 1 and 2 N<sub>2</sub> Pressures

After the S1 radiator arrays were launched and installed on ISS during flight 9A in October 2002, a review of the flight data determined that there was a N<sub>2</sub> pad pressure leak of approximately  $2 \times 10^{-5}$  sccs from the S1-3 radiator array flow path 1 side. This leak rate was less than half of the allowable leak rate requirement and some percentage of the leak was through the seals in the array quick disconnects. There was no indication of a N<sub>2</sub> leak from flow path two prior to ammonia servicing in November 2007, as shown in Figure 5.2-1. The ammonia quick disconnects (QDs) leakage allowable is  $9.2 \times 10^{-5}$  sccs N<sub>2</sub> and the panel 7 flow path's proof pressure test minimum detectable leak rate was  $1.5 \times 10^{-3}$  sccs N<sub>2</sub>. The on-orbit leak rate was not detectable by the ground as tested so it may have existed prior to launch.

After N<sub>2</sub> venting from S1 array flow path 2, the loop was connected to the ISS loop A, as shown in Figure 5.1-1, and serviced with ammonia. The leak detection capability of loop A is limited and requires a large leak rate to be seen in the flight data. A leak rate as high as  $1.5 \times 10^{-2}$  sccs N<sub>2</sub> the requirement that can over pressurize the panel cavity over several years would be below the serviced ammonia loop A leak detection capability. Therefore, an internal panel flow tube N<sub>2</sub> leak from side 1 or ammonia from side 2 could have existed or occurred and leaked through the extrusion silver-filled epoxy into the panel interior and over pressurized the face sheet.

precaution, the NASA and Boeing EATCS ISS system teams recommended isolating the S1 radiator array from loop 2 and vented the ammonia overboard on May 15, 2009.

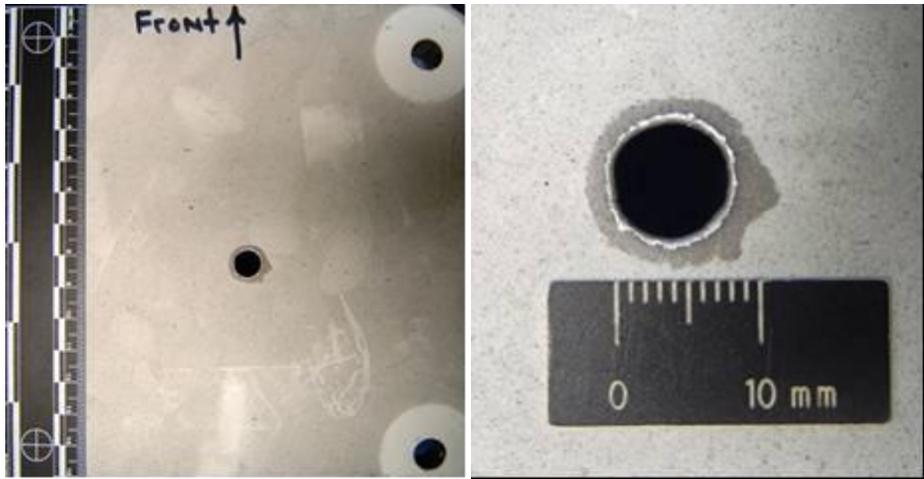
*Figure 5.3-2. Impact Test #9; Exit Side and Exit Hole Size (~0.31-inch-diameter) for a 6.35 mm Projectile [ref. 1]*

Image review of the ISS S1-3 panel 7 with the face sheet peeled up showed an MMOD impact entering on the panel back side and exiting near the panel top side outer edge, as shown in Figure 5.3-1. The team reviewed three reports [refs. 1, 16 and 17] on MMOD testing and analysis results to determine if an impact could induce the panel 7 damage. The findings in these reports indicated that MMOD particles would induce only localized damage for the size (~0.375-inch-diameter) round exit hole observed in the panel face sheet. None of the test results of larger particles indicated that MMOD could induce the observed face sheet peel. Figure 5.3-2 shows an exit hole through a radiator-like panel that is similar to the hole that was observed on panel 7. However, none of these reports had impacts on a pressurized void. So, no conclusions could be made if the MMOD hit on panel 7 was the initiation impulse or the hit occurred after the face sheet was displaced. MMOD impact testing through pressurized voids by Boeing showed a similar deflection ring around the exit hole, as shown in Figure 5.3-2. This could indicate the MMOD particle impacted a pressurized void in the panel and the impact shock wave initiated the dynamic event of the radiator face sheet peel up.

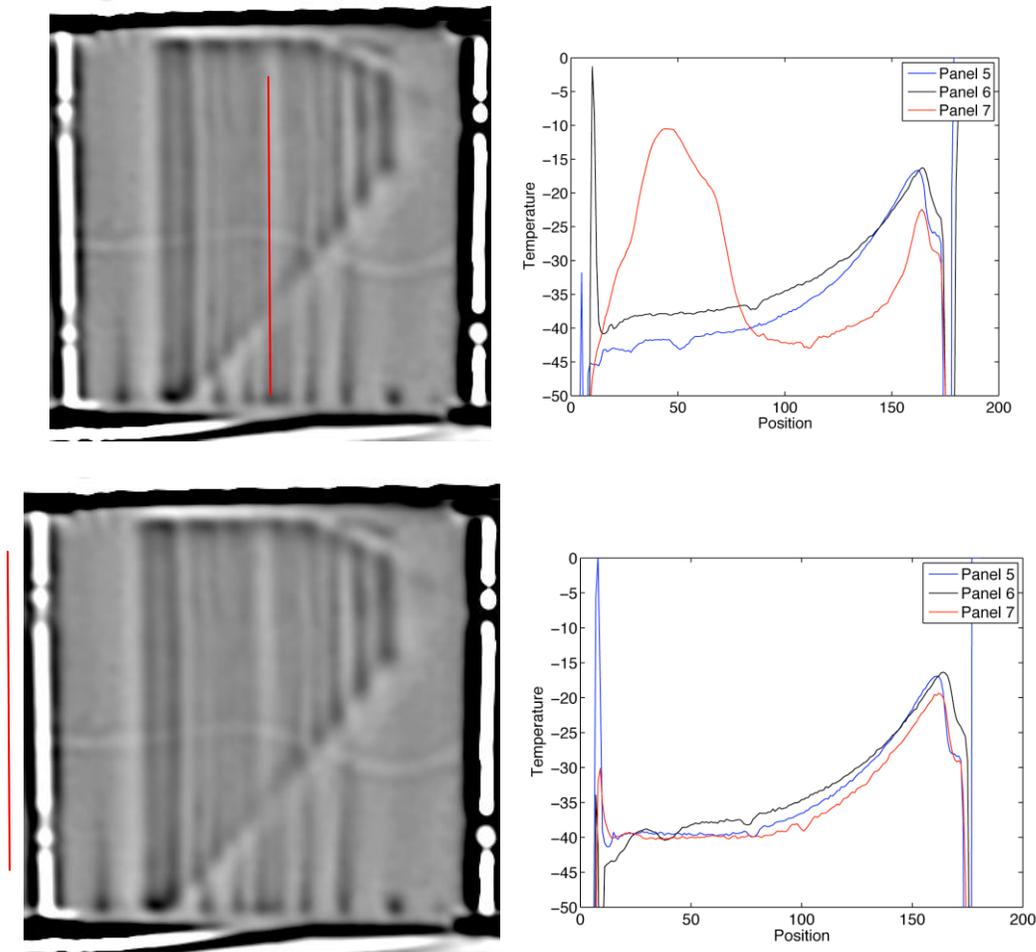
**Figure 5.4-10. Temperature Profiles for Analogous Cooling Tubes Compared for Each Radiator**

Each cooling tube was analyzed by plotting its temperature along the length of the tube, and the analogous tube in each panel directly evaluated, see Figure 5.4-10. Temperature profiles for underperforming cooling tubes are readily apparent. The tube entrance is on the right-hand side of the figure.

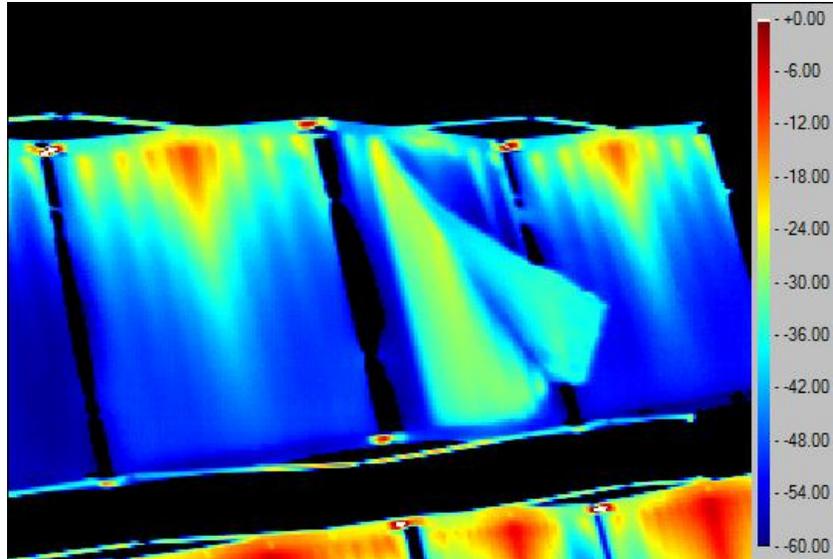
Figure 5.5-2. IR Imagery Depicting Panel-to-Panel Temperature Trends

Inspection of the geometry suggests that the form factor to space increases as distance from the radiator panel base increases, which leads to the expectation of decreasing temperatures from the forward to the aft direction. Additionally, there is a difference in form factor to space on adjacent panels due to the accordion-fold orientation (i.e., every other panel shows the increasing form factor to space trend whereas the panels in between show a different, but increasing, trend which is explained by their different orientation). This trending provides a qualitative correlation with the observed decreasing temperature trend (i.e., corresponding points on similarly pointed panels, moving from forward to aft) observed in the IR imagery, as shown in Figure 5.5-2.

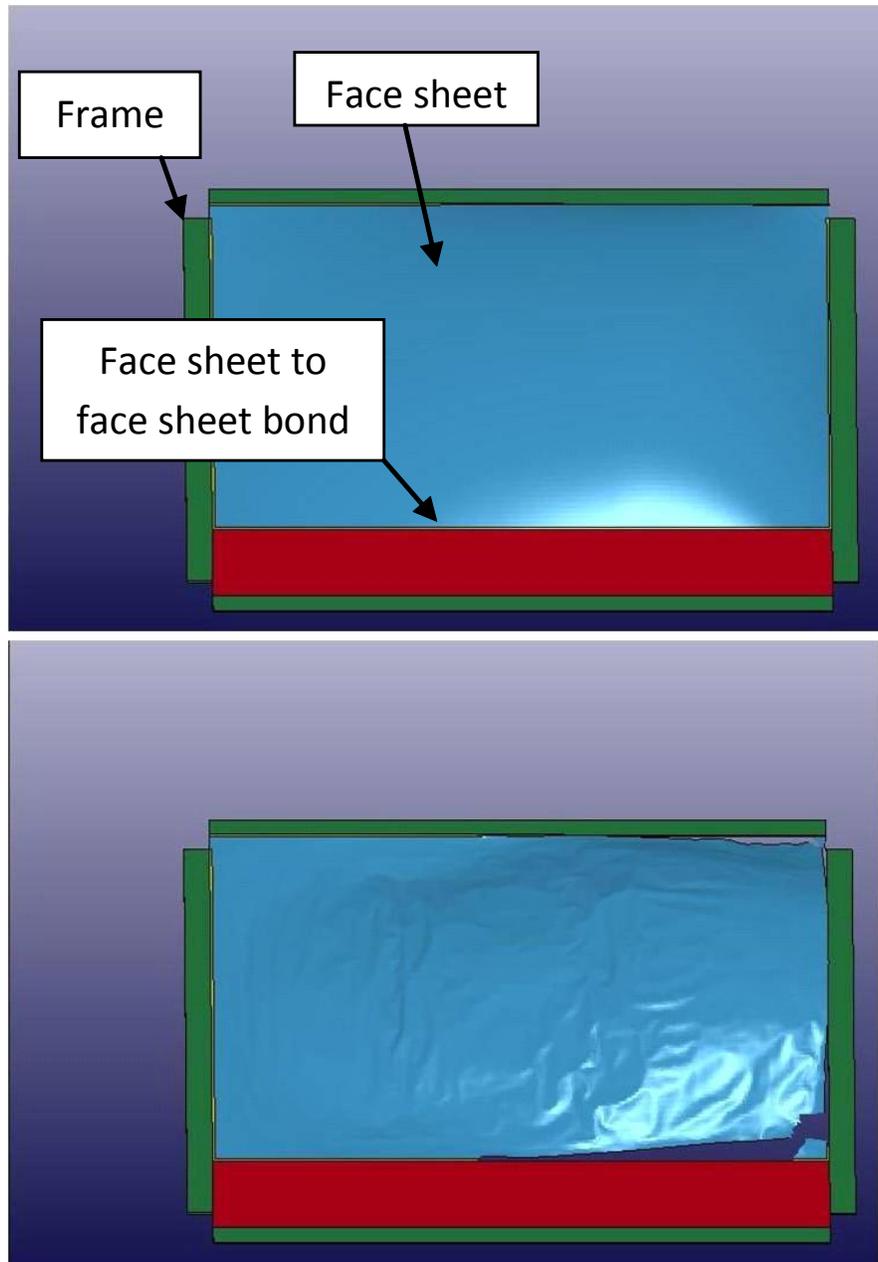
***Figure 6.2-1. (Top) State of Face Sheet Prior to Failure Initiation, (Bottom) Face Sheet Failure Propagation***

In the simulation, the face sheet is lifted in the direction of pressure (Figure 6.2-1, top). The failure initiated at the edge on the side of the largest load and propagated in both directions along the edge, turned the corners and continued along the edge (Figure 6.2-1, bottom). The face sheet lifted and folded over while tearing from the edge as shown in Figures 6.2-2 and 6.2-3.

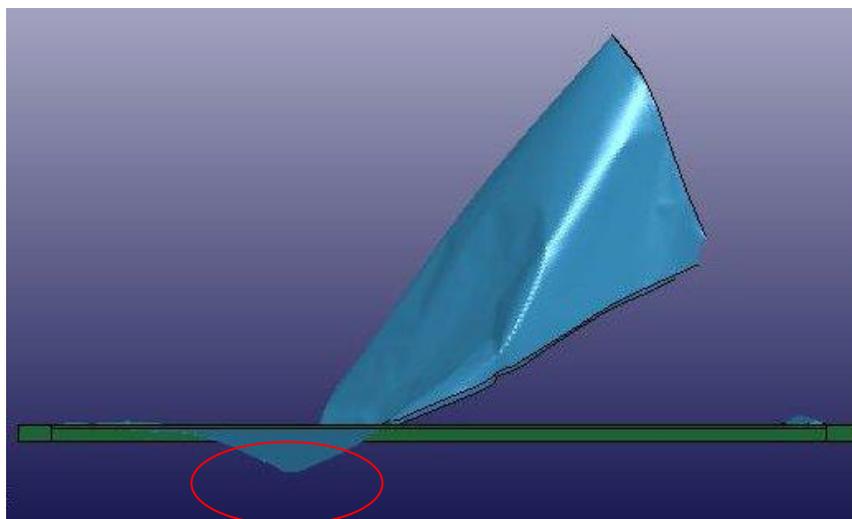
*Figure 6.2-4. Side View of Figure 6.2-2 Depicting Incorrect Penetration of the Face Sheet into the Honeycomb Volume*

As previously stated, the honeycomb substrate was not included in the model as it was not expected to add to the face sheet loading during rupture. However, the lack of a honeycomb boundary in the model resulted in an analytical artifact in which the face sheet penetrated into the volume in which the honeycomb would have been (Figure 6.2-4). In reality, contact with the honeycomb would constrain the face sheet from entering this volume. An analytical contact surface representing the honeycomb boundary was added to Model 2.0.

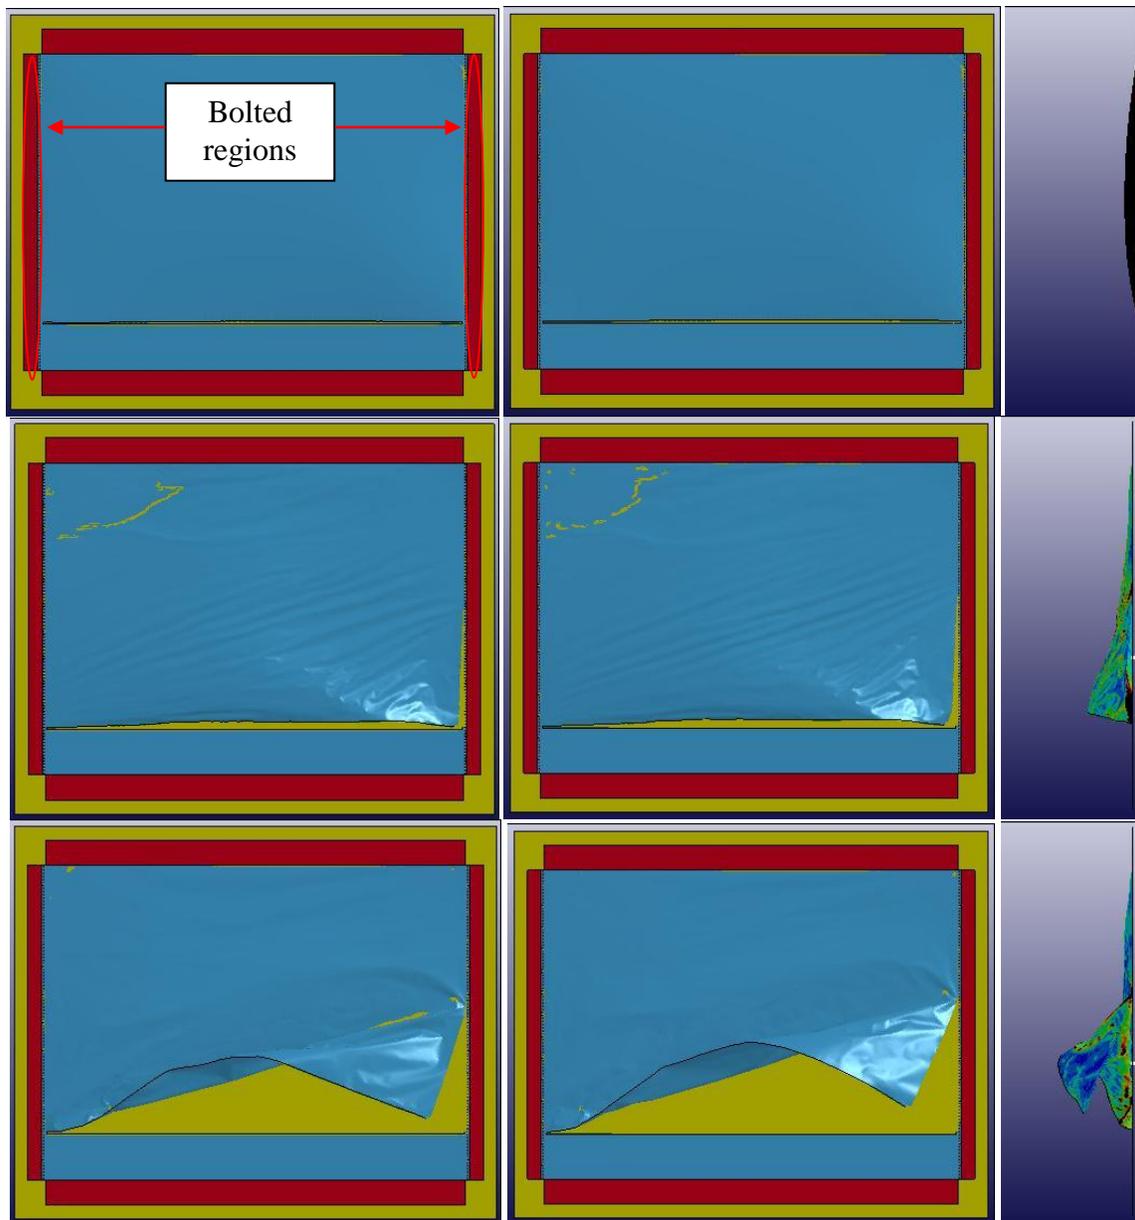
*Figure 6.3-3. Failure Propagation in Model 2.0, Front and Side Views*

A comparison between Figures 6.3-3 and 6.3-4 shows the sensitivity of the pressure ramp down to the final state of the face sheet. The uncertainty in the load ramp down after rupture was studied by analyzing two different definitions for the pressure decay during the rupture event (Figure 6.3-2). The two definitions are the only difference between Models 2.0 and 3.0. Model 4.0 implemented the original linear version of the load ramp down. The final model version (i.e., 5.0) used a different curve based on an updated calculation.

In the simulation, the failure was initiated at the face sheet-to-face sheet lap shear bond. The failure propagated around the right corner, and then continued tearing along bolt holes. The face sheet lifted and began to fold. In both models, with greater face sheet-to-radiator angle, the face sheet begins to tear from the bolted constraint (see Figures 6.3-3 and 6.3-4). Key events in the time sequence begin with: first element failure at 0 seconds, followed by full bolt pullout and face sheet-to-face sheet bond failure at 0.05 seconds, maximum face sheet height above panel at 0.15 seconds, face sheet initial contact with itself at 0.21 seconds, and then impacts the neighboring panel at 0.25 seconds. The tearing was much greater in Model 3.0. The face sheet made a high-energy contact with itself (i.e., a whipping motion), and extensive permanent face sheet wrinkling occurred.

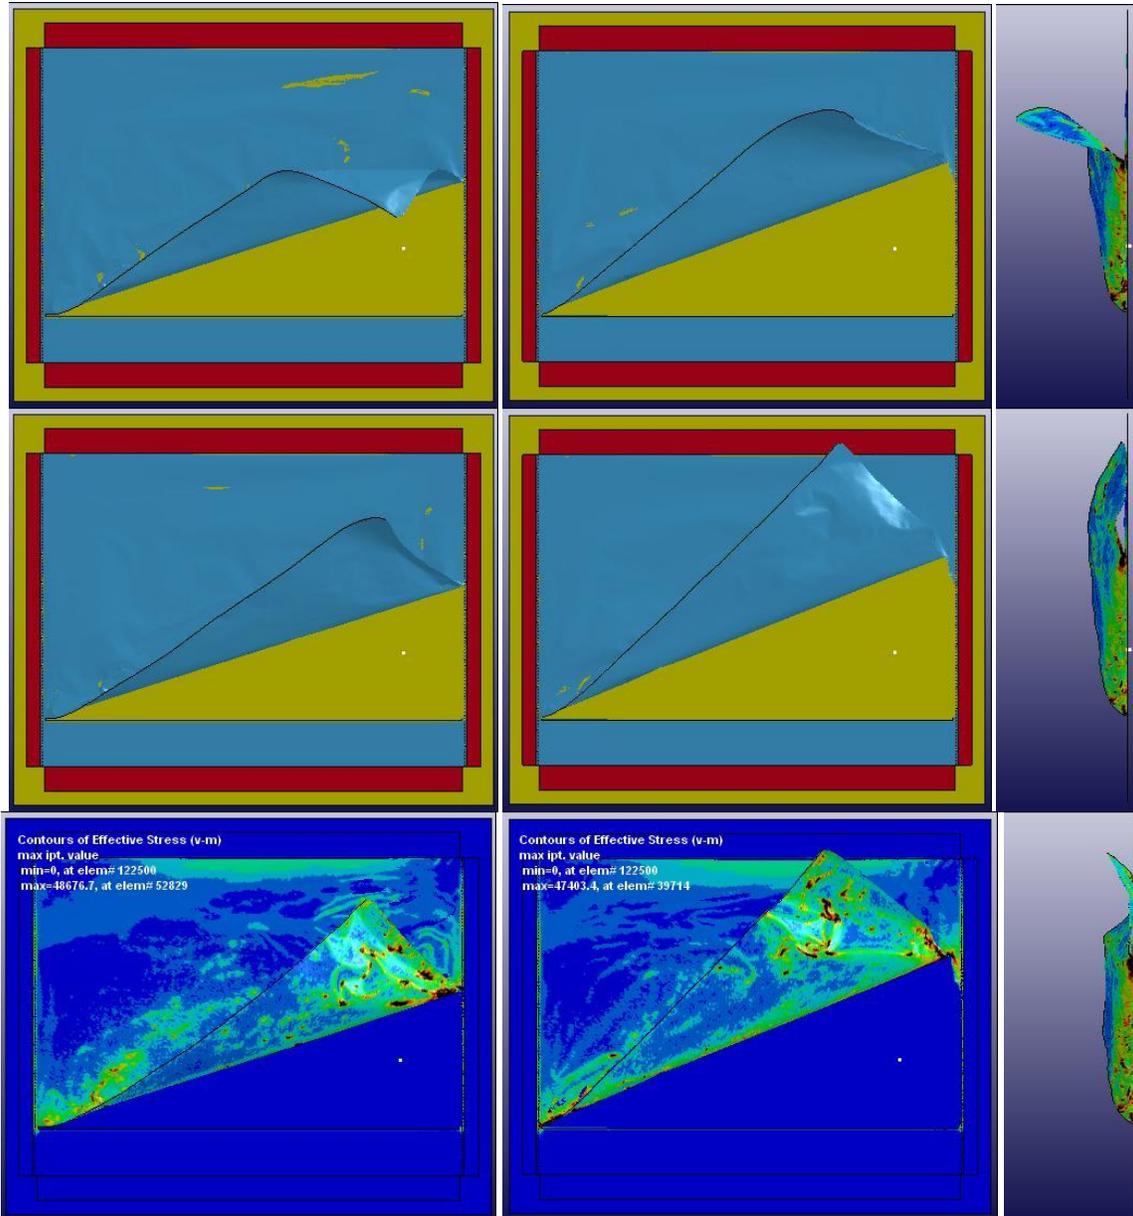
**Figure 6.3-4. Failure Propagation in Model 3.0, Front and Side Views**

Figure 6.3-4 includes a side view of the stress state (note the stresses in the folded region). The model shows permanent deformation in this folded region. Due to computational constraints, the model was not run long enough to show the face sheet final resting form. However, this permanent deformation implies curvature will remain in the face sheet during its resting state. On-orbit images of the damaged panel 7 show this phenomenon, as seen in Figure 6.3-5.

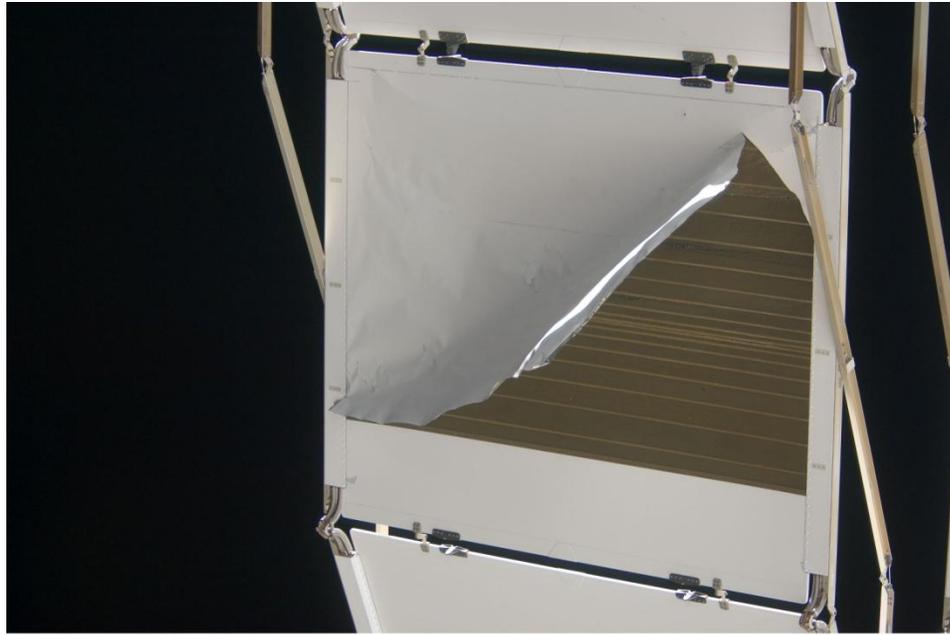
ISS017E020030

**Figure 6.3-5. On-orbit Image of Radiator Panel showing Face Sheet Displacement**

bond failed as the face sheet lifted from the panel. Additionally, the on-orbit images (Figure 6.3-5) showed that this bond had separated rather than ruptured.

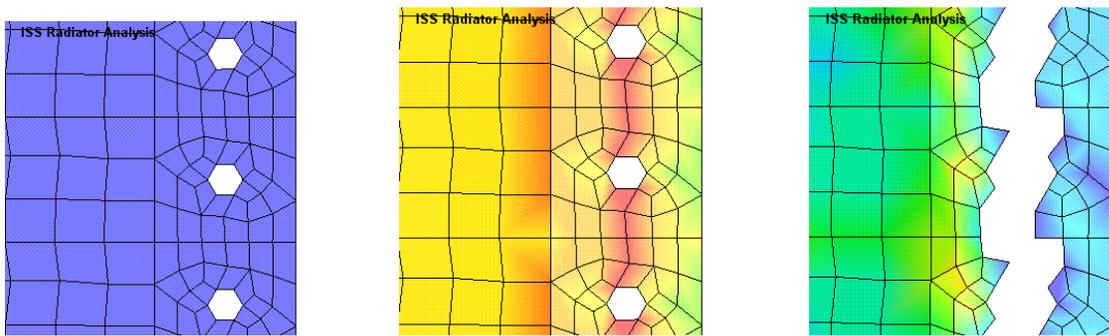
Figure 6.3-6 presents another similarity of the model to the on-orbit photos in the tearing away of the face sheet from the bolted constraint region.

**Figure 6.3-6. Face Sheet Tearing Along the Bolt Holes**

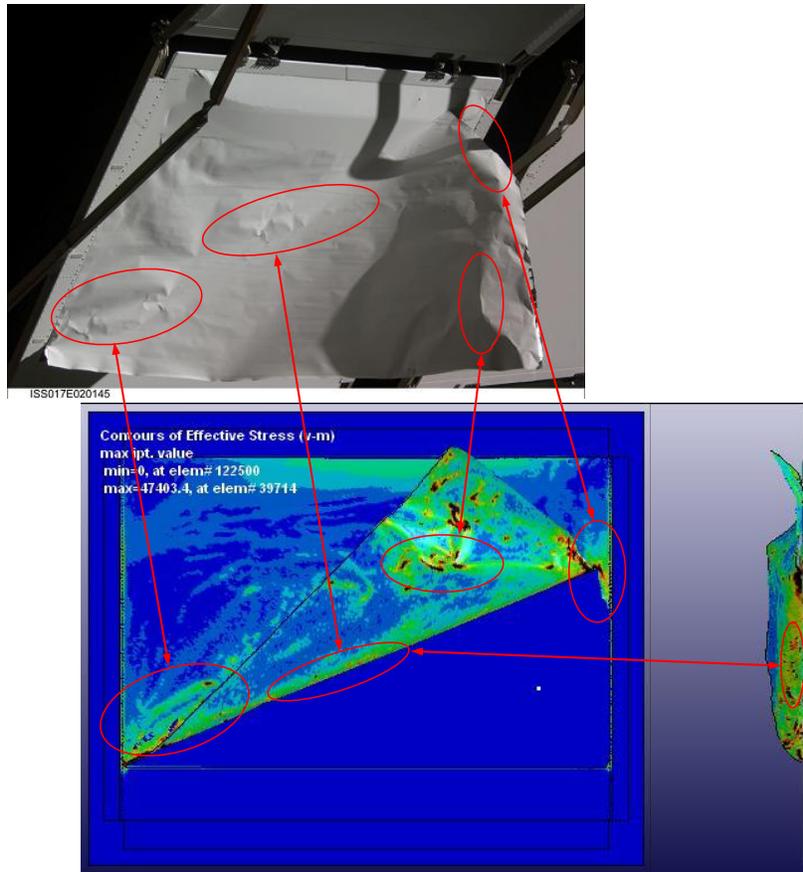
Figure 6.3-7 shows a comparison of modeling wrinkling features to similar features from on-orbit images. Note that the face sheet in the model snapshot is in a folded position only because it was not run long enough to equalize to the lifted resting position.

*Figure 6.3-7. Comparison of Wrinkling Features to On-orbit Images*

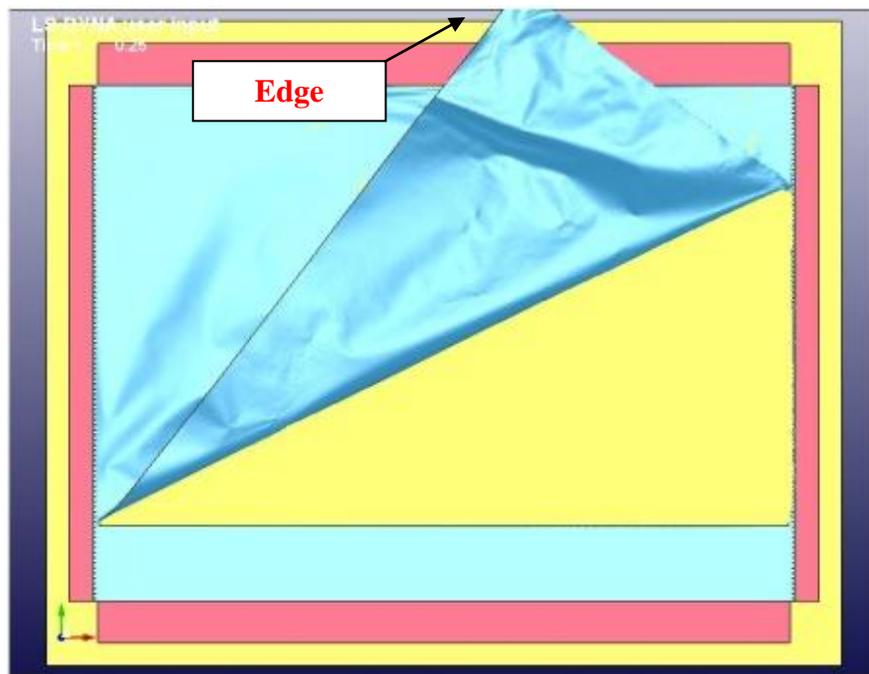
Similar to previous models, the face sheet lifted and folded on itself, and tore from the bolted region, as shown in Figure 6.4-2. Previous models showed the impact of the face sheet top edge in a whipping motion. In Model 4.0, the pressure at rupture was higher. This added rupture energy allowed the face sheet to tear further along the bolted region, which caused the impact to occur off the panel.

*Figure 6.4-2. Model 4.0 at Impact State*

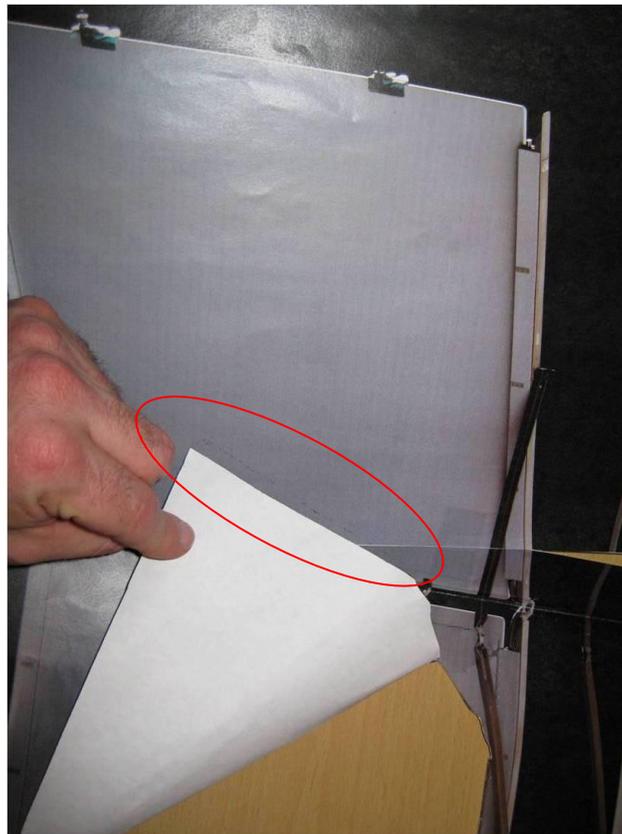
On-orbit images showing marking (Figure 6.4-3) on the neighboring panel confirm face sheet impact on the neighboring panel. A simple paper model of the panel was used to show that the markings line up with a folded face sheet and is shown in Figure 6.4-4.

*Figure 6.4-4. Simple Paper Model shows the Folded Face Sheet Lines up with the Marking on the Neighboring Panel*

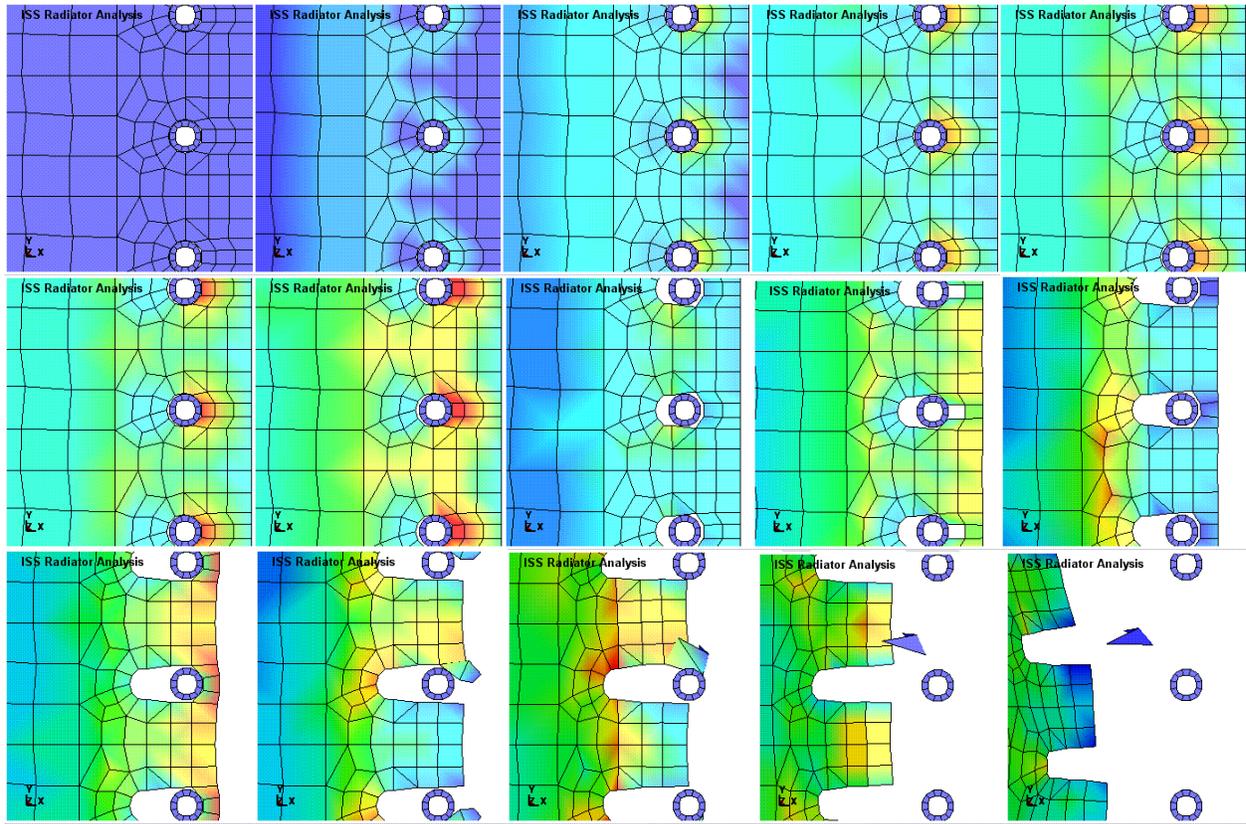
In the Model 5.0 simulation, the face sheet was lifted in the direction of pressure. The failure initiated at the bolt holes as they began to pull from the bolts (Figure 6.5-3). The red regions in this figure indicate locations where stresses were approaching the material failure criterion. When this criterion is exceeded, the element was deleted, allowing for the bolt to pullout. The bolt pullout phenomenon propagated in both directions from the initiation location as the face sheet began to lift locally. Further from the failure initiation location, the failure phenomenon transitioned from bolt pullout to tearing along the bolt holes. As the failure reached the face sheet-to-face sheet bond, the bond failed in peel. The face sheet proceeded to lift and to fold. As the angle of the face sheet to the radiator increased, the face sheet began to tear from the bolted region. The face sheet then made contact with the analytical contact surface representing the neighboring face sheet in a high-energy whipping motion.

*Figure 6.5-3. Zoomed View of the Failure Progression as the Face Sheet Pulls from the Bolts*

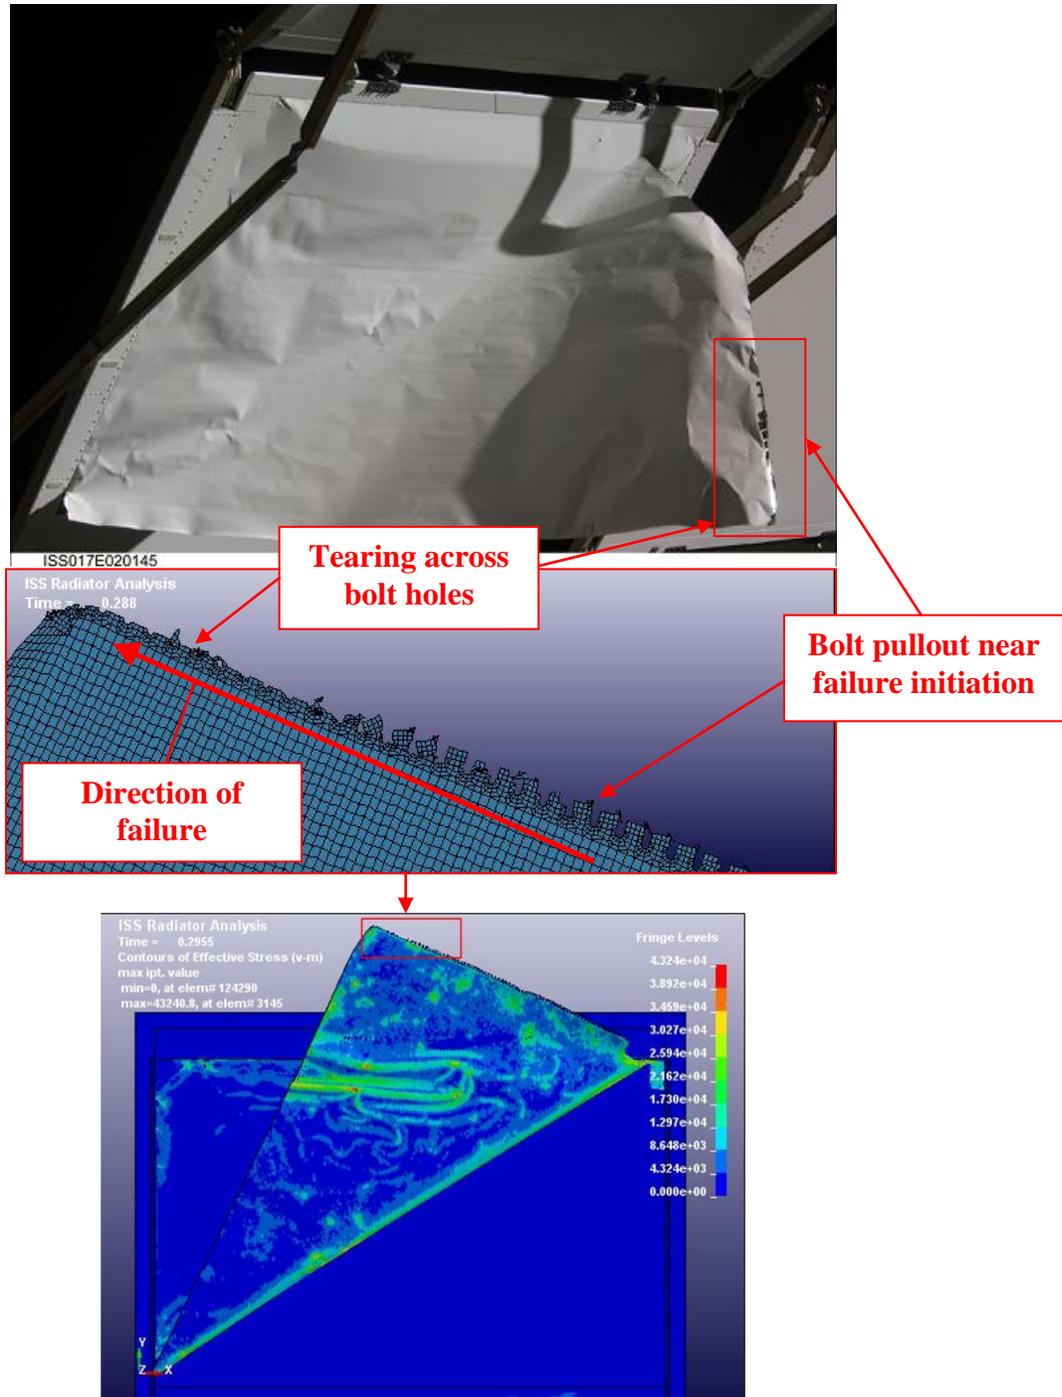
The model and the on-orbit images show a distinct bolt pullout region. Figure 6.5-4 shows the bolt pullout region to be the location of failure initiation. It may be theorized that the on-orbit face sheet rupture initiated where the bolt pullout features initiated in the region where bolt pullout features have been discovered. In another similarity to the model, the on-orbit images show a permanent transition from bolt pullout to tearing across the bolt holes.

Figure 6.5-4. Comparison of Bolt Pullout Near Failure Initiation and Tearing Along Bolt Holes

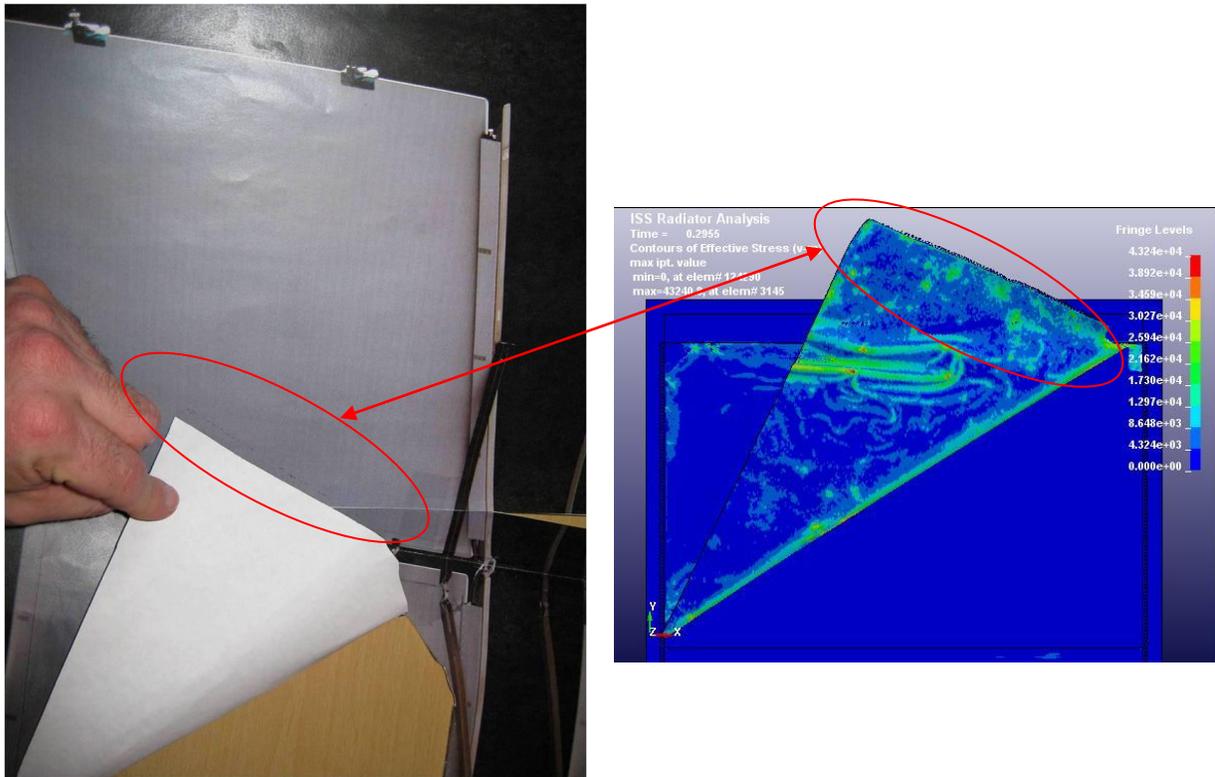
In Model 5.0, the failure propagated further than in previous models. This allowed the location of the high-energy impact of the face sheet edge to correspond more closely with the on-orbit markings on the neighboring panel as shown in Figure 6.5-5.

**Figure 6.5-5. Comparison of the Location of the Contact Edge in the LS-DYNA<sup>®</sup> Model to the Paper Model**
